Catastrophic Failure of Aging Underground Pipelines Is Inevitable in Corrosive Soils and CP Shielding Conditions False Sense of Security!

M. ZEE, PHD

Sept . 7, 2017

Exova

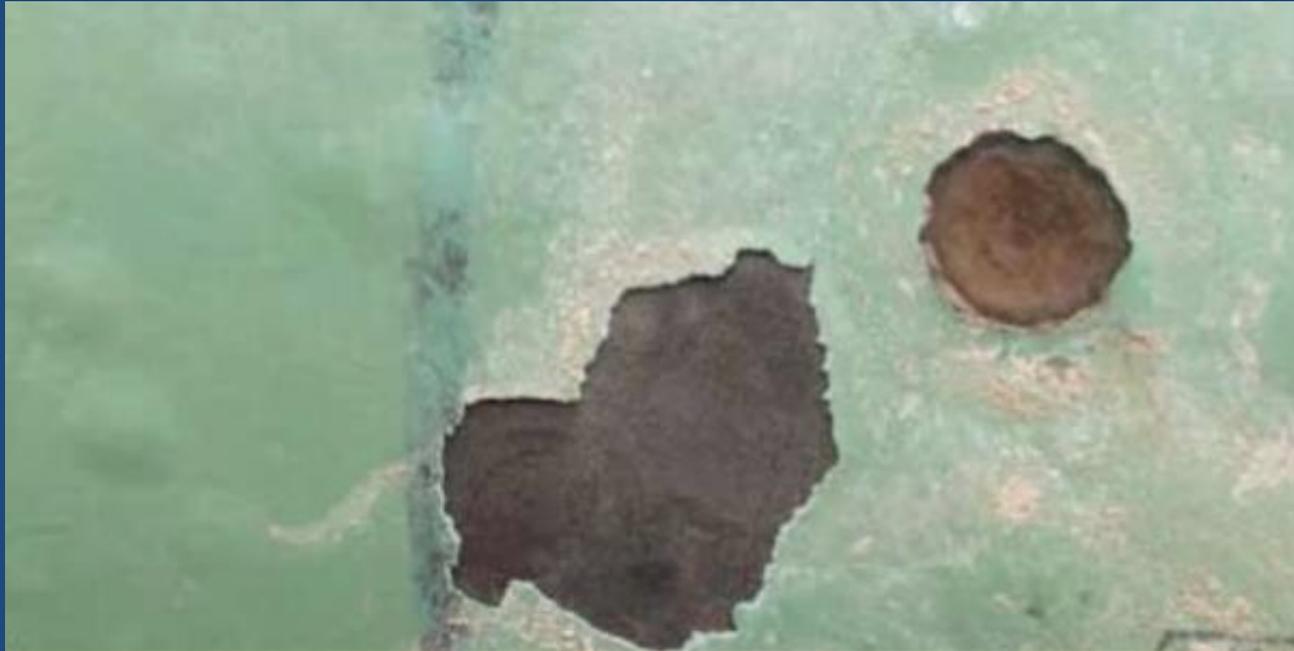
Localized Corrosion?

1-Cathodic Protection Shielding

2-Electrodeposition and Conductive Soil

3-Excessive Potentials: Active and or Noble Potential

4-Stray Current and AC Interference

5-No or Less than Adequate CP

6-Copper Grounding

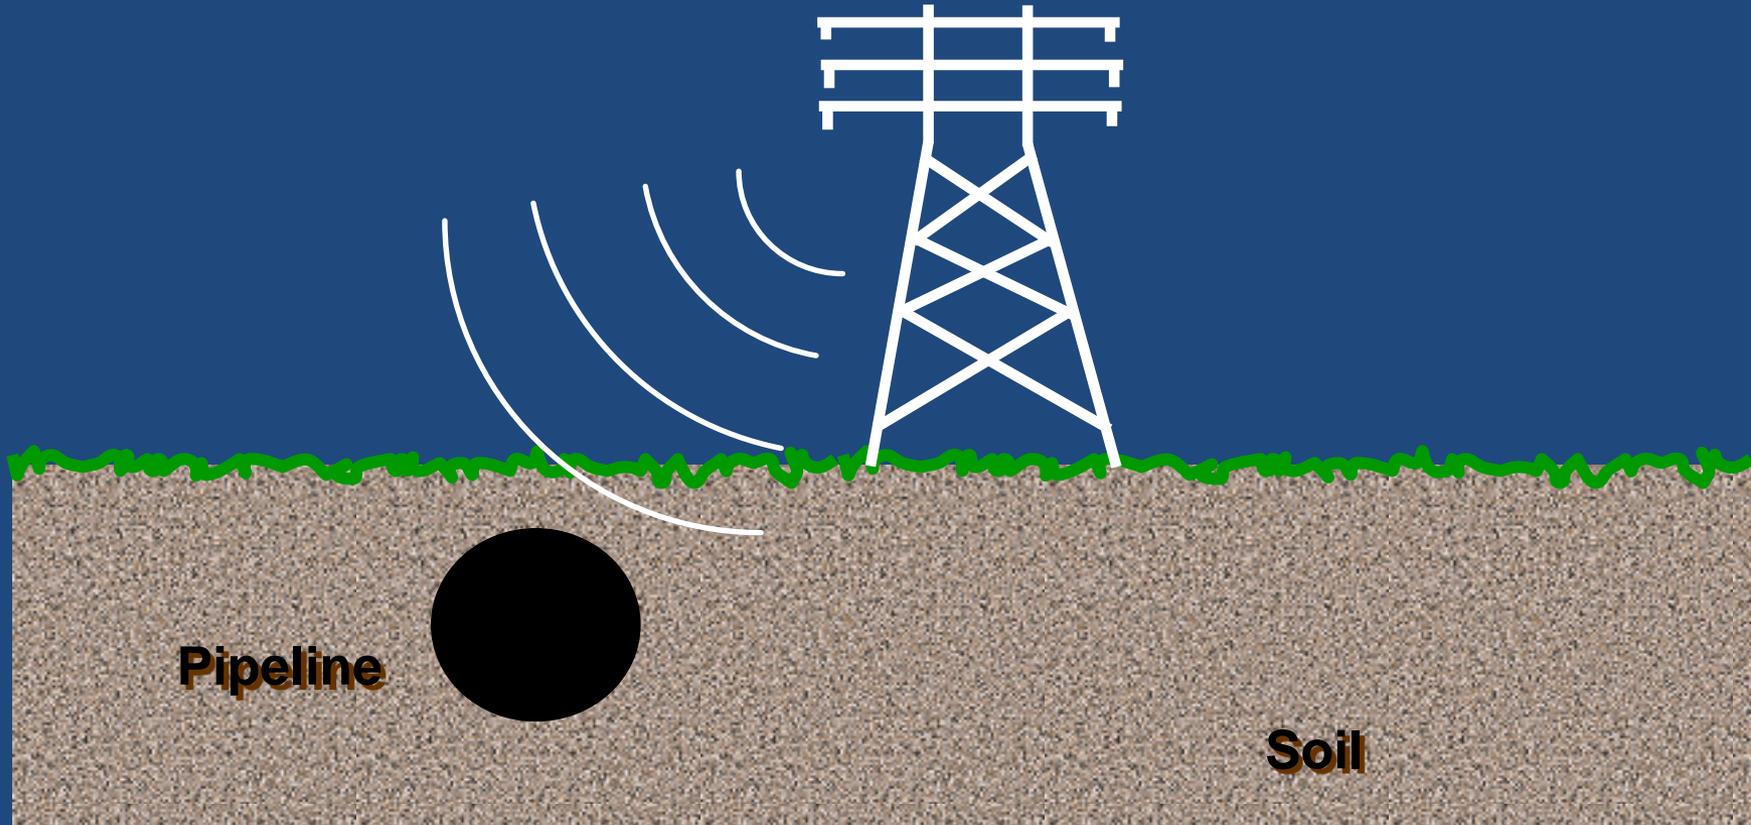
AC Interference

The magnetic field generated by the overhead power lines induces an AC voltage onto the pipeline. The magnitude of such currents depend on many factors such as coating condition, soil resistivity, power line voltage, distance, etc.

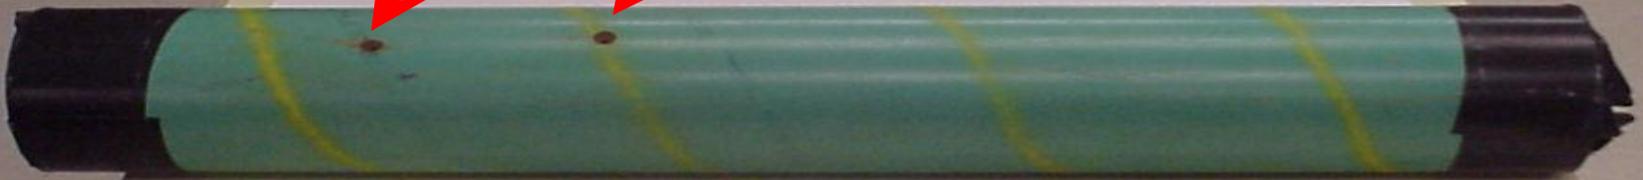
Underground Corrosion

Stray Current Corrosion: Unacceptable Risk: Immediate Action

**Stray Current Corrosion
(6 months only)**

Highly Localized

**No problem with
coating**

**Potential
Irregularities**

**Materials Meet
Specifications**

Root Cause of Failure: Stray Currents

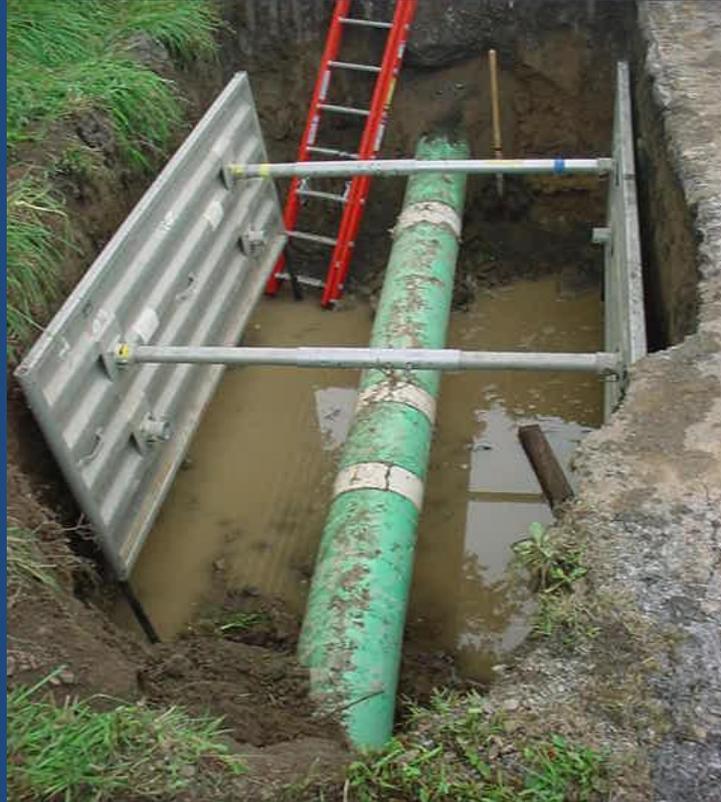
Aging Pipeline
Coatings

Corrosive Soils/Ions

Corrosive Water Table

DC stray corrosion

AC Interference

Shielding to CP

MIC

Detection of corrosion activity at blistered areas prior to deep penetration in the pipe is of great importance under corrosive conditions

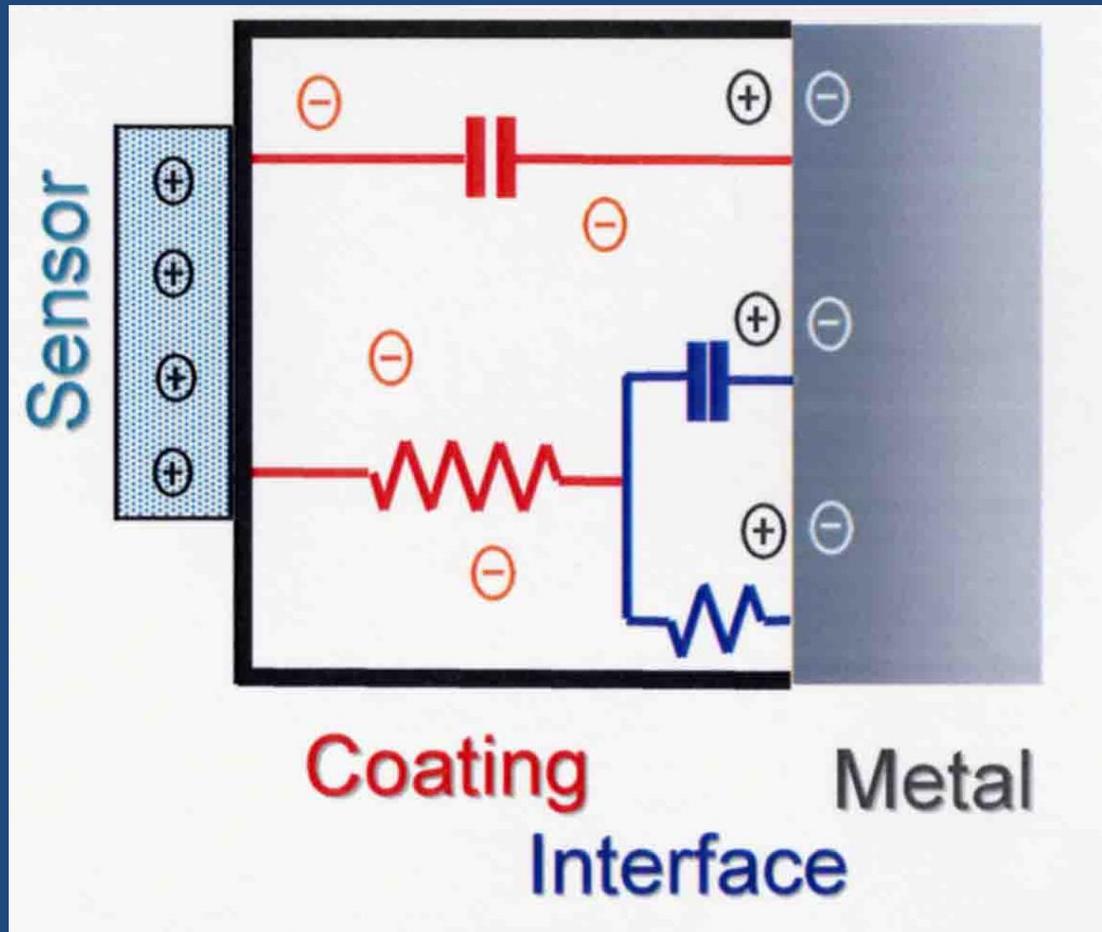
Electrochemical Test Set-Up

- These tests use a computerized electrochemical system and EIS software to collect data and help with analyses.

Below are basic set-ups used for testing coatings:

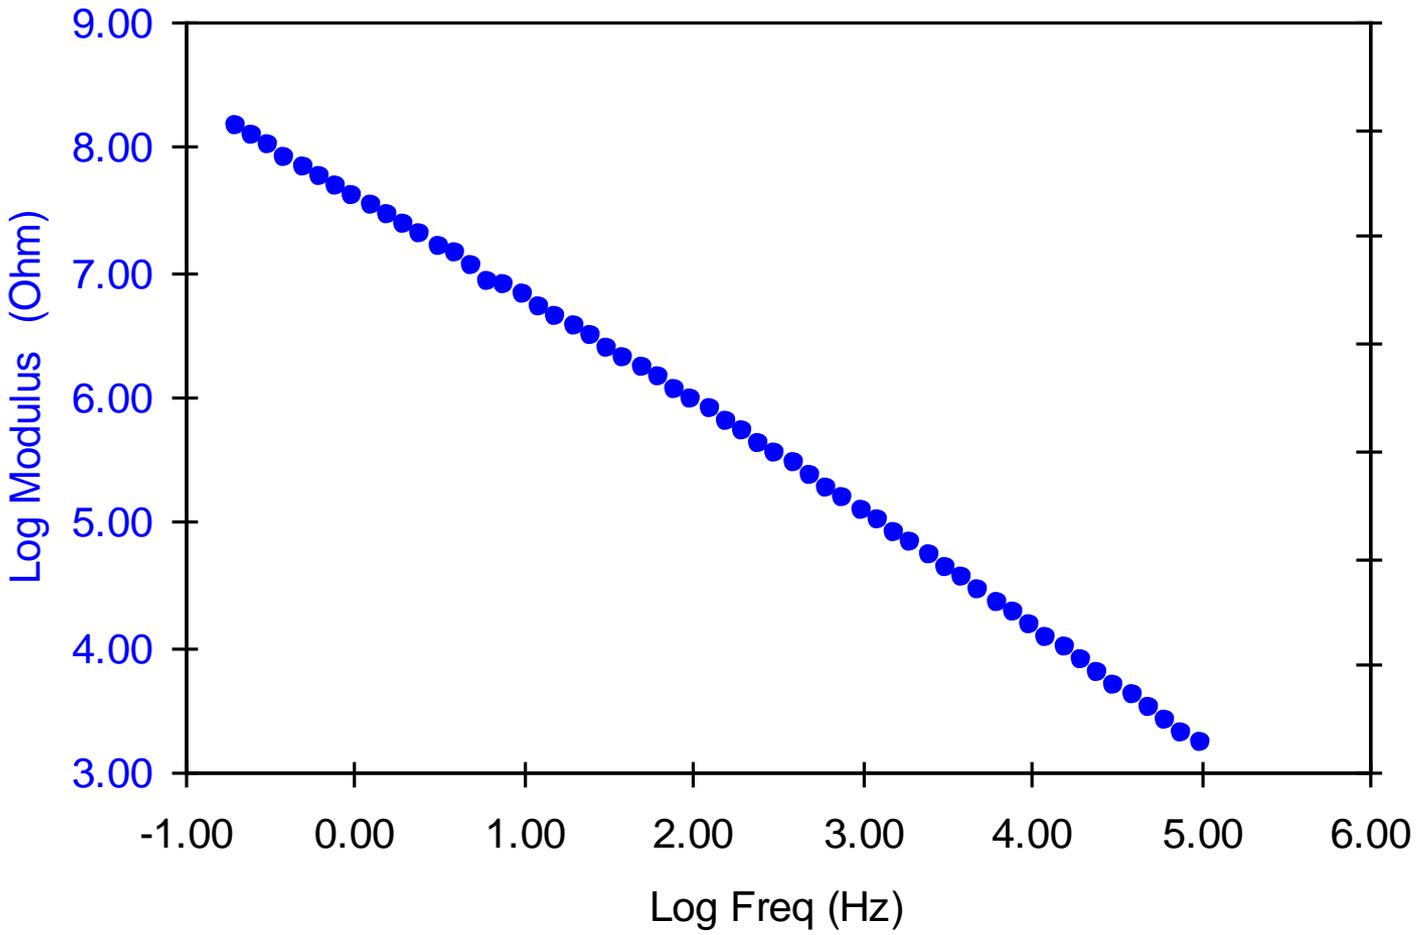
Electrochemical Behavior of a Purely Capacitive Coating (Ideal)

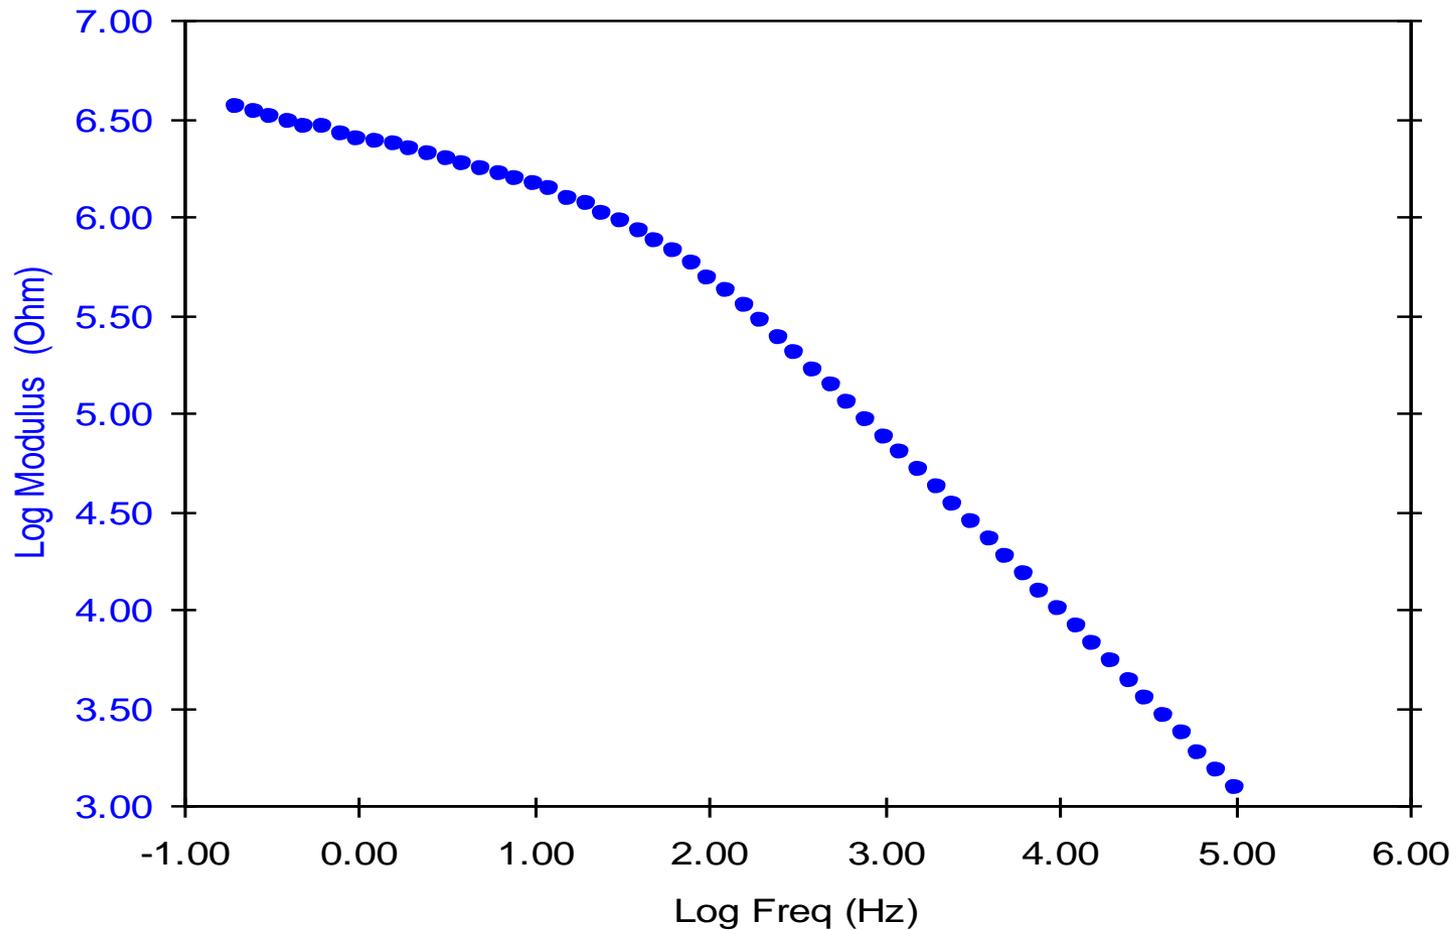
Electrochemical Degradation (from Ideal) of an Organic Coating

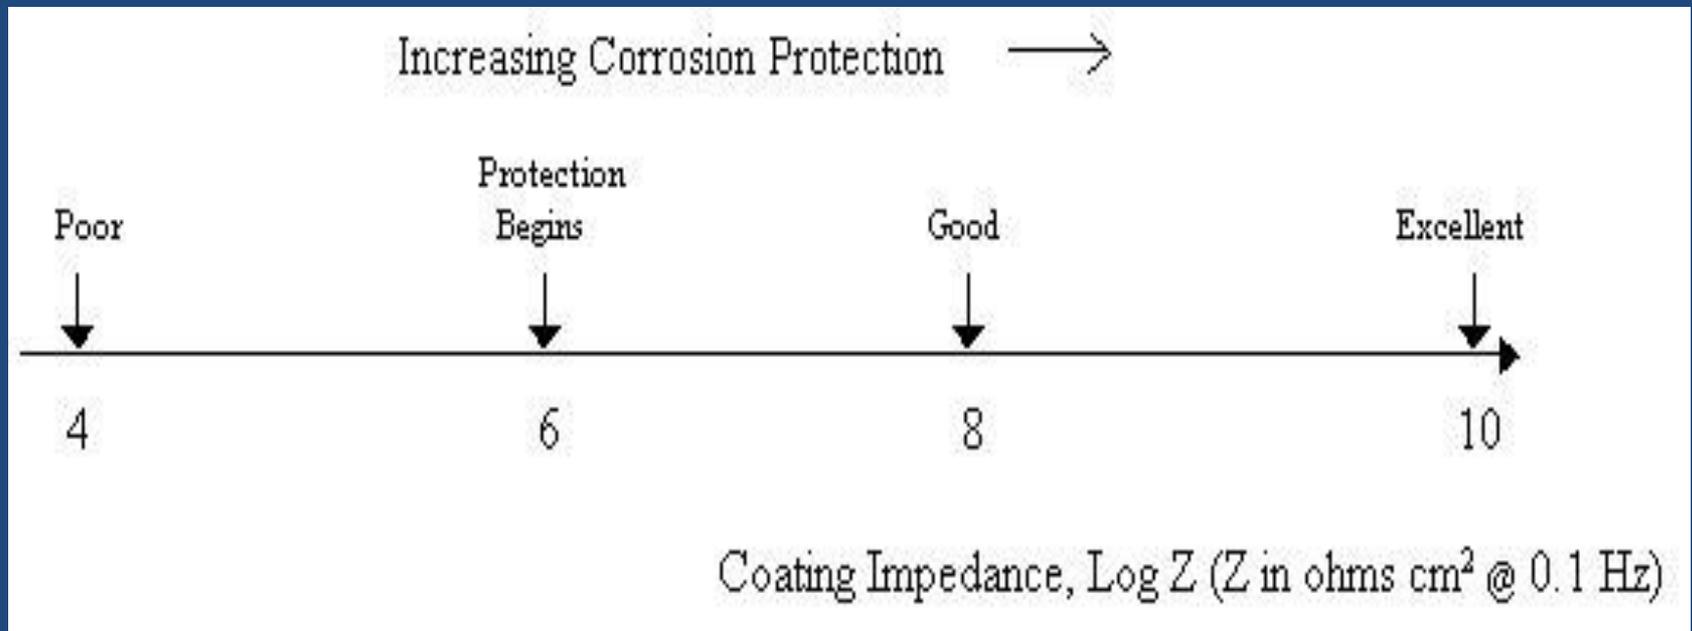
Corrosion Protection of Organic Coating In Moderately Corrosive Immersed Conditions

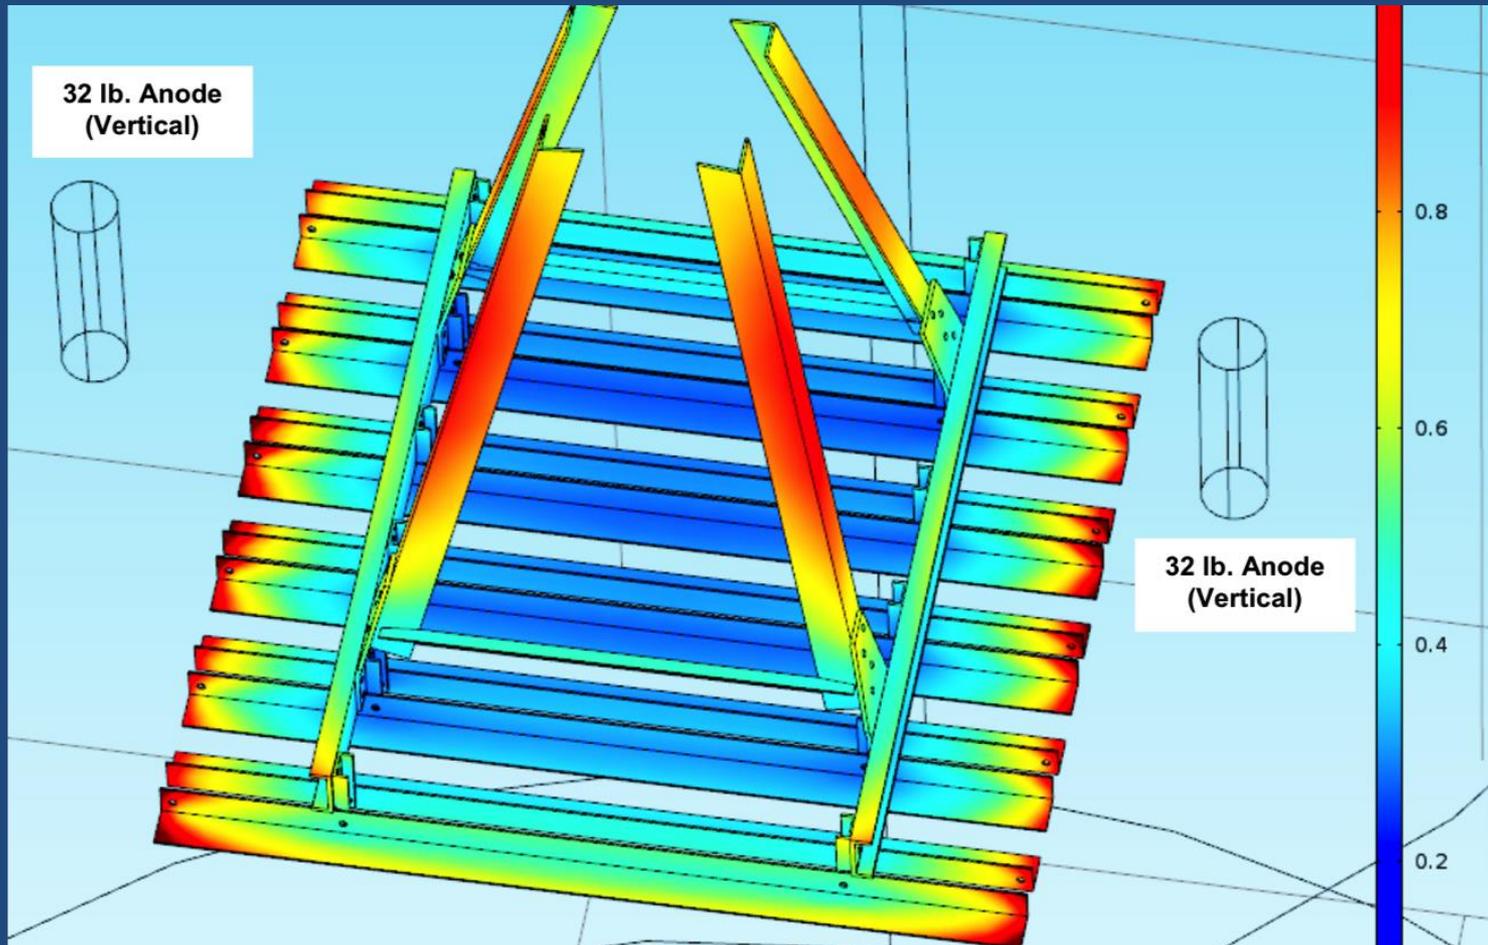
Potential Distributions and Shielding

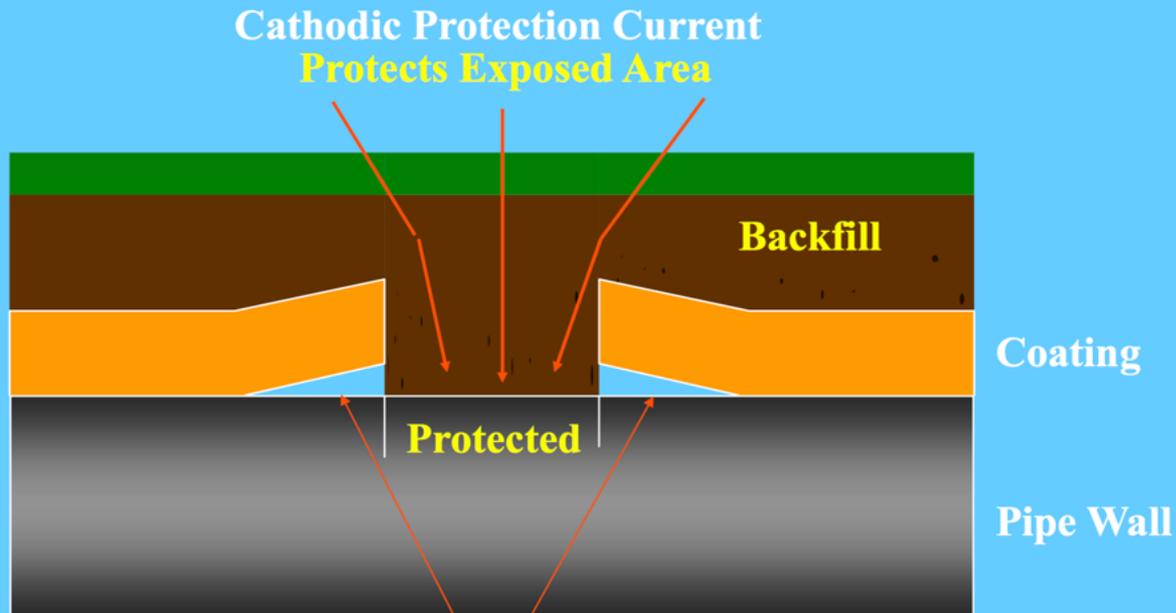
Coating Disbondment & CP Shielding

Cathodic Protection Current Does Not Protect
Area Under Disbonded Coating

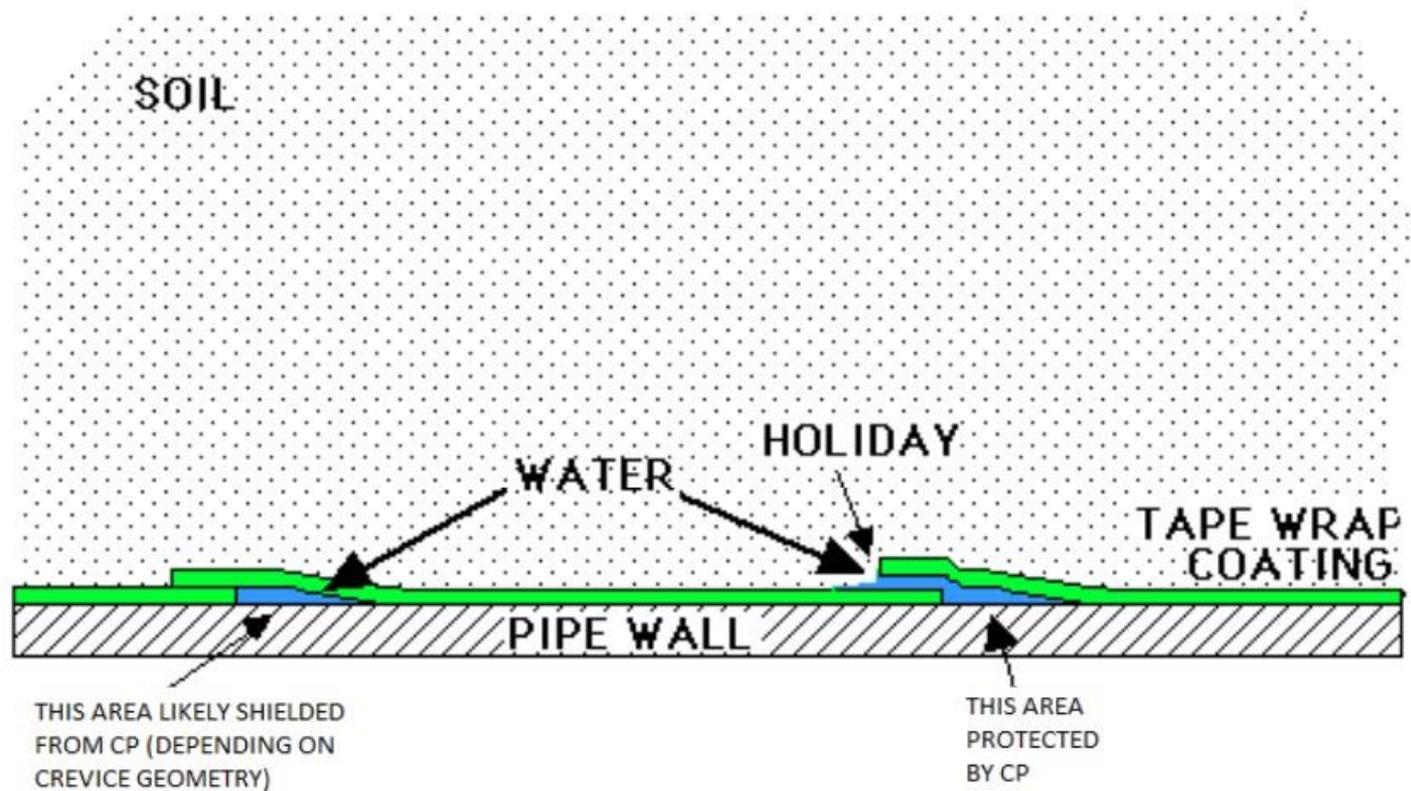
CP Shielding by Tape Wraps

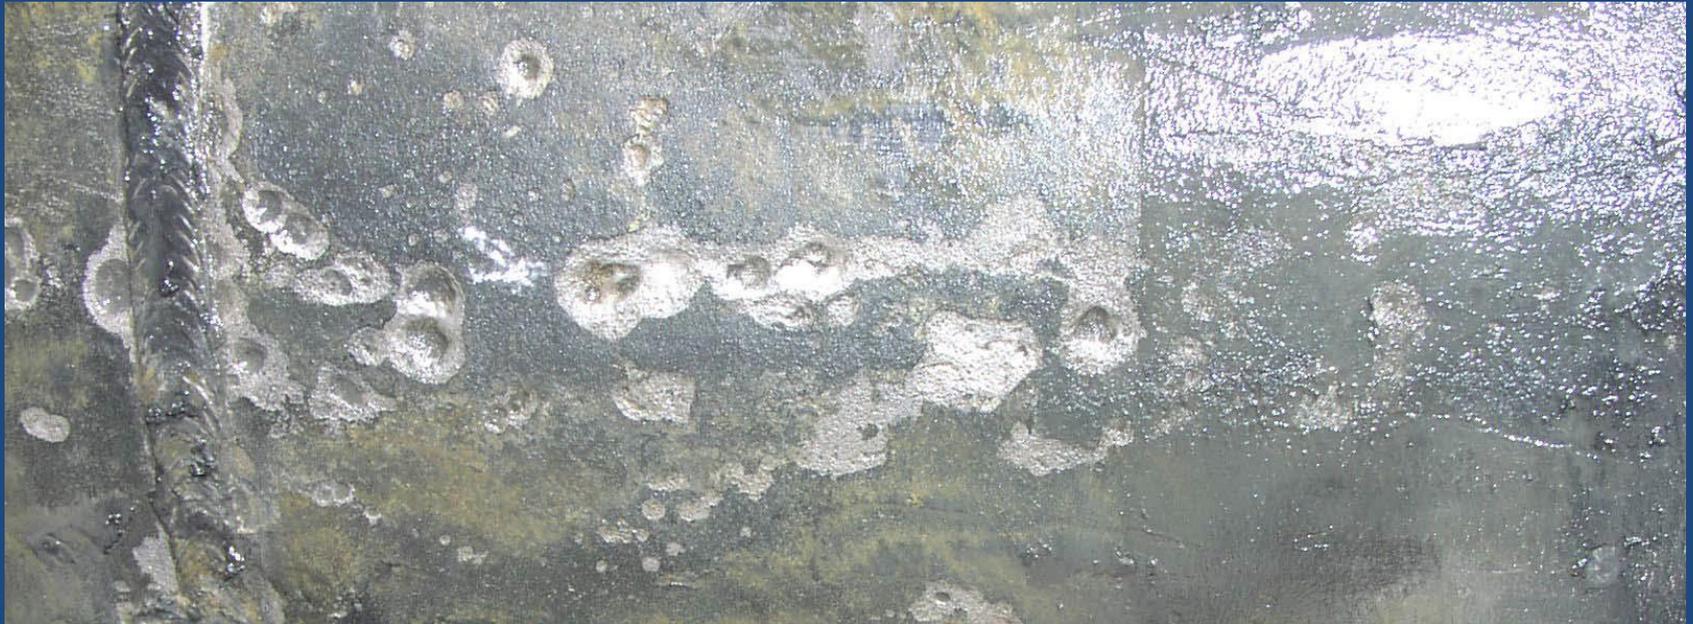
Corrosion Under Coating That Shields CP

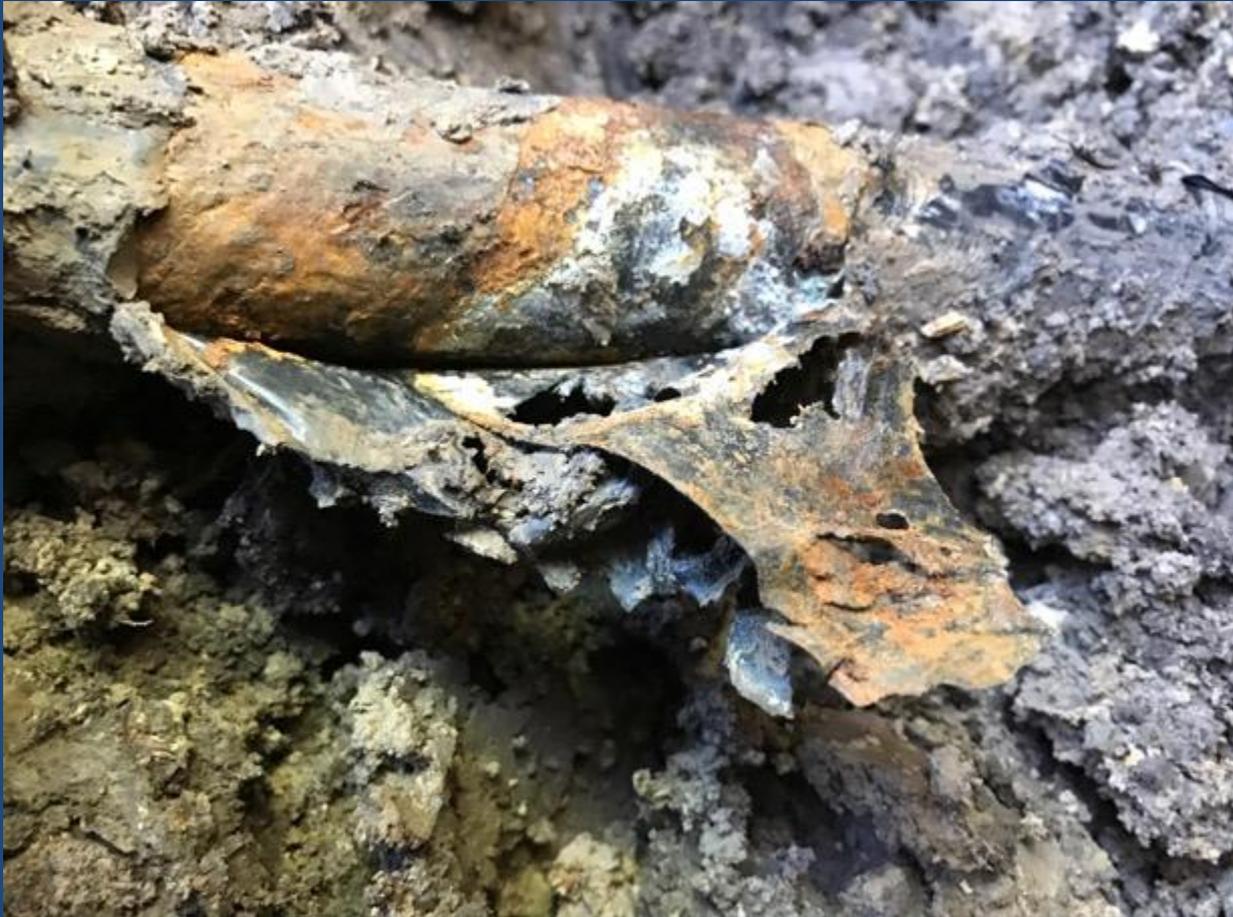
Coating That Shield Cathodic Protection

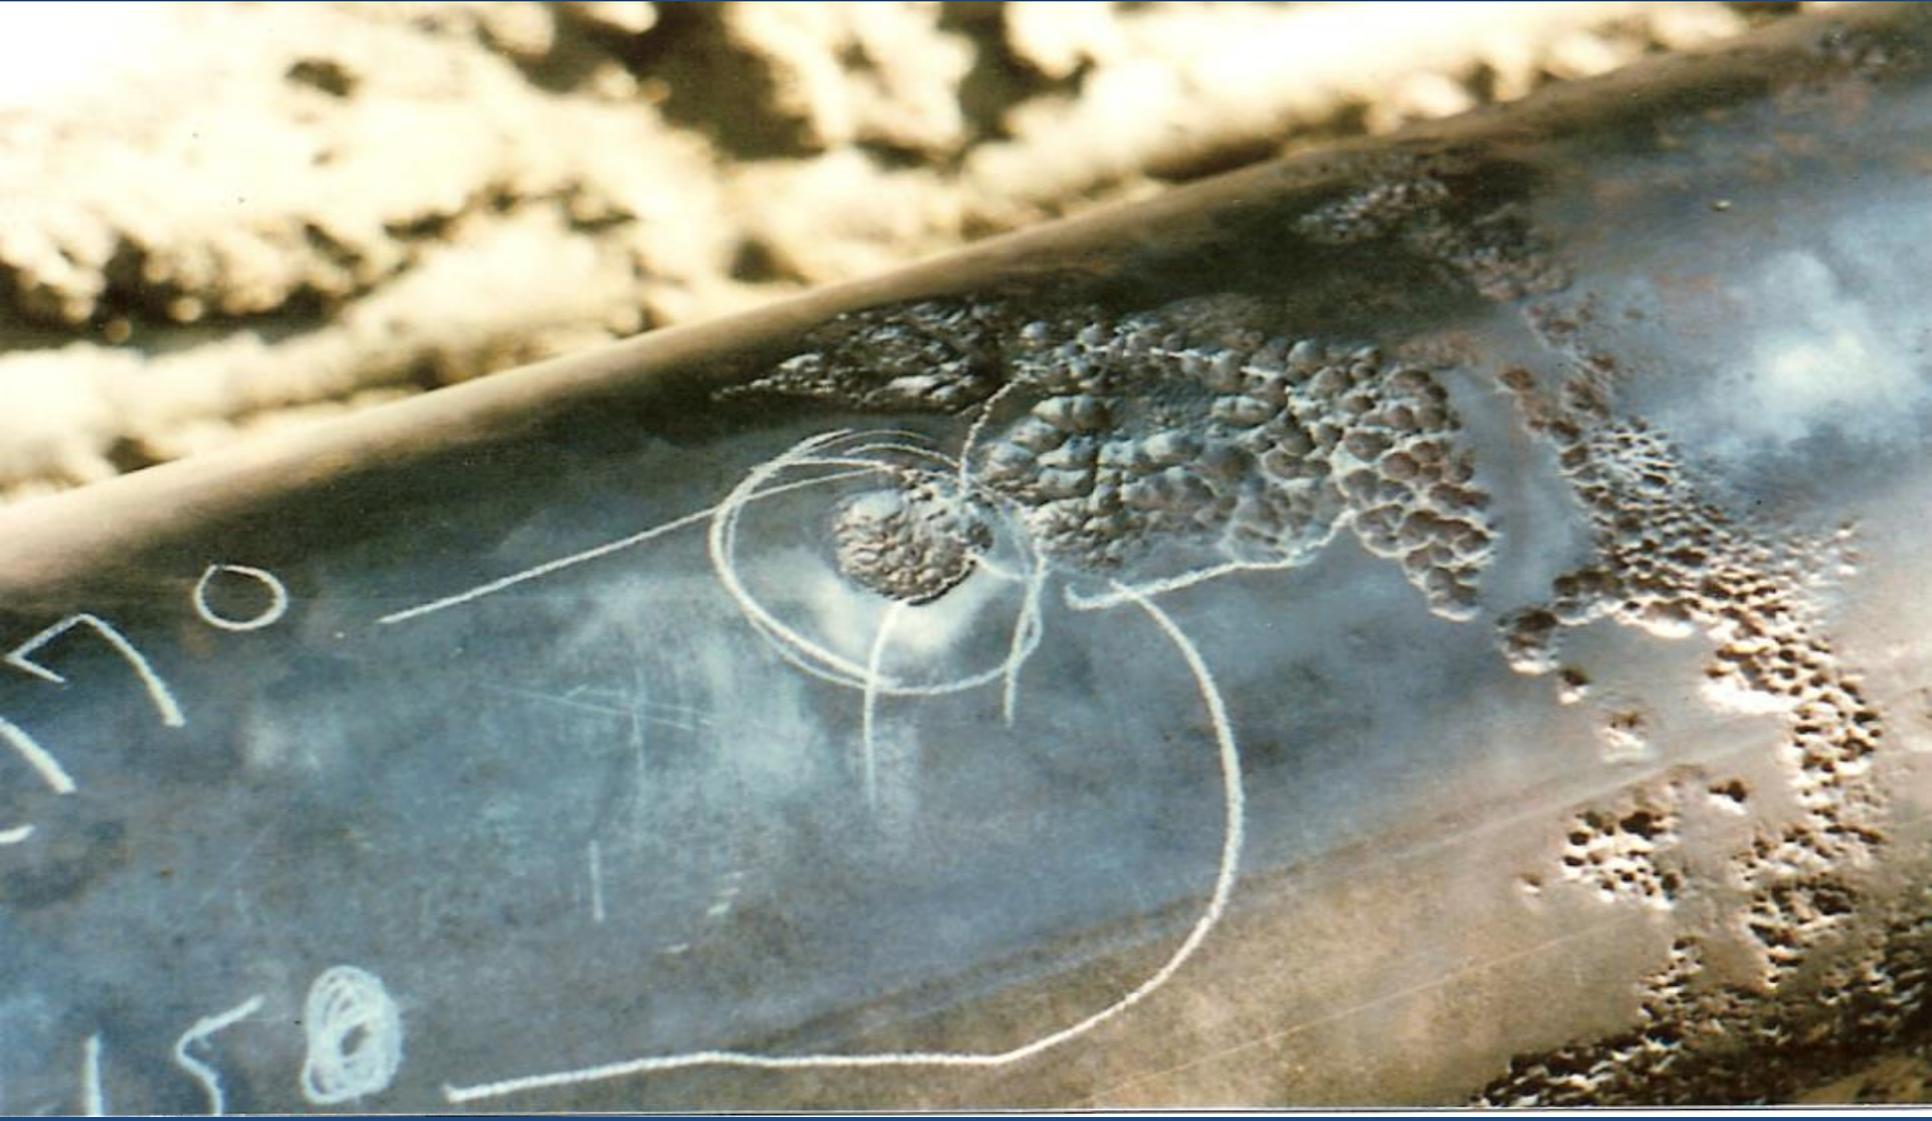
Accelerated Corrosion Due to CP Shielding

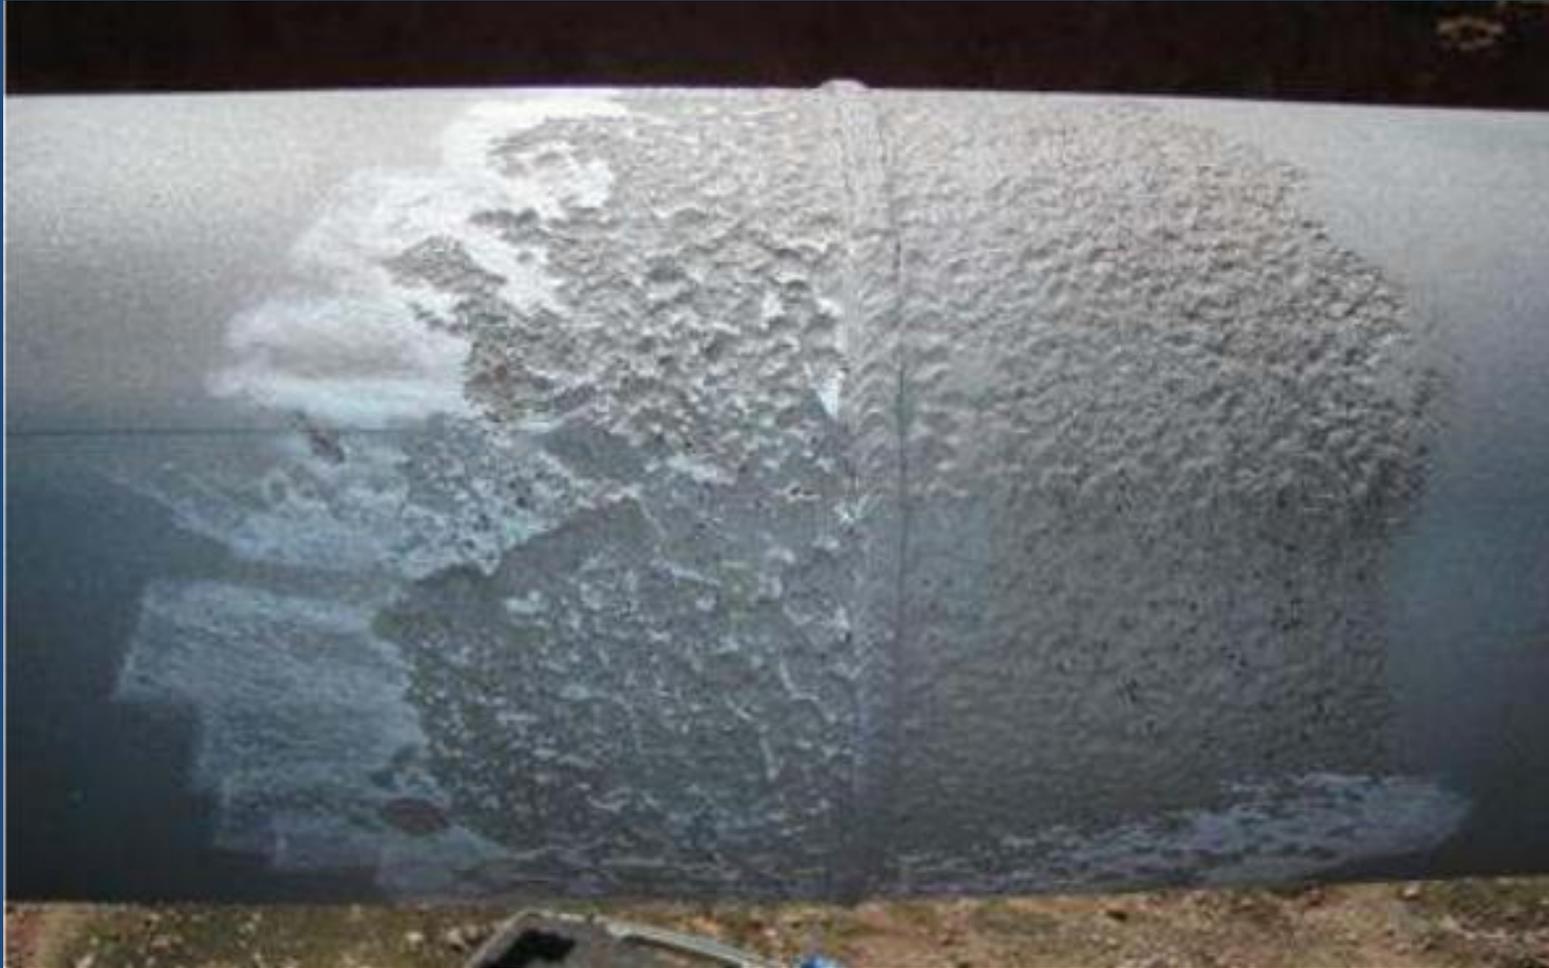
Corrosion Under Disbonded Coating

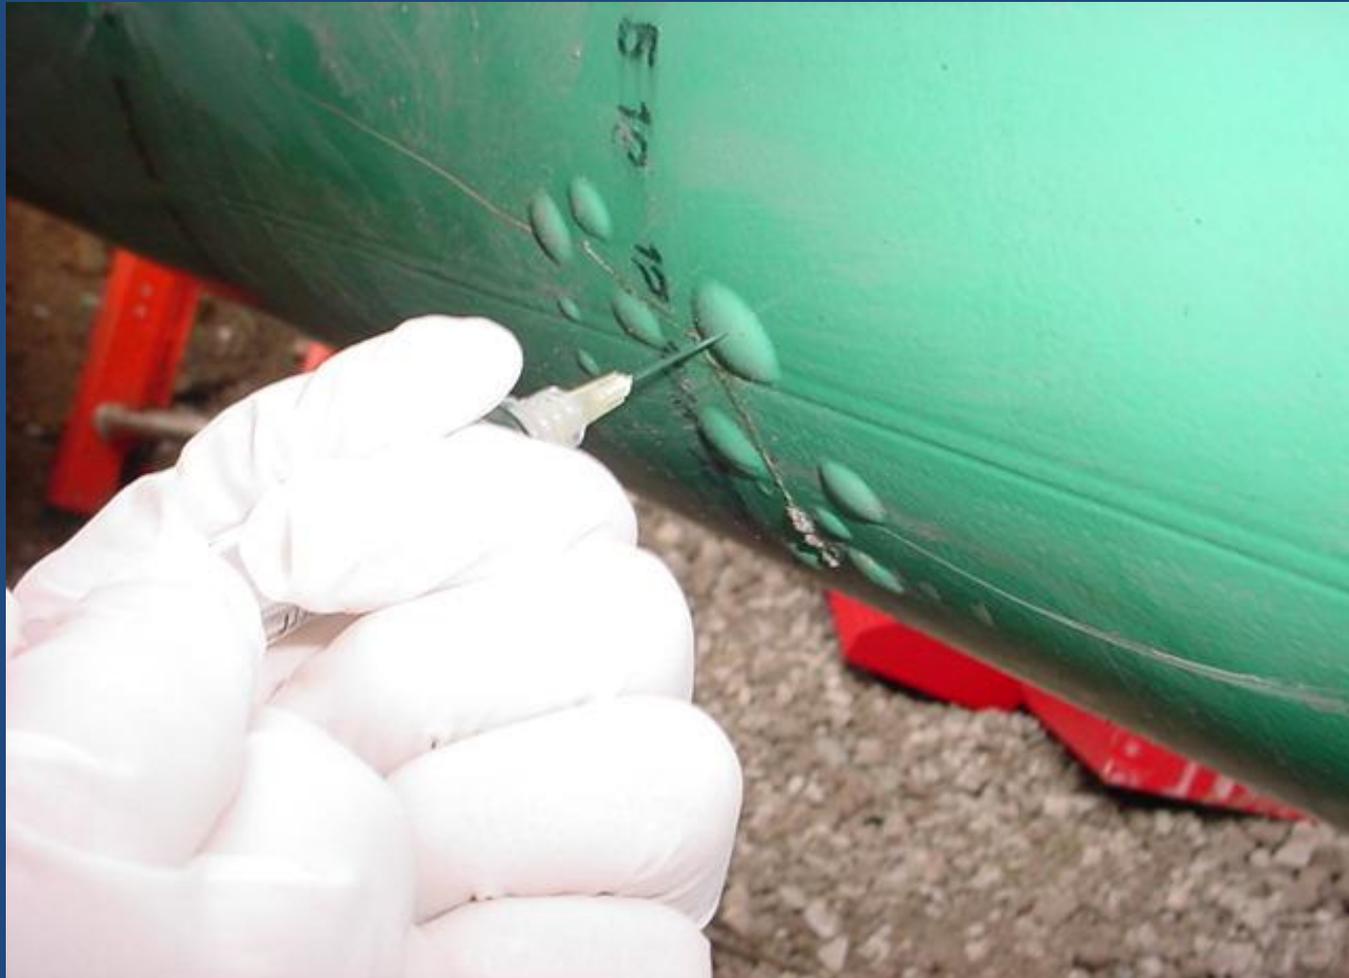
Fusion Bonded Epoxy (FBE)

What's cooking inside the blister?

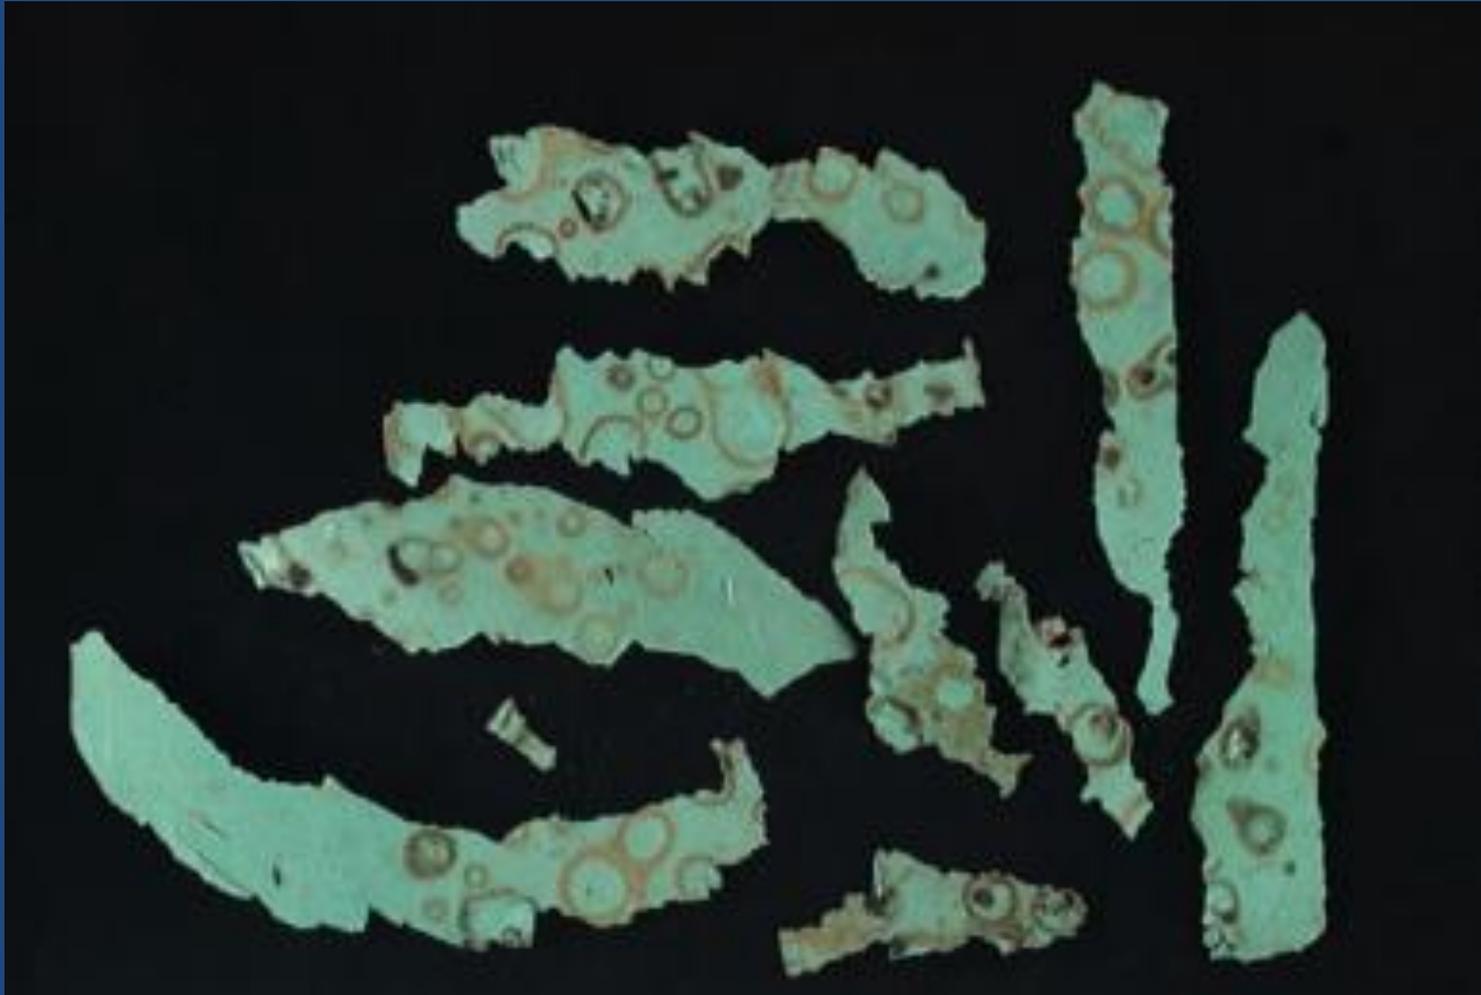
Back Side of FBE Samples

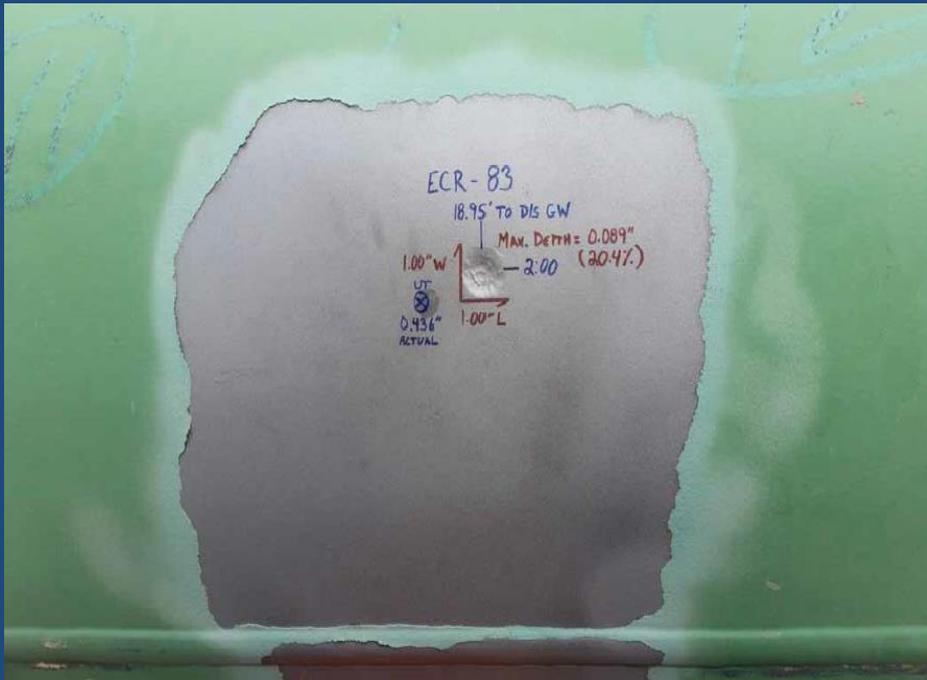
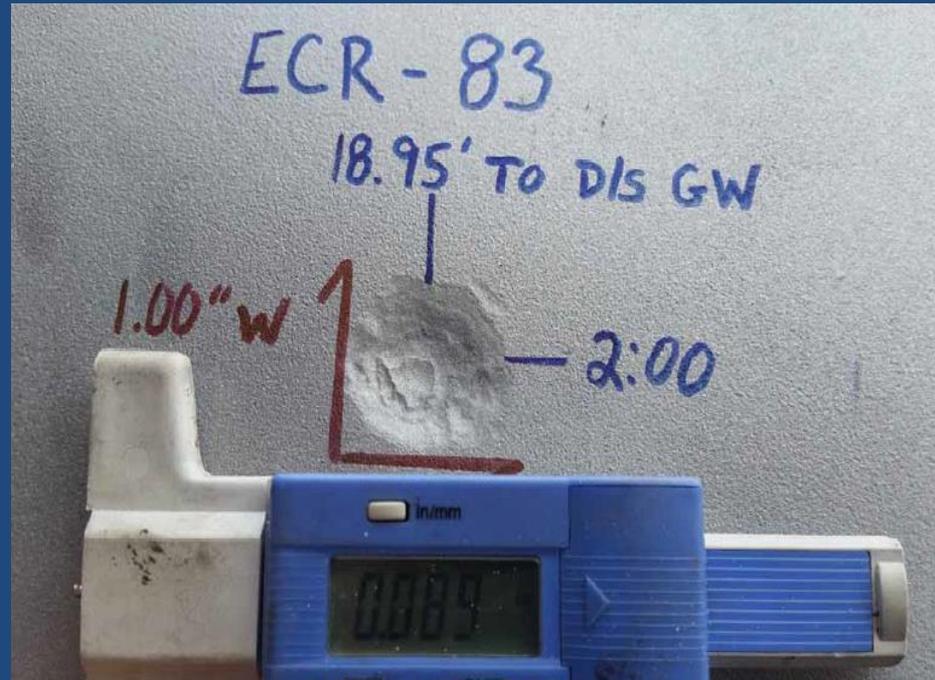
Localized Pitting Corrosion in Disbonded Area

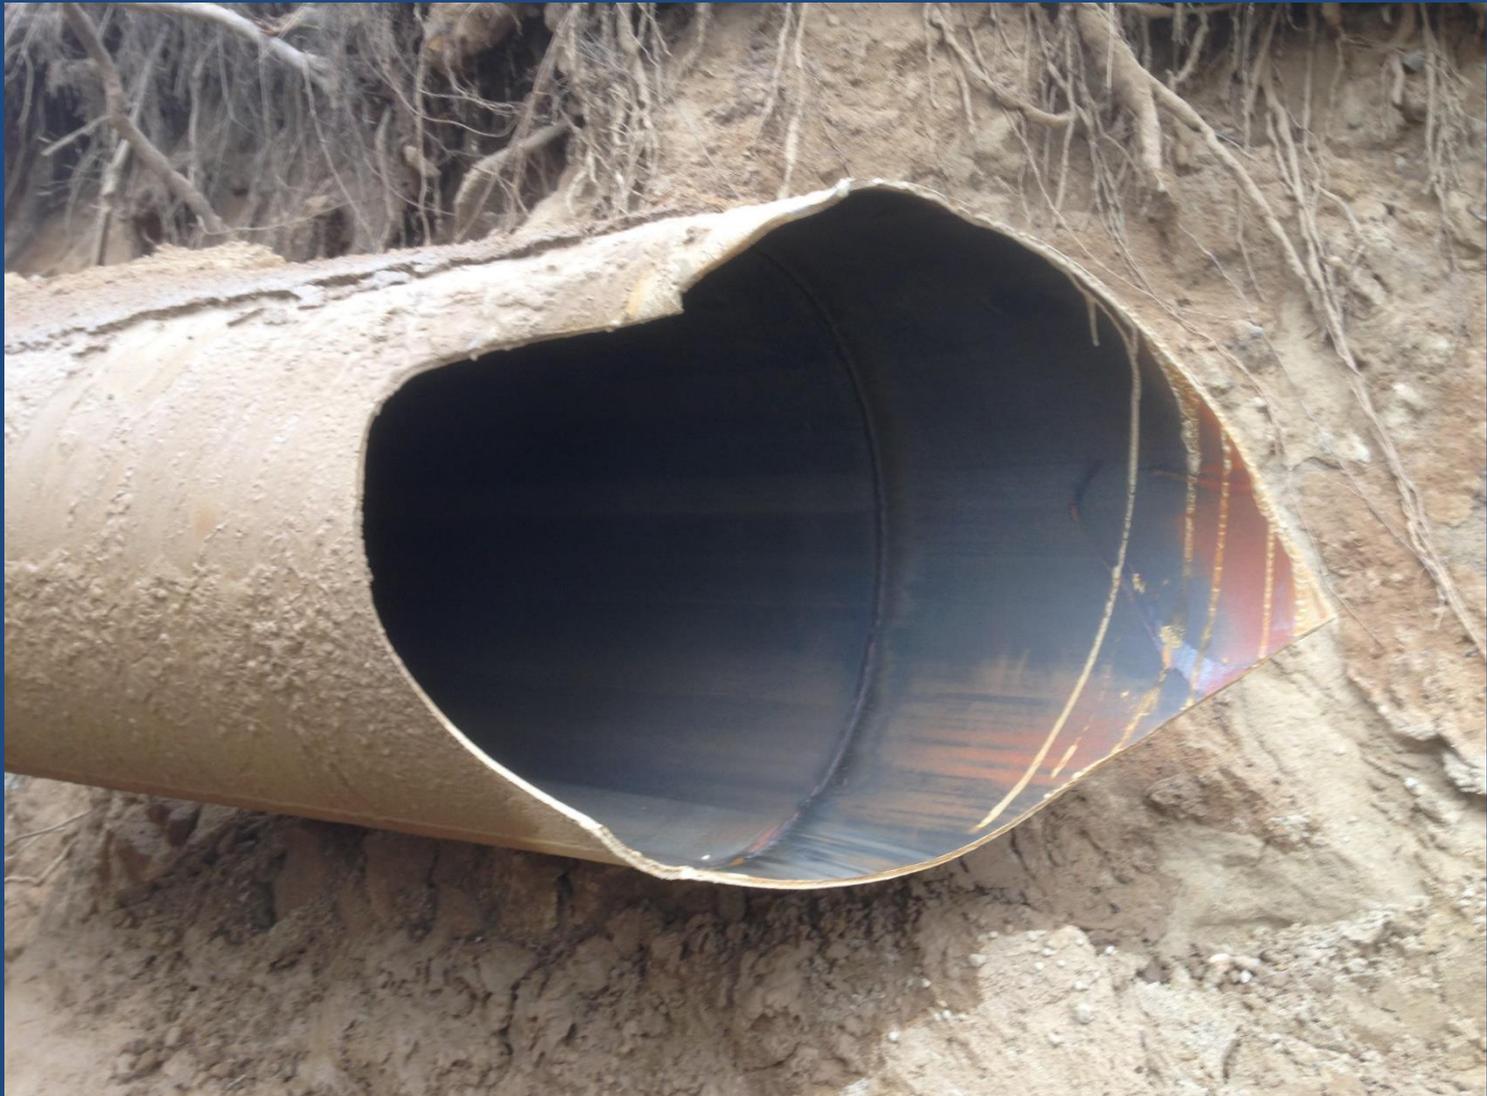
Stress Corrosion Cracking Fracture
