Catastrophic Failure of Aging Underground Pipelines Is Inevitable in Corrosive Soils and CP Shielding Conditions False Sense of Security!

M. ZEE, PHD

Sept . 7, 2017

Exova

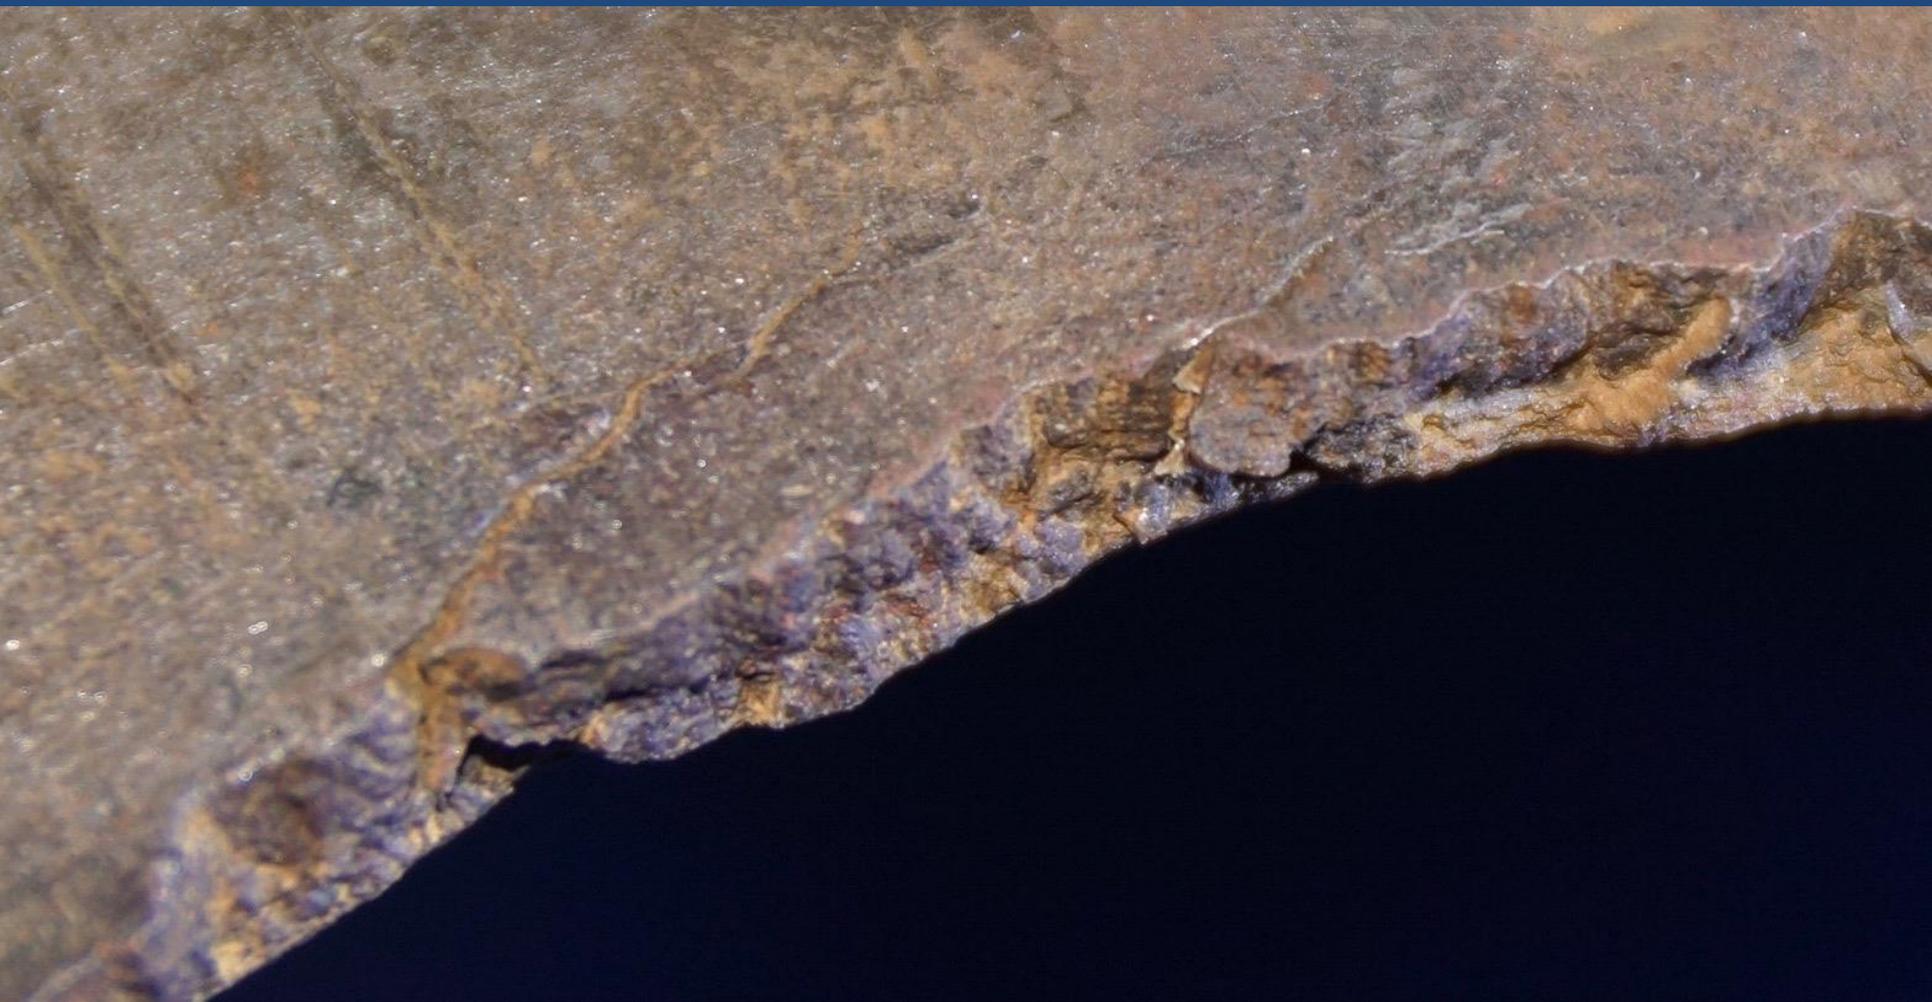
SCC Fracture Surface

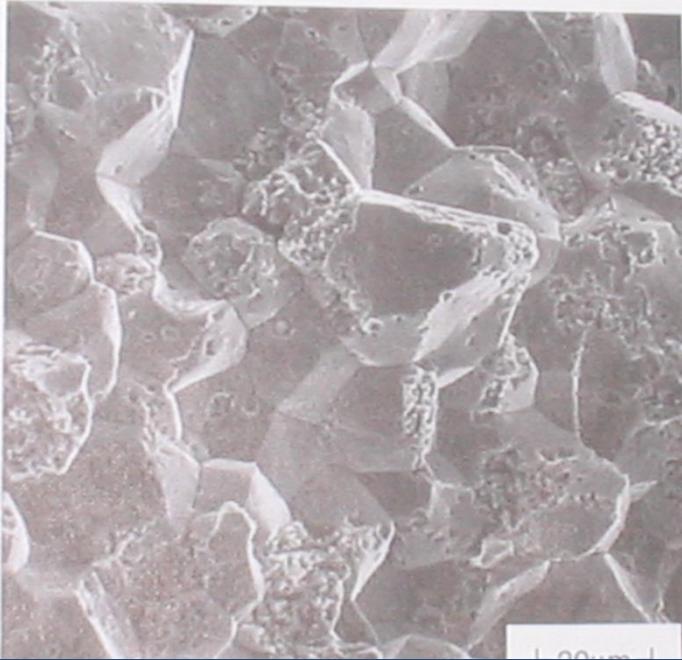
(a)

**Fracture surface of
intergranular SCC on
carbon steel**

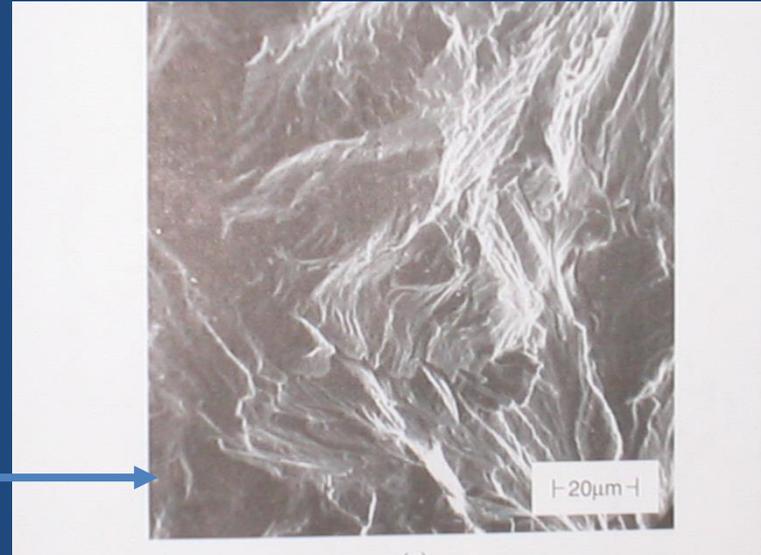
**Fracture surface of
transgranular SCC**
