DC INTERFERENCE TESTING CASE STUDIES USING RECTIFIER INFLUENCE TOOLS

PPUC- PIPELINE SAFETY SEMINAR

By Paul Sedlet, Accurate Corrosion Control, Inc.

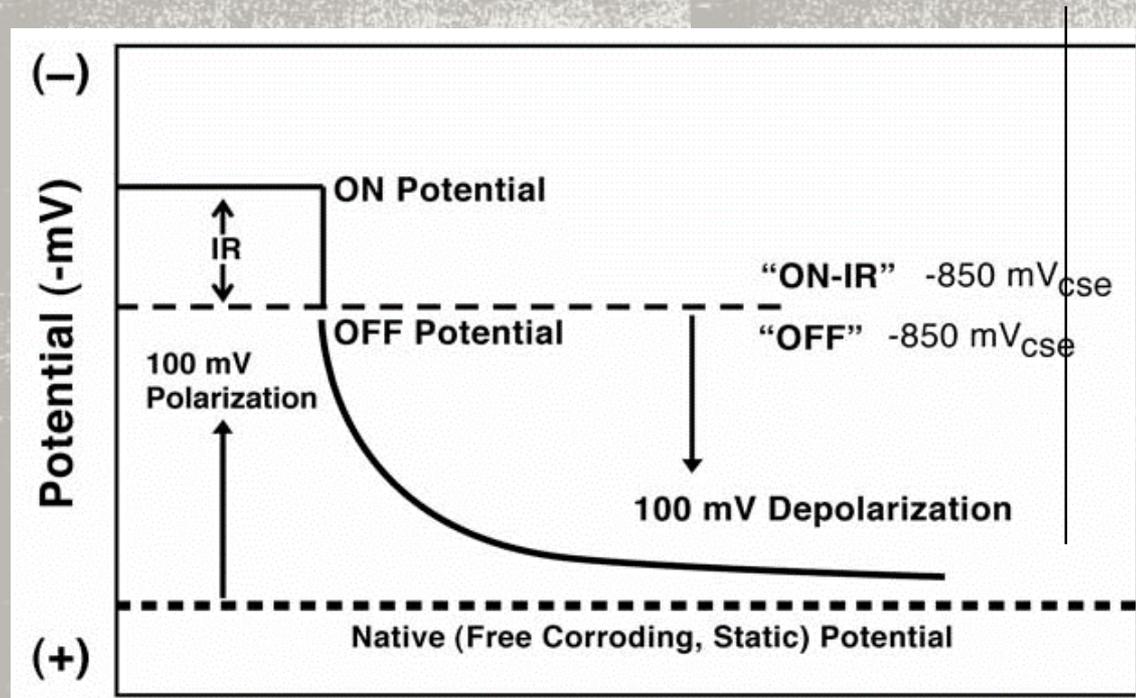
POLARIZATION GRAPH- AND GENERALLY ACCEPTABLE AND USED CP CRITERION

- **-850mV “ON”**
 - With CP applied
 - Knowing which CP systems have influence on this number is helpful
- **-850mV “IRF”**
 - Synchronous current interruption is generally required
 - Knowing and understanding which CP Systems and current sources have an influence on this number is necessary
- **100mV Polarization**

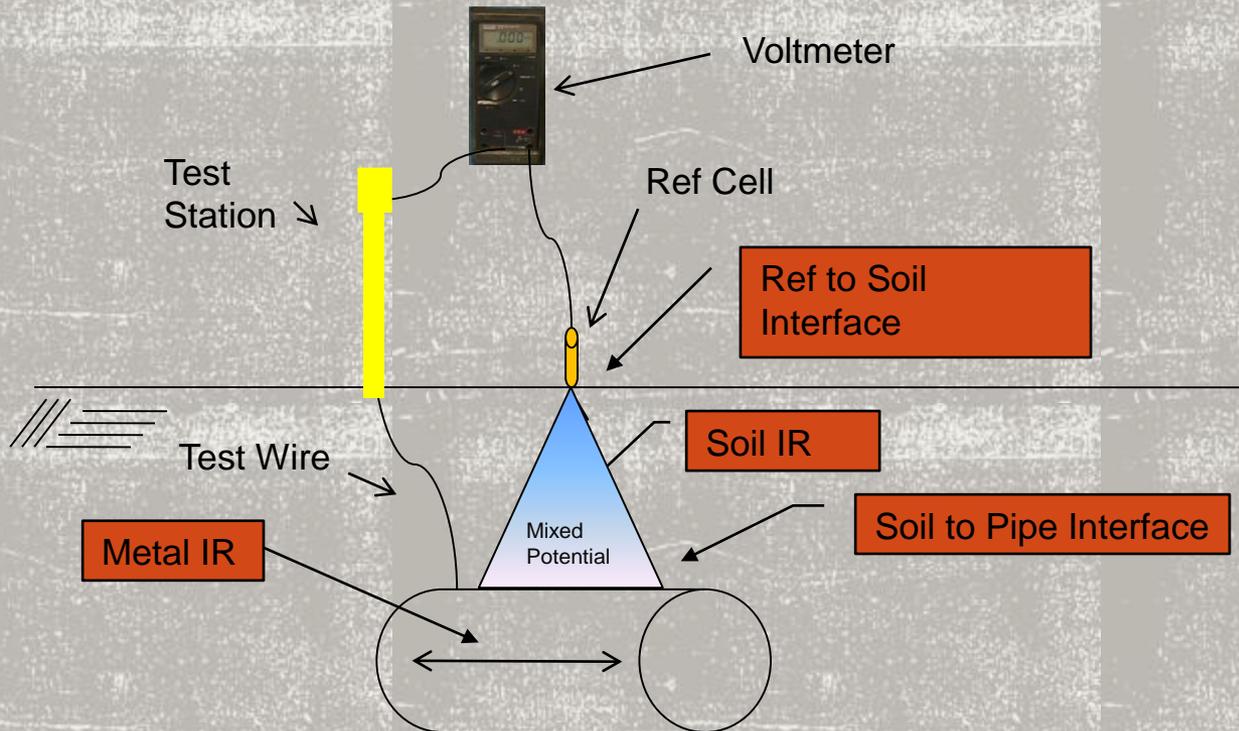
PIPE-TO-SOIL POTENTIAL COMPONENTS

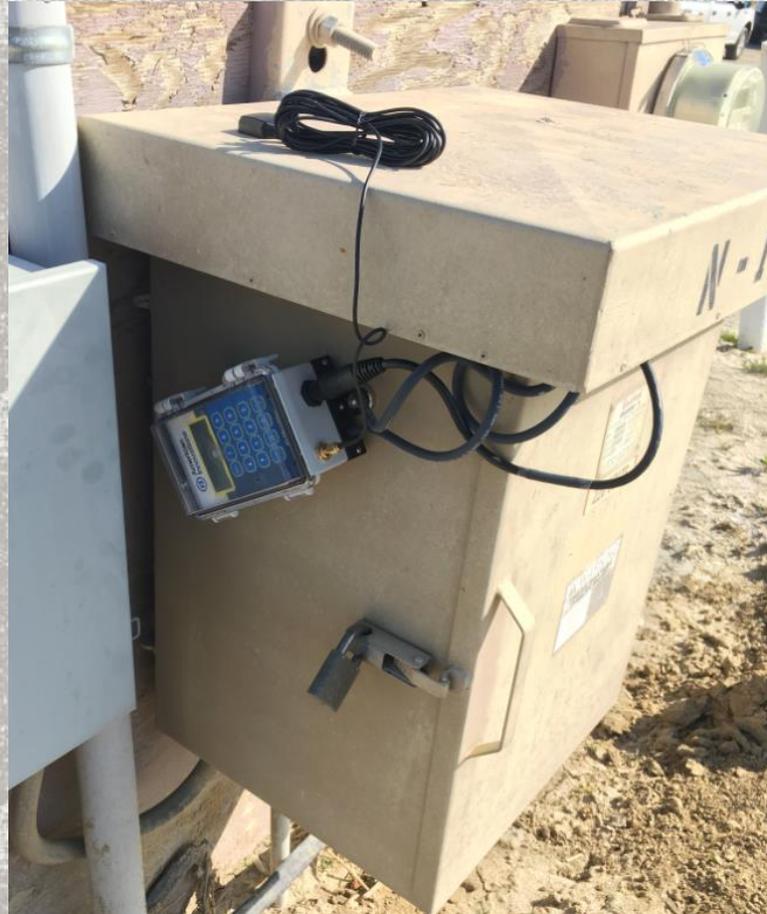
INSTALL PORTABLE GPS CURRENT INTERRUPTERS WITH RECTIFIER INFLUENCE PROGRAM

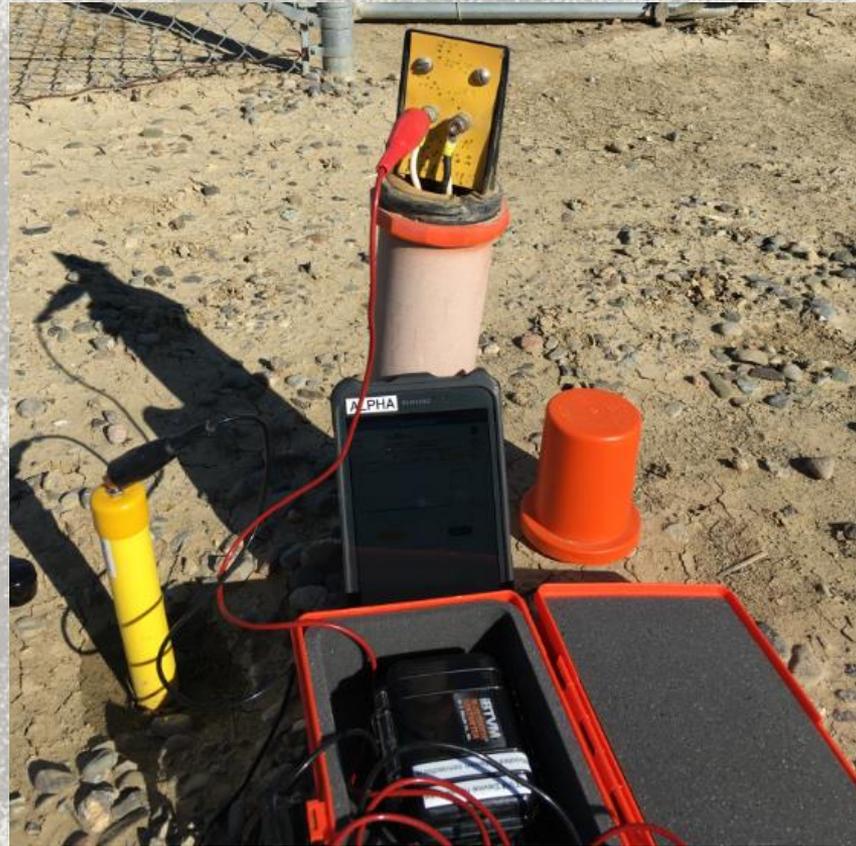
BLUETOOTH VOLTMETER WITH TABLET SETUP AT TP TO RECORD PIPE TO SOIL POTENTIAL WAVEFORM

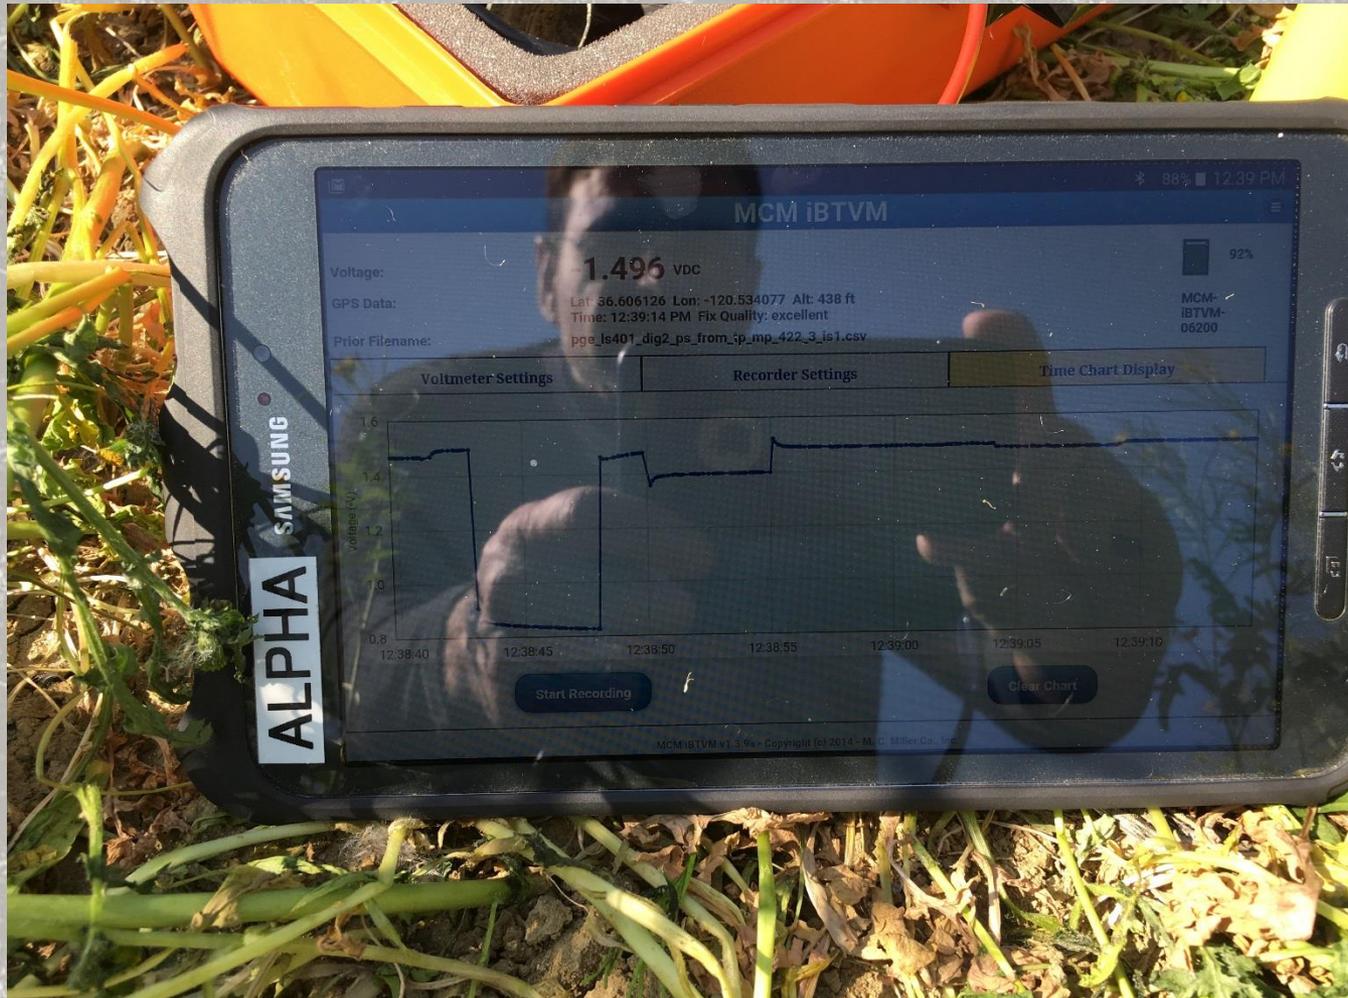
PIPE TO SOIL WAVEFORM RECORDING IN THE FIELD

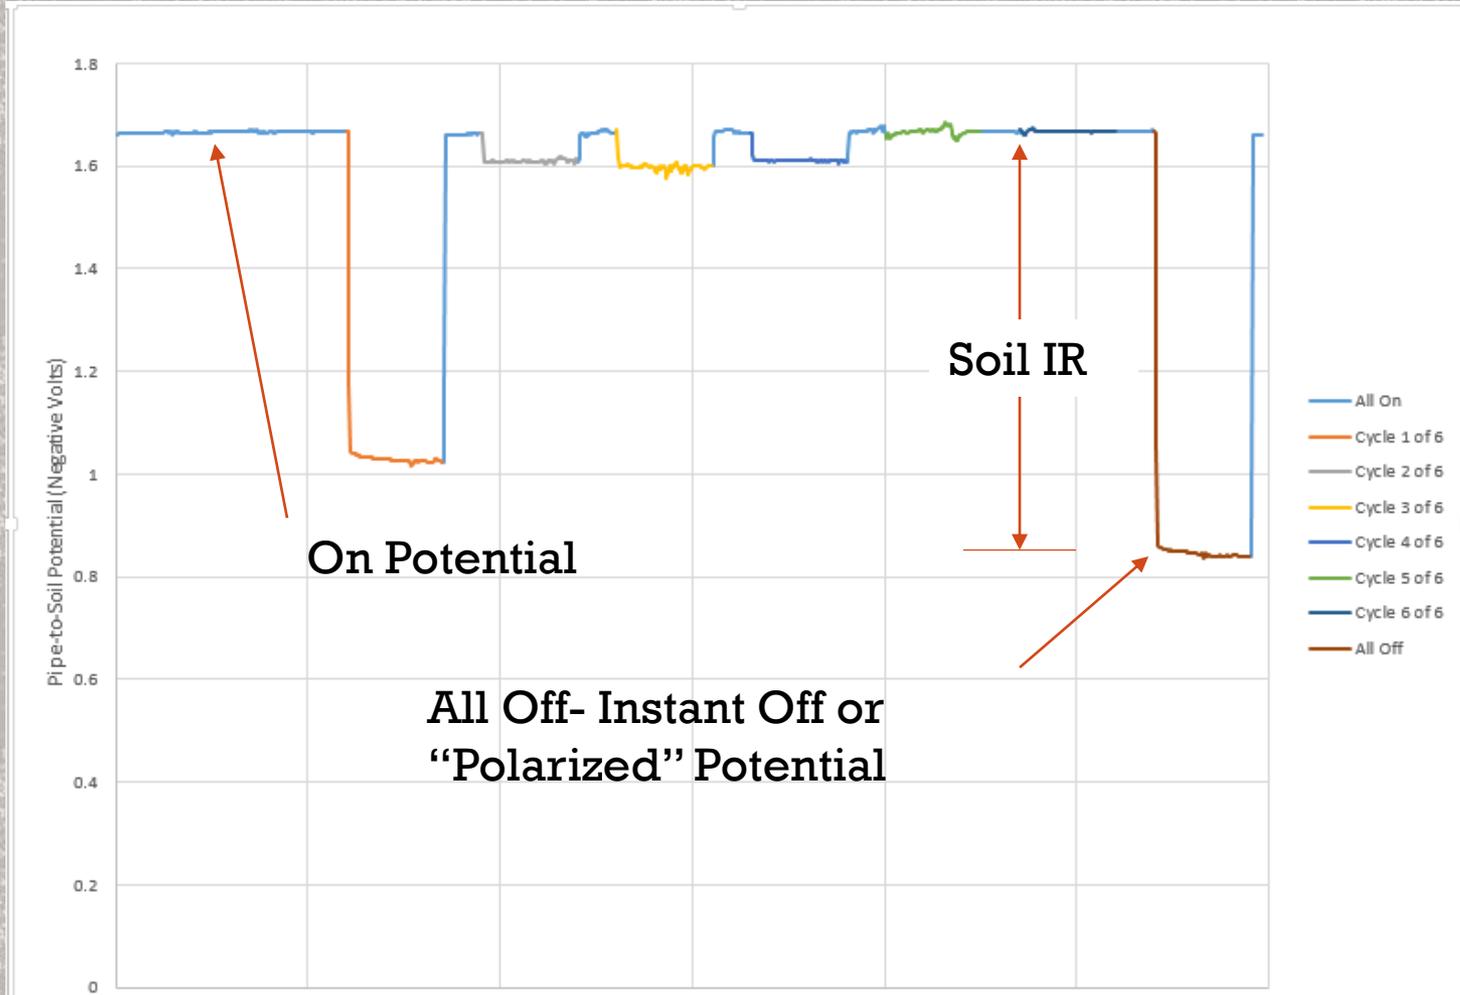
PIPE-TO-SOIL WAVEFORM- P/S MEASURED OVER 60-SECONDS WHILE INTERRUPTING

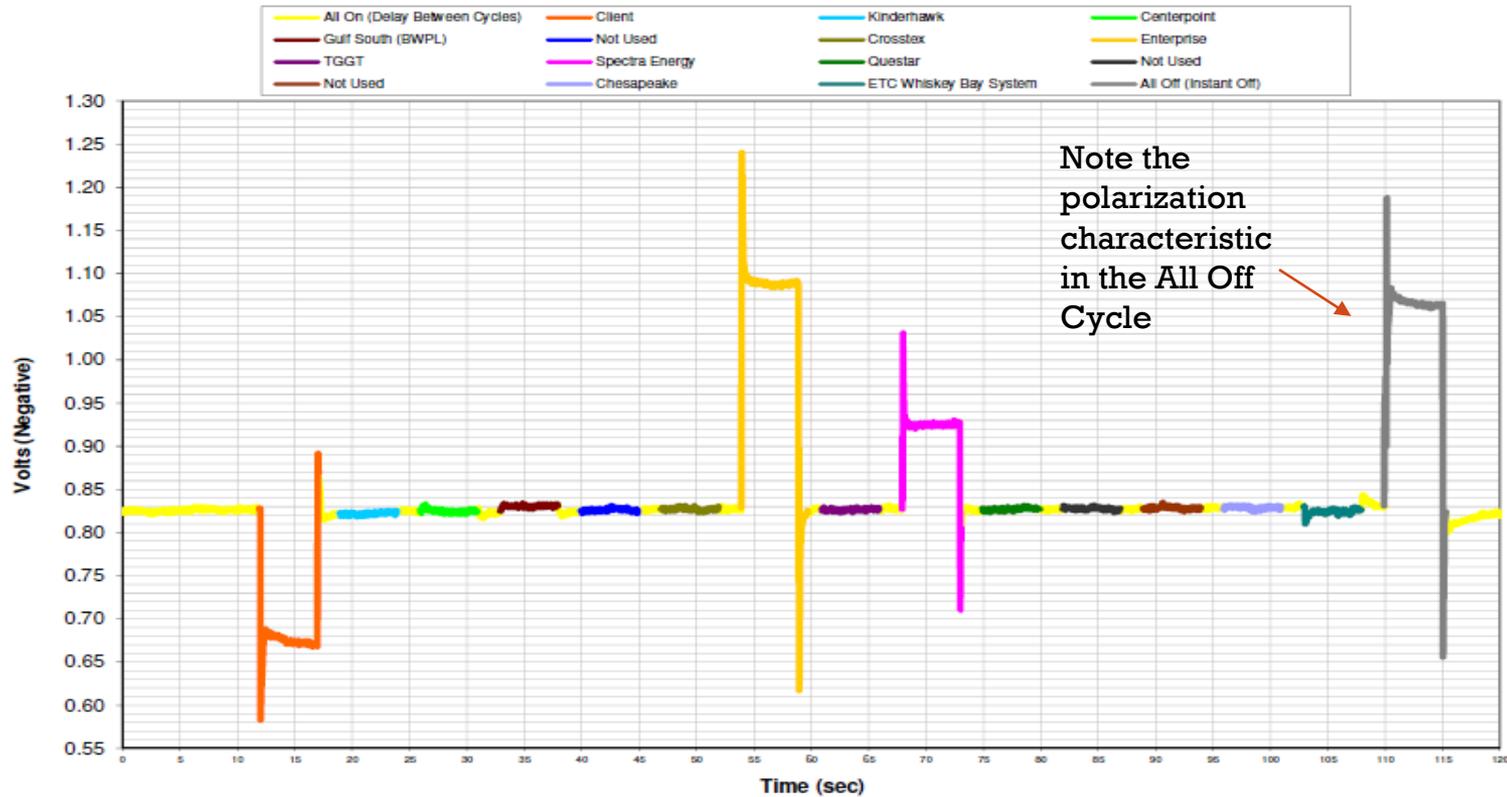
Client_77_2_3_TP_407416

INFLUENCE ONLY- POLARIZED POTENTIAL MORE NEGATIVE THAN -1000MV

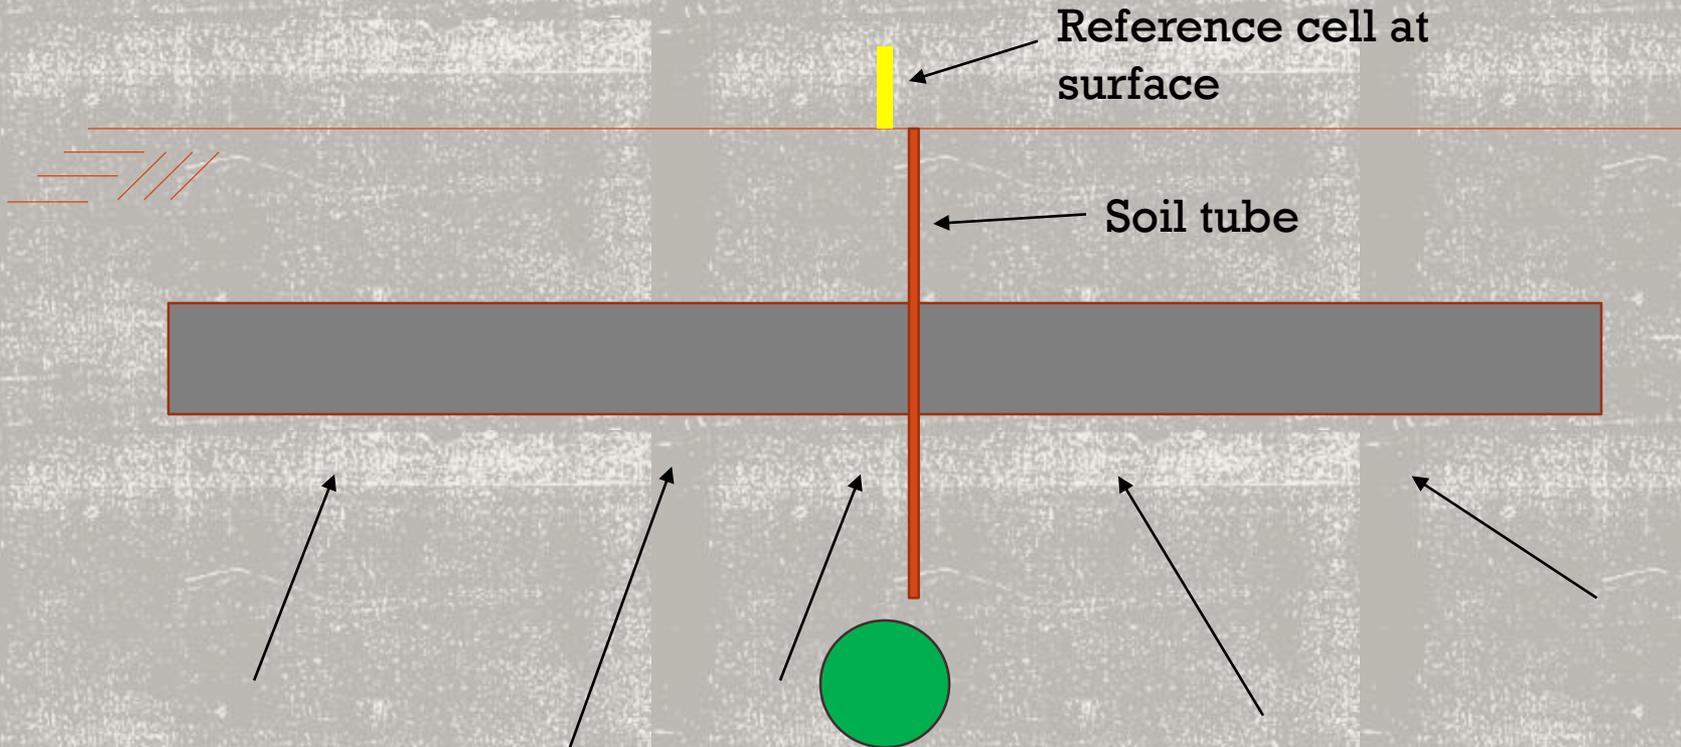
PIPELINE CONFIGURATION AT CROSSING

Well coated line bored under poorly coating line. Soil IR from foreign line is a large component of the surface P/S

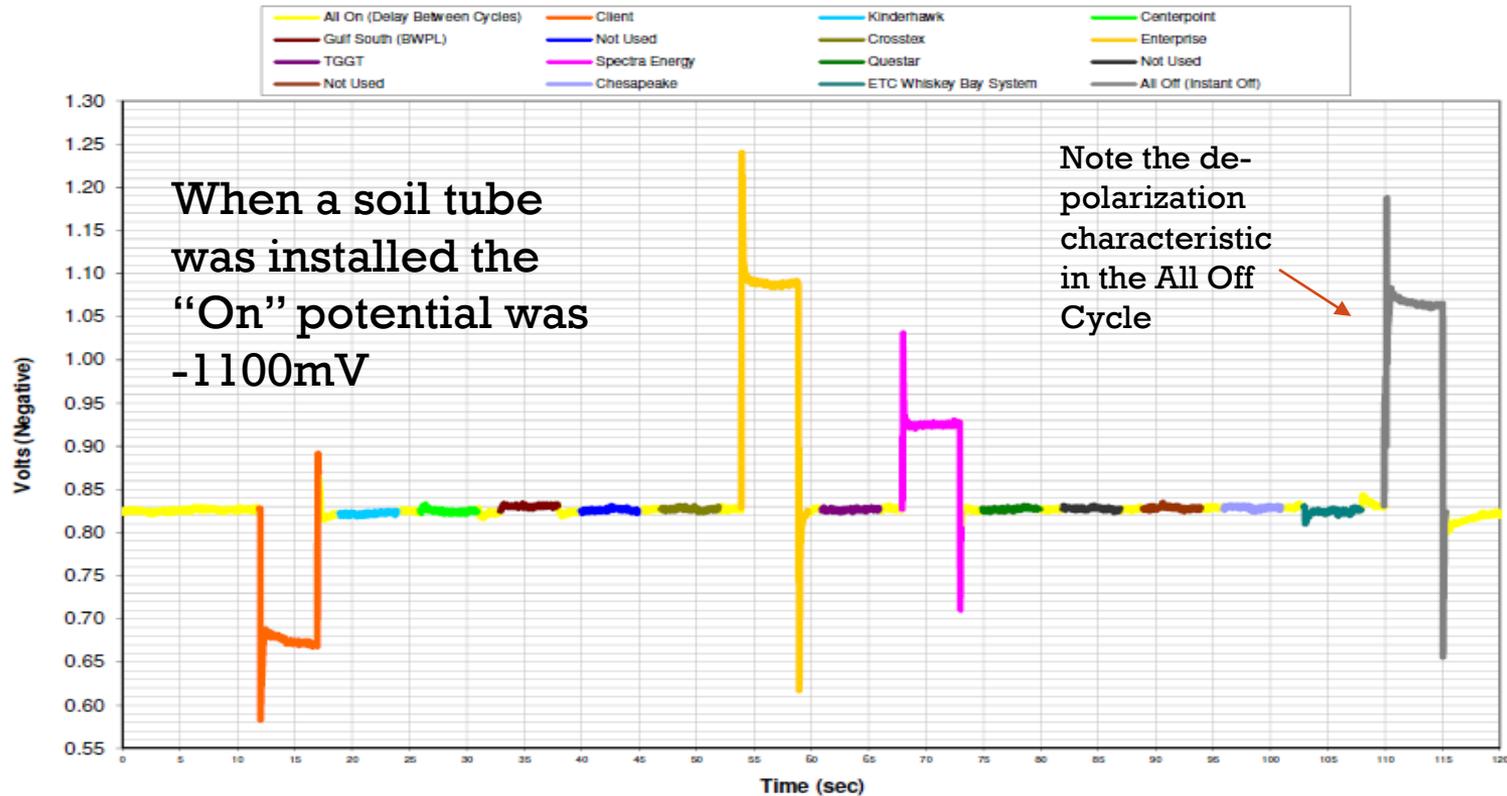
Client_77_2_3_TP_407416

CONCLUSION- NO STRAY CURRENT INTERFERENCE (INVALID "ON" POTENTIAL)

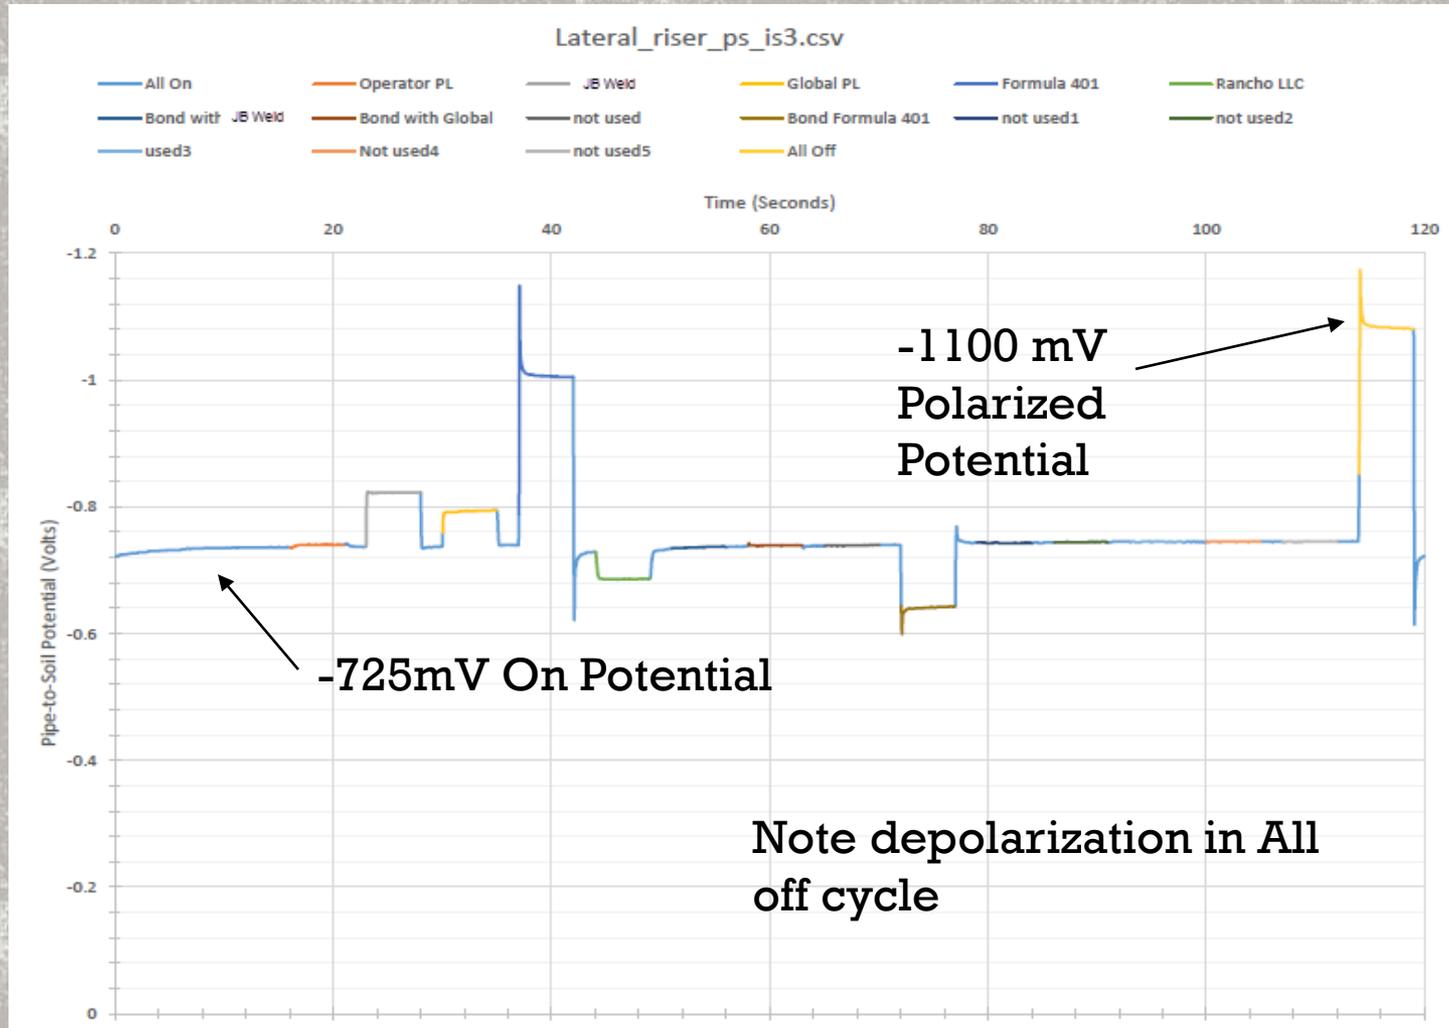
P/S WAVEFORM AT RISER IN STATION- INVALID "ON" POTENTIAL. NO INTERFERENCE

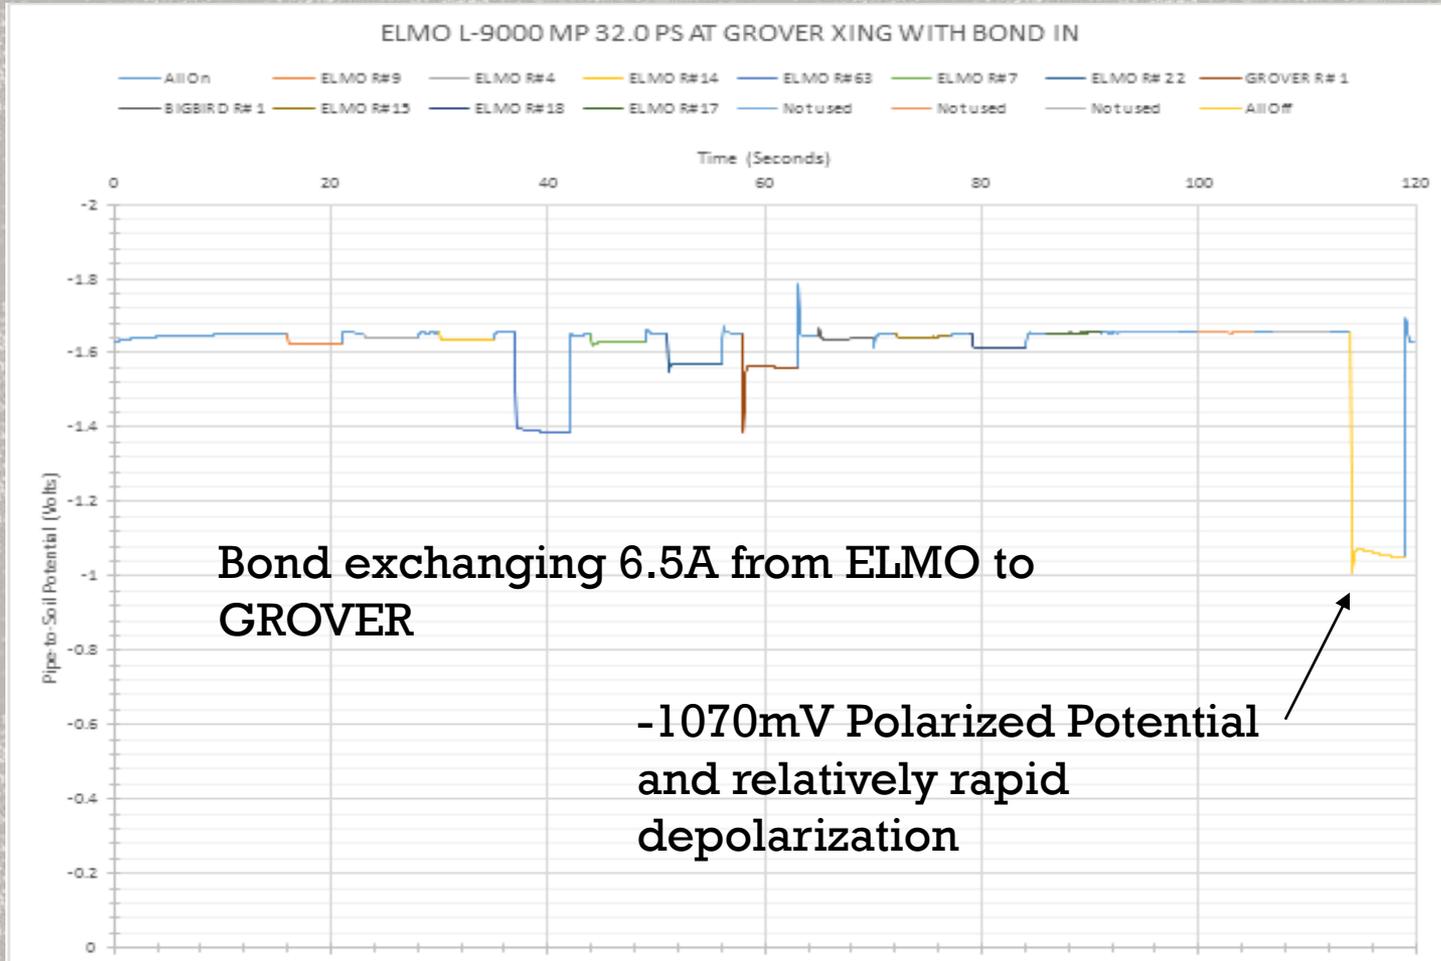
P/S WAVEFORM AT CROSSING WITH BOND IN PLACE (AS FOUND)

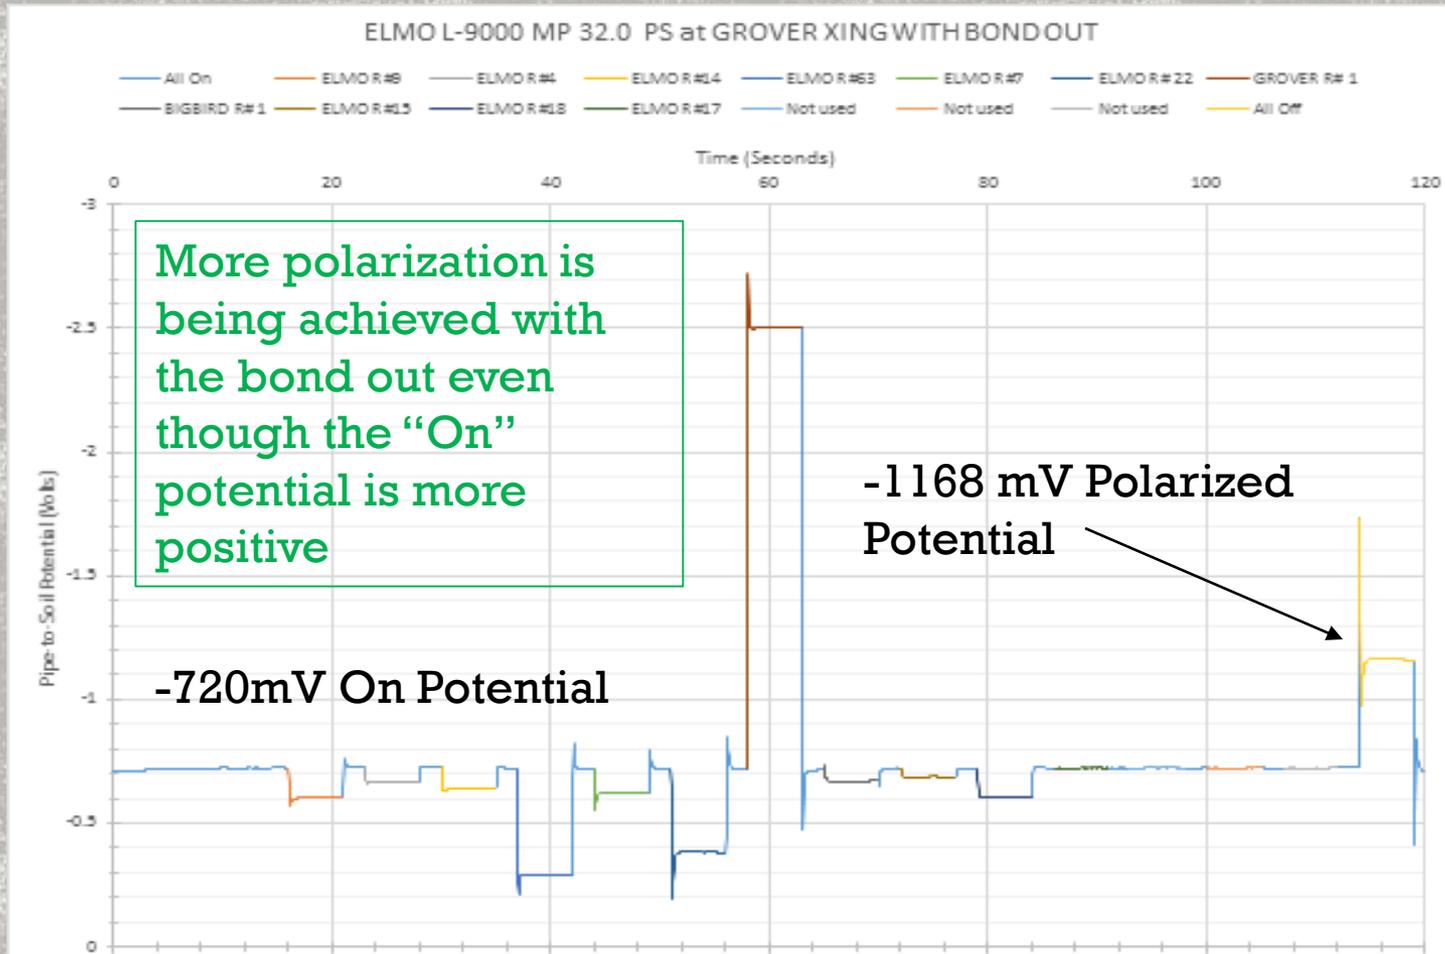
P/S WAVEFORM AT CROSSING WITH BOND REMOVED (AS LEFT)

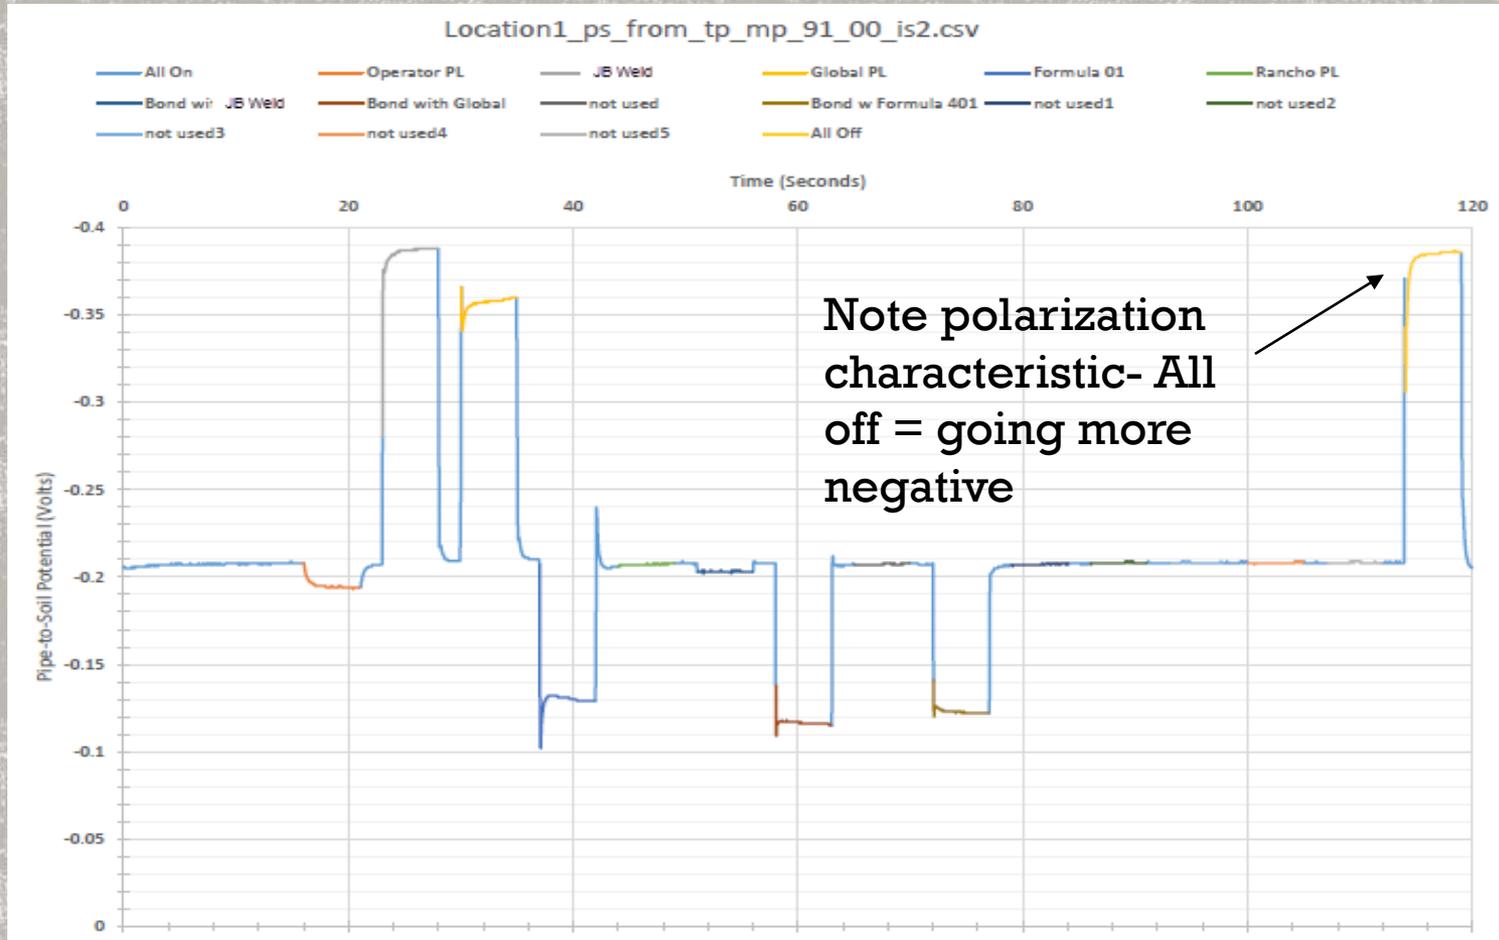
P/S WAVEFORM IN A PIPELINE CORRIDOR- AT WALL LOSS FOUND WITH ILI

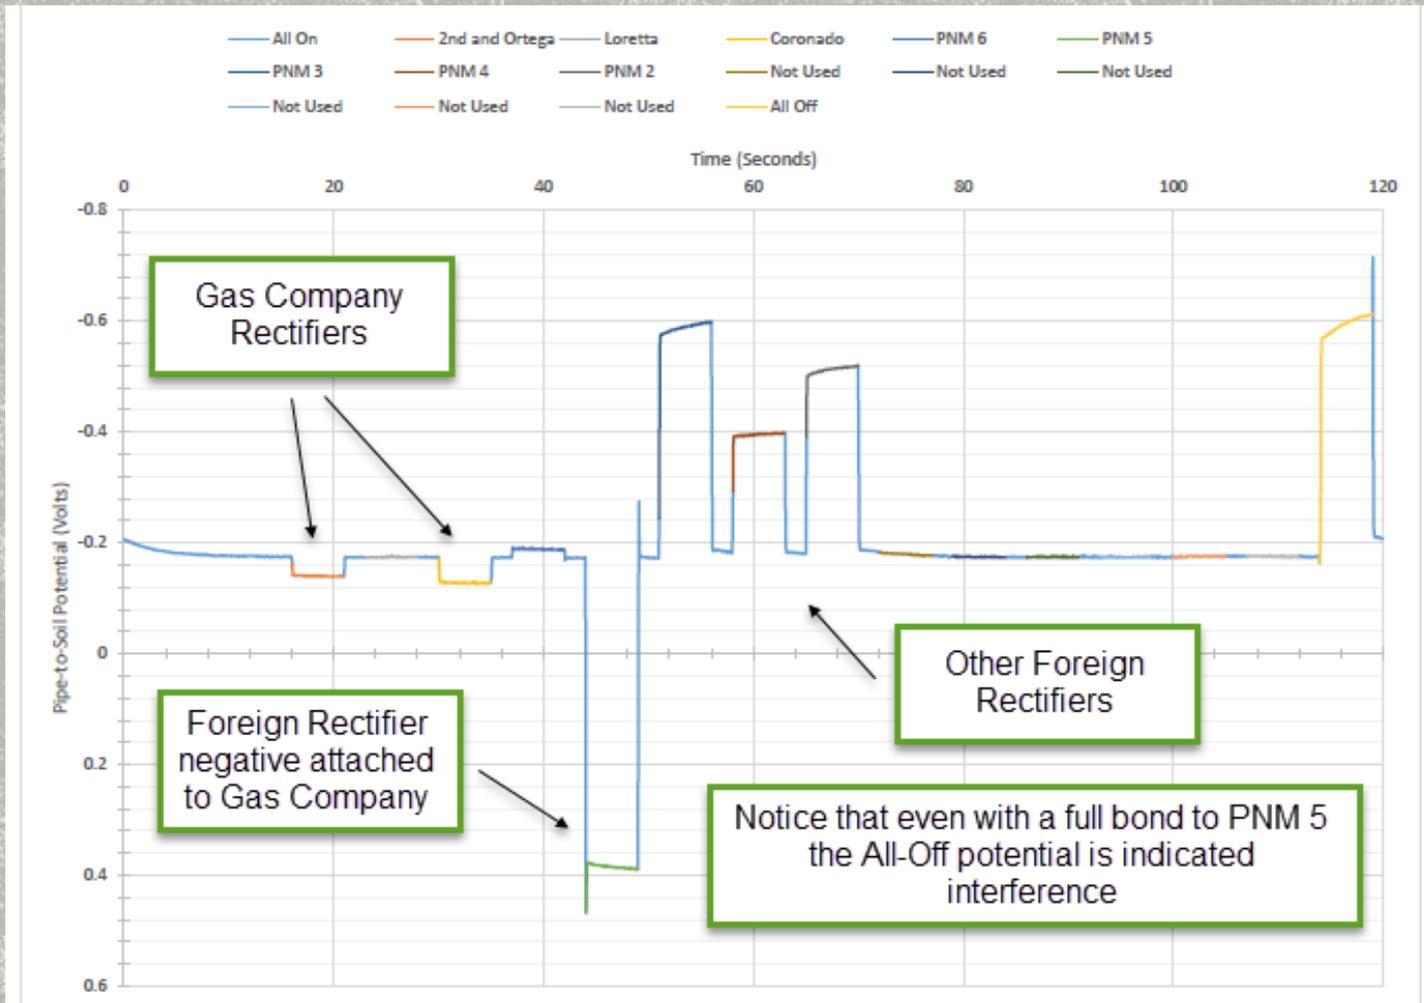
EXAMPLE- EVEN WITH A BOND INTERFERENCE NOT MITIGATED

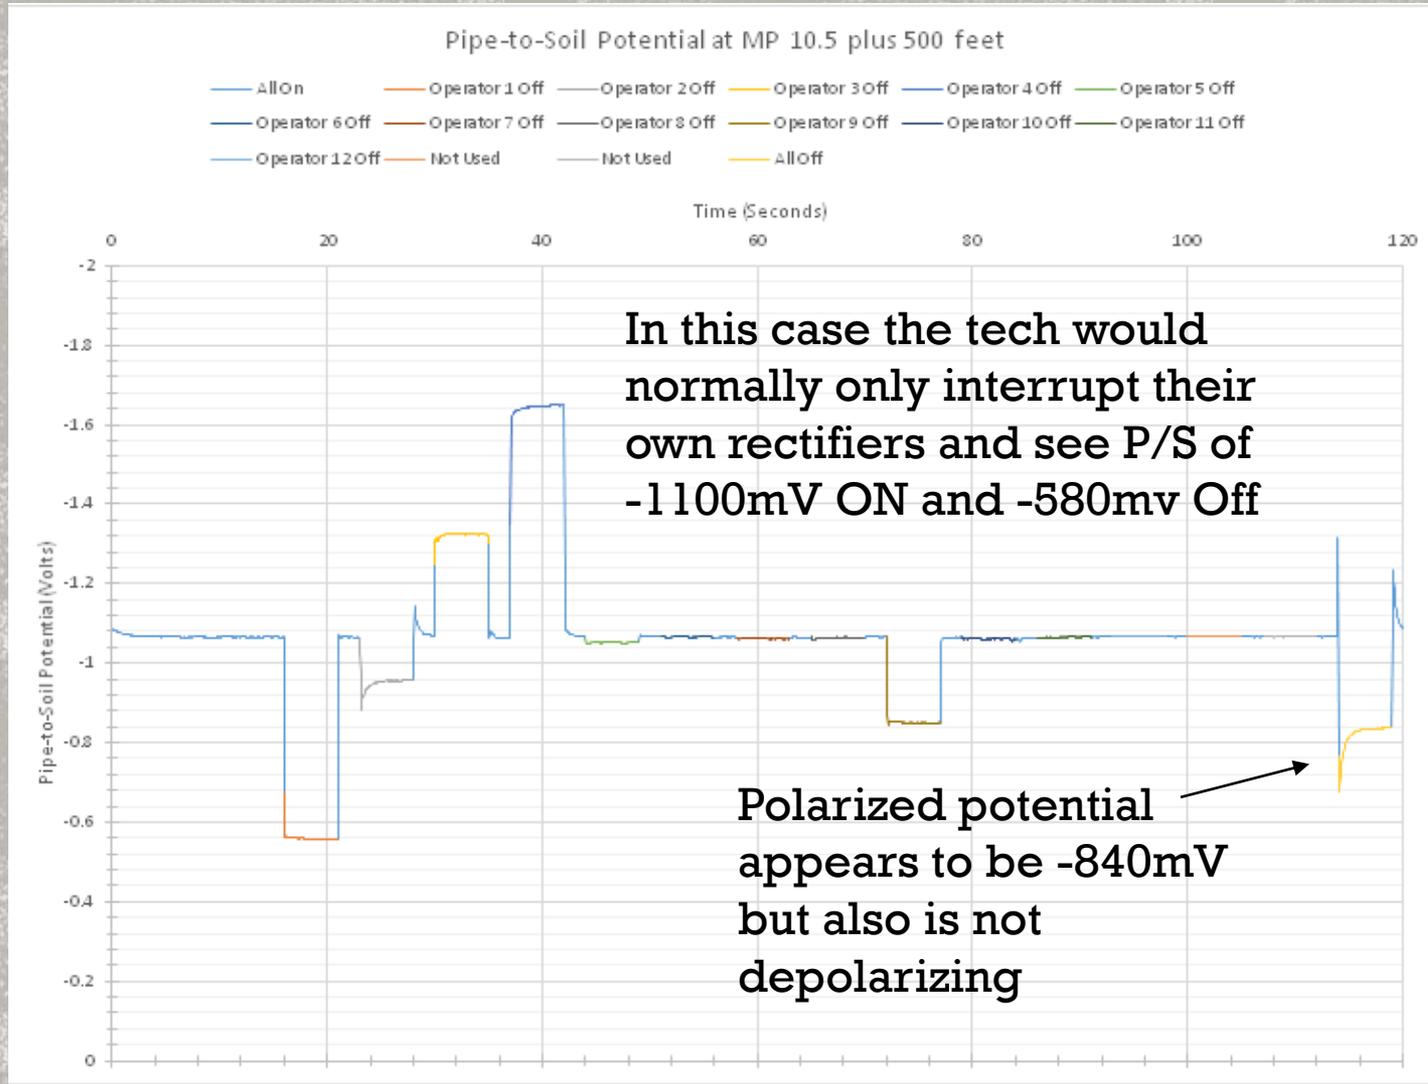
AS FOUND P/S WHERE I/O IS < -850MV

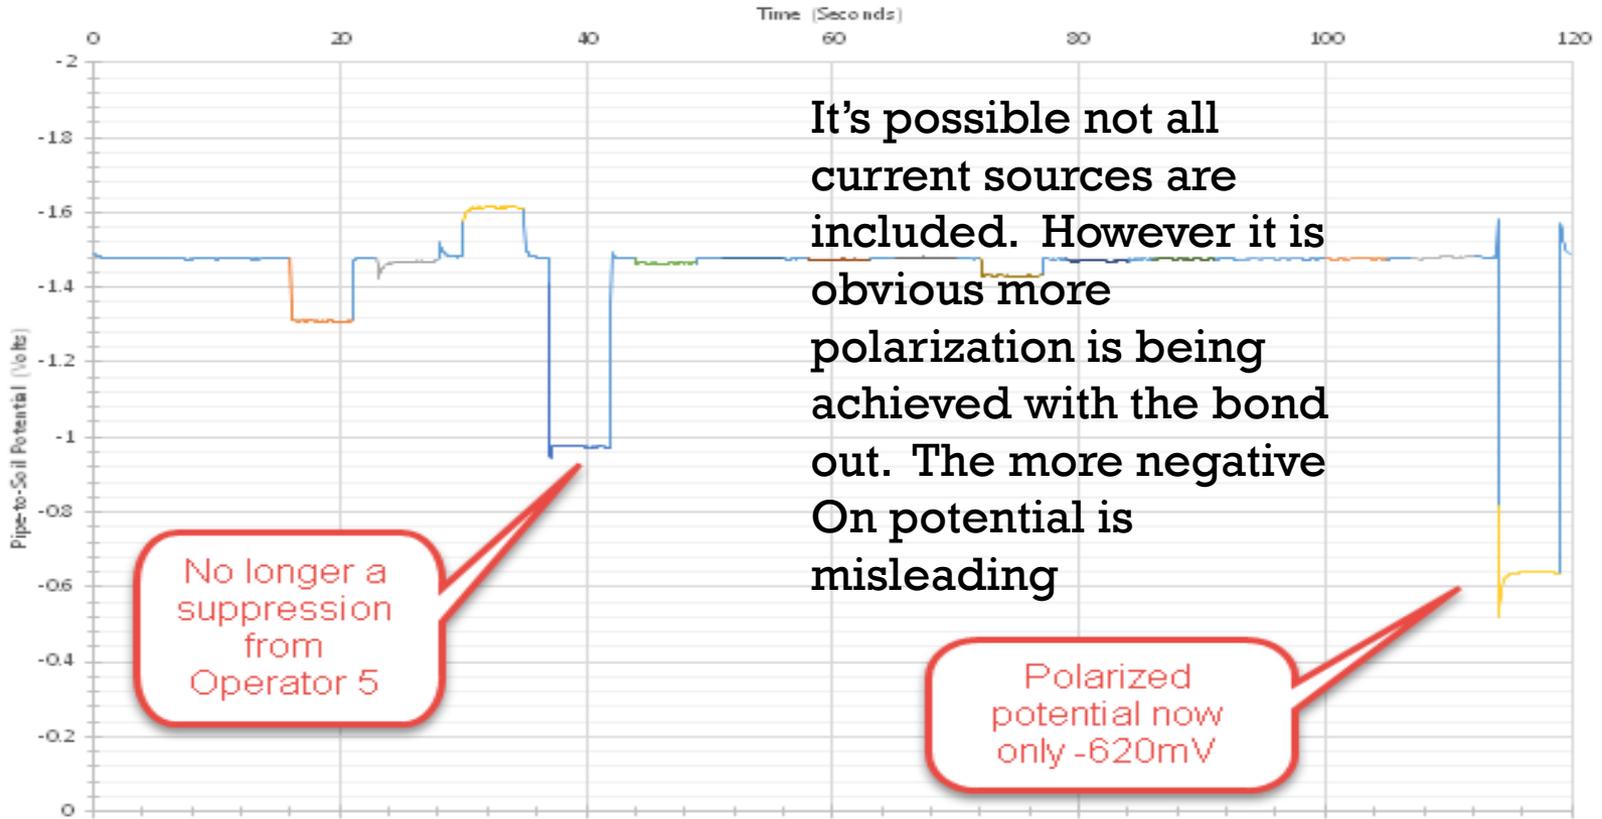
P/S WAVEFORM AT THE SAME TP WITH A TEMP BOND INSTALLED

Pipe-to-Soil Potential at MP 10.5 plus 500 feet with Temp Bond in to Operator #4

It's possible not all current sources are included. However it is obvious more polarization is being achieved with the bond out. The more negative On potential is misleading

No longer a suppression from Operator 5

Polarized potential now only -620mV

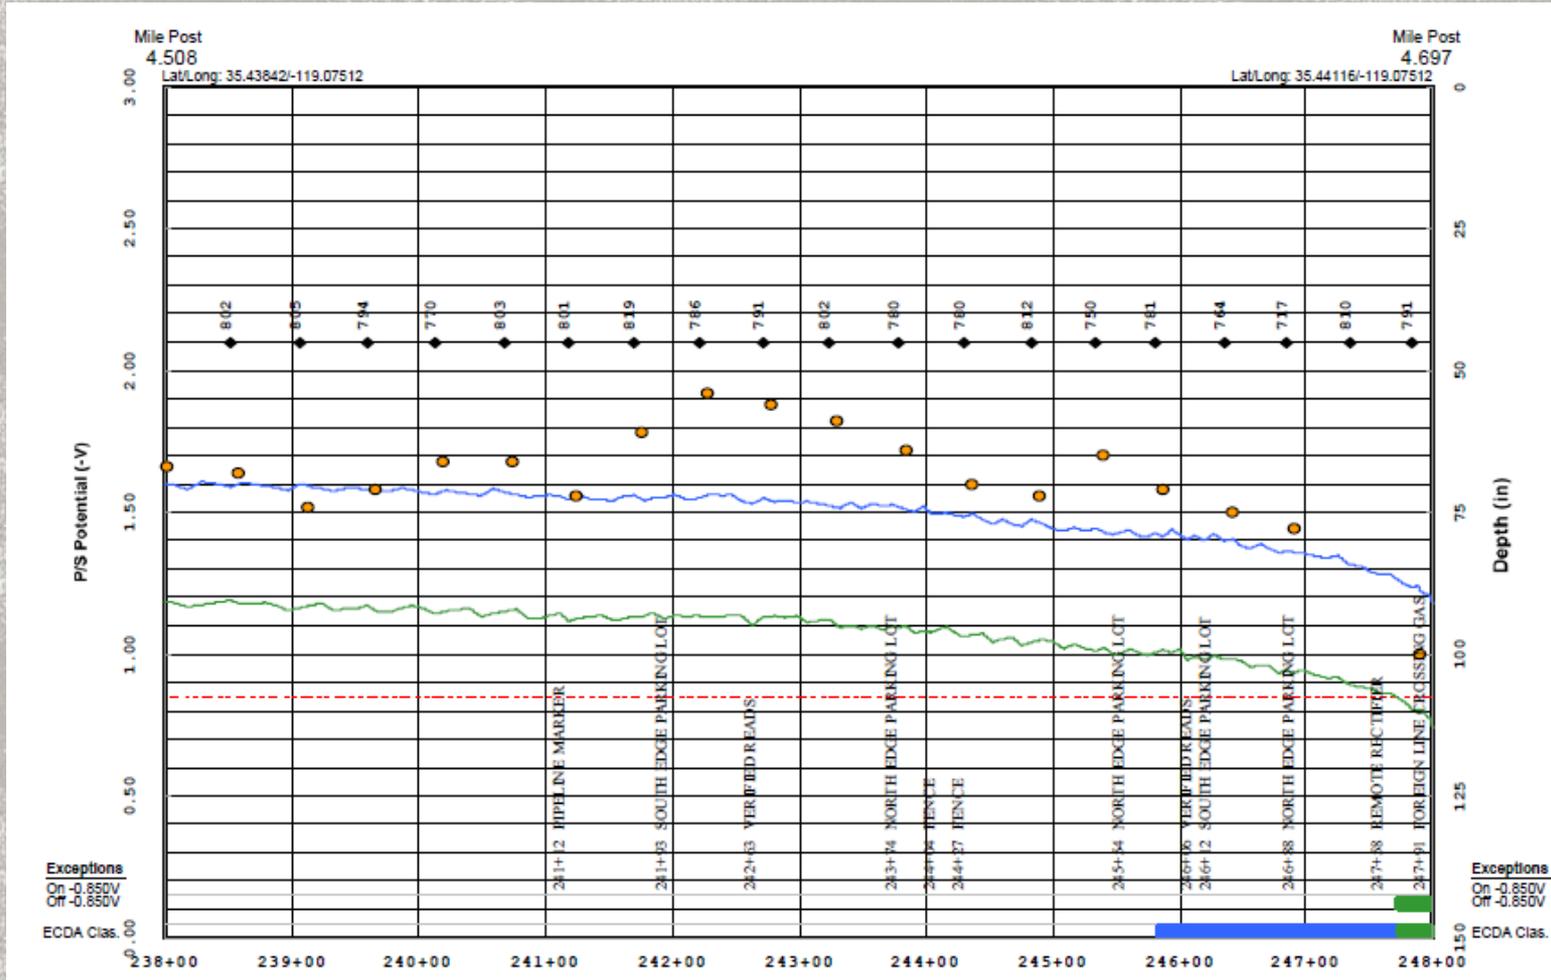
CIS WITH LOW P/S AT FOREIGN LINE XING

- **A CIS was performed and the following location has a dip in potentials below criteria at a foreign line crossing.**
- **This was flagged as possible static DC interference requiring additional investigation**

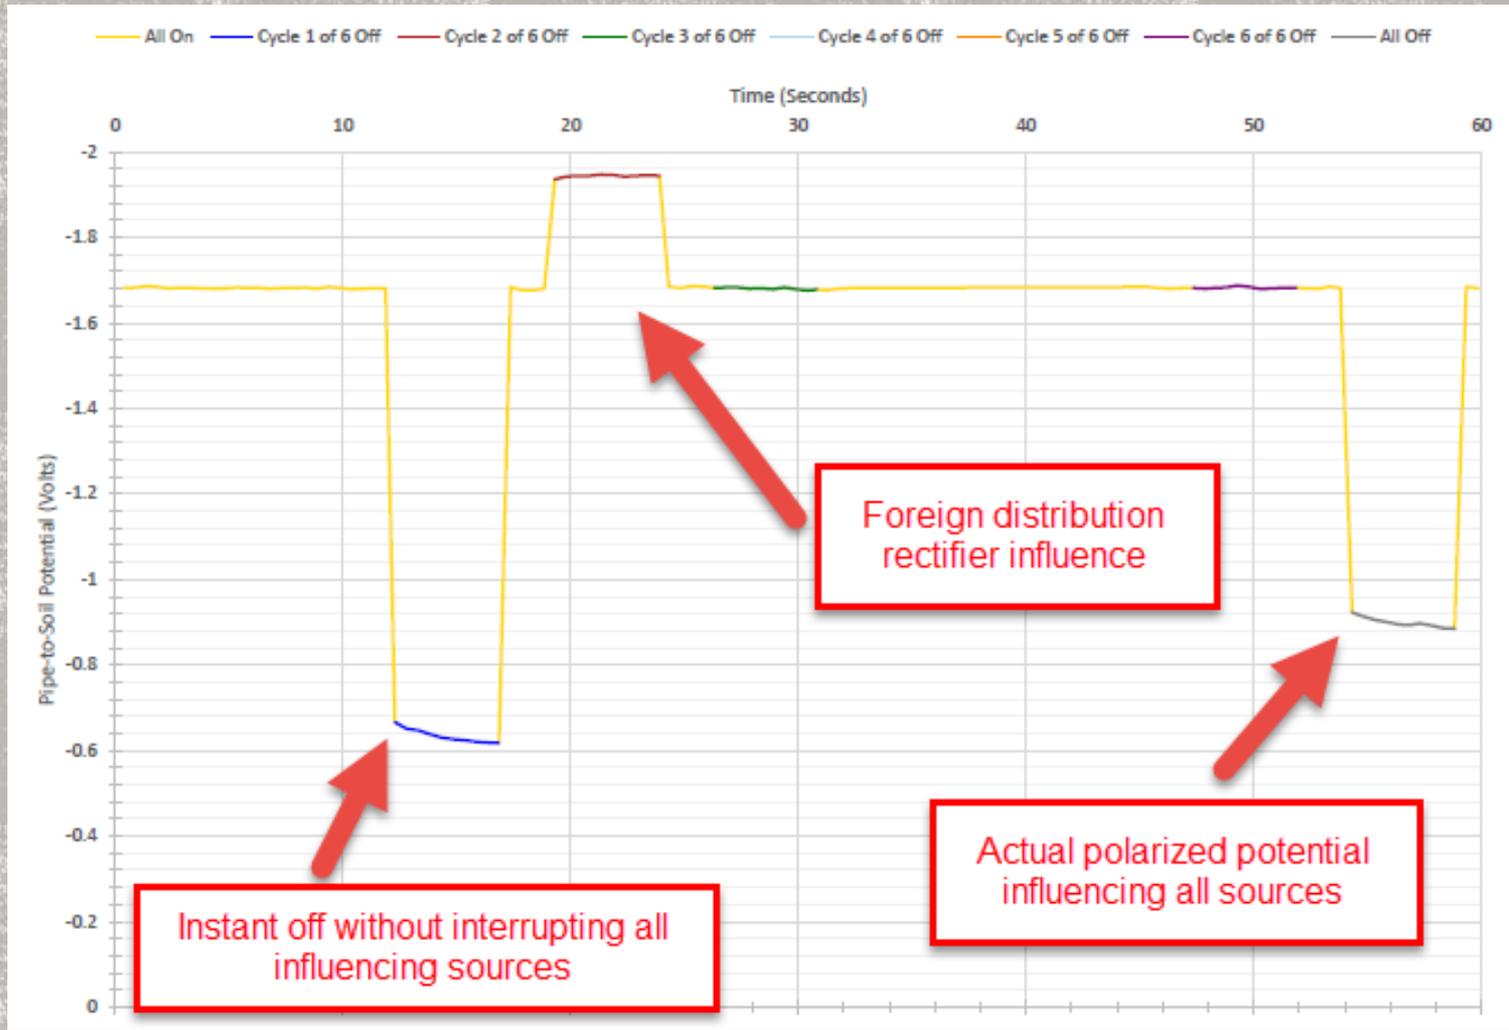
P/S WAVEFORM AT LOW READ LOCATION
