DC INTERFERENCE TESTING CASE STUDIES USING RECTIFIER INFLUENCE TOOLS

PPUC- PIPELINE SAFETY SEMINAR

By Paul Sedlet, Accurate Corrosion Control, Inc.

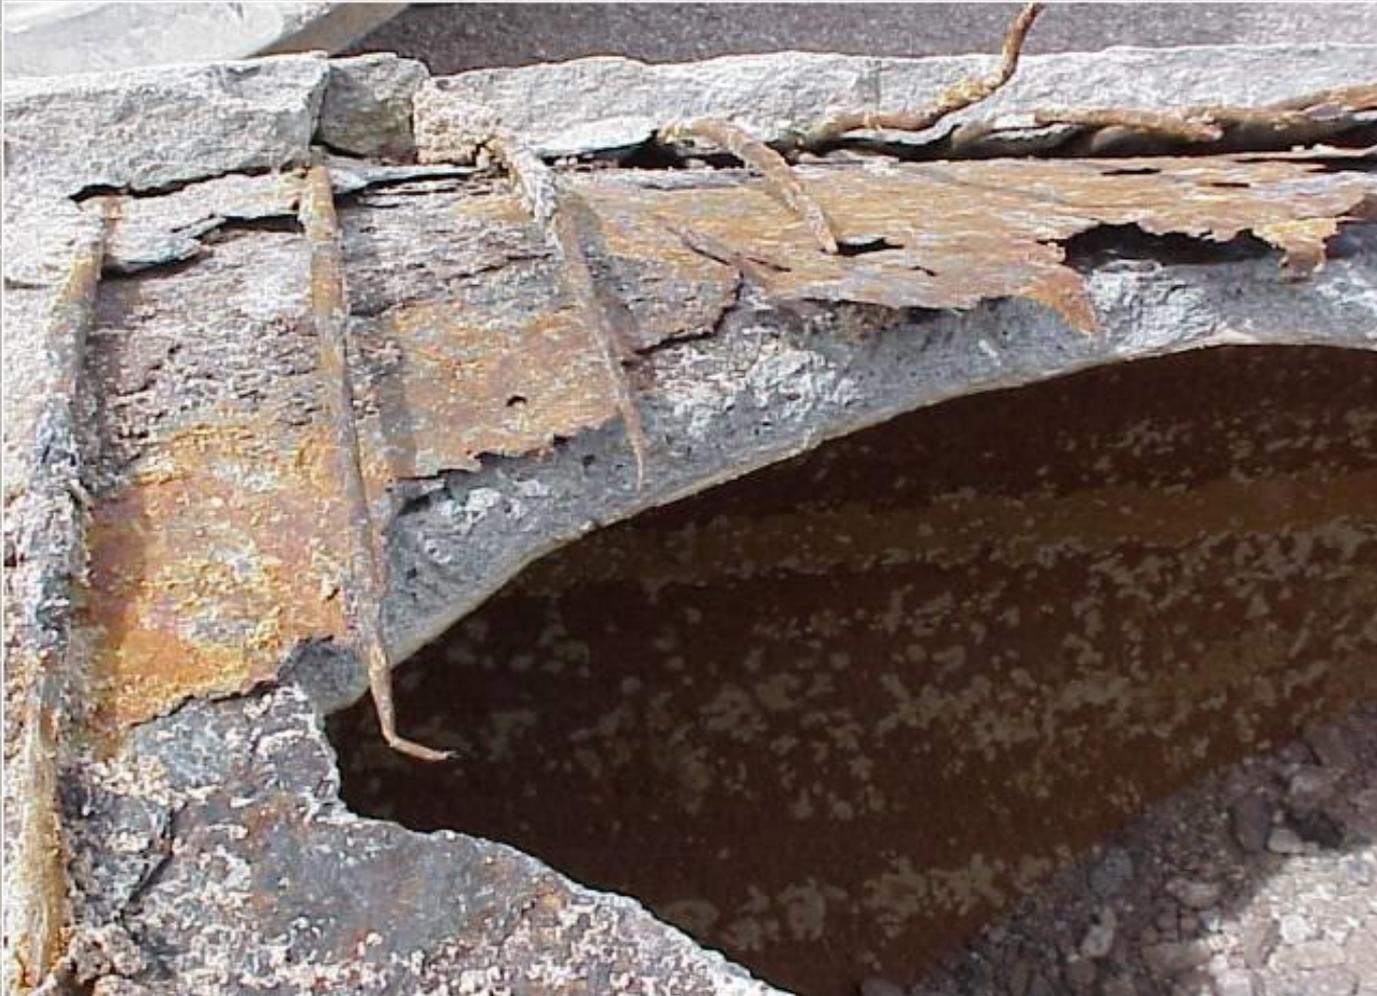
OBLIGATORY PHOTO OF CORROSION

- At failure the Pipe-to-soil was + potential
- Test points at aprox. 1000-foot intervals
- “Bonded joints”
- No CP installed on water line
- Water Line runs parallel to Gas Line with CP in the road.
- Multiple Gas Line Rectifier/Deep Anodes are in the area

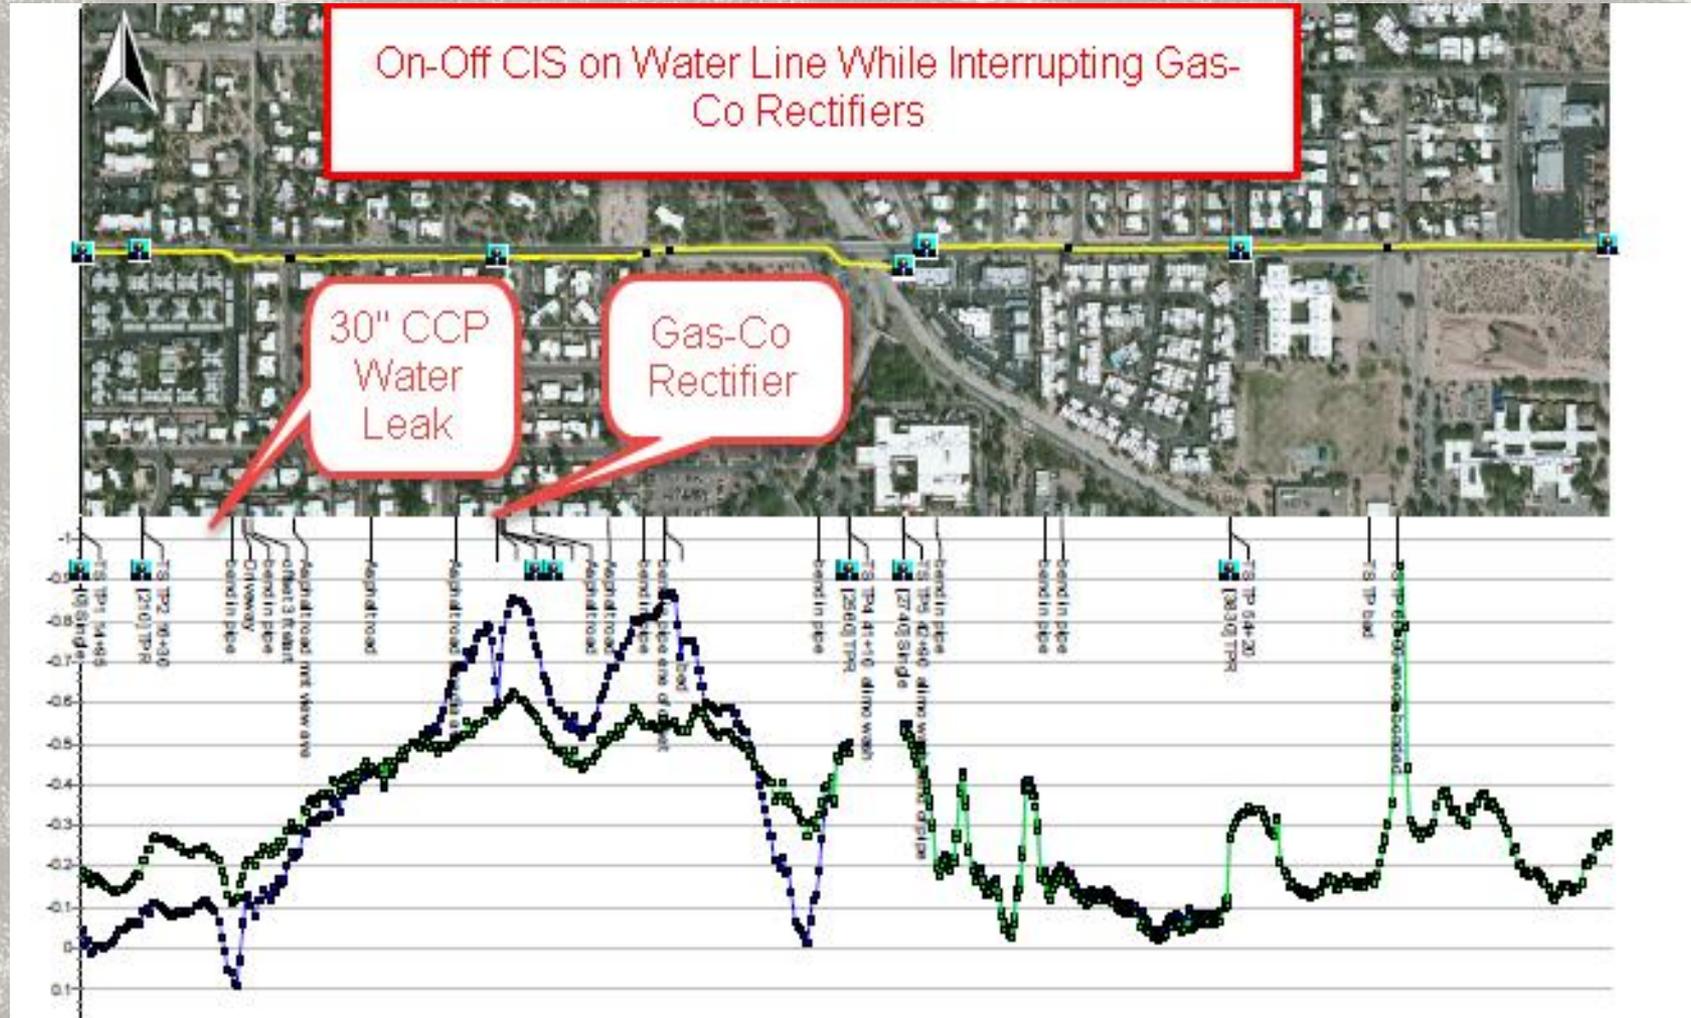
IDENTIFYING LOCATION OF INTEREST USING CIS

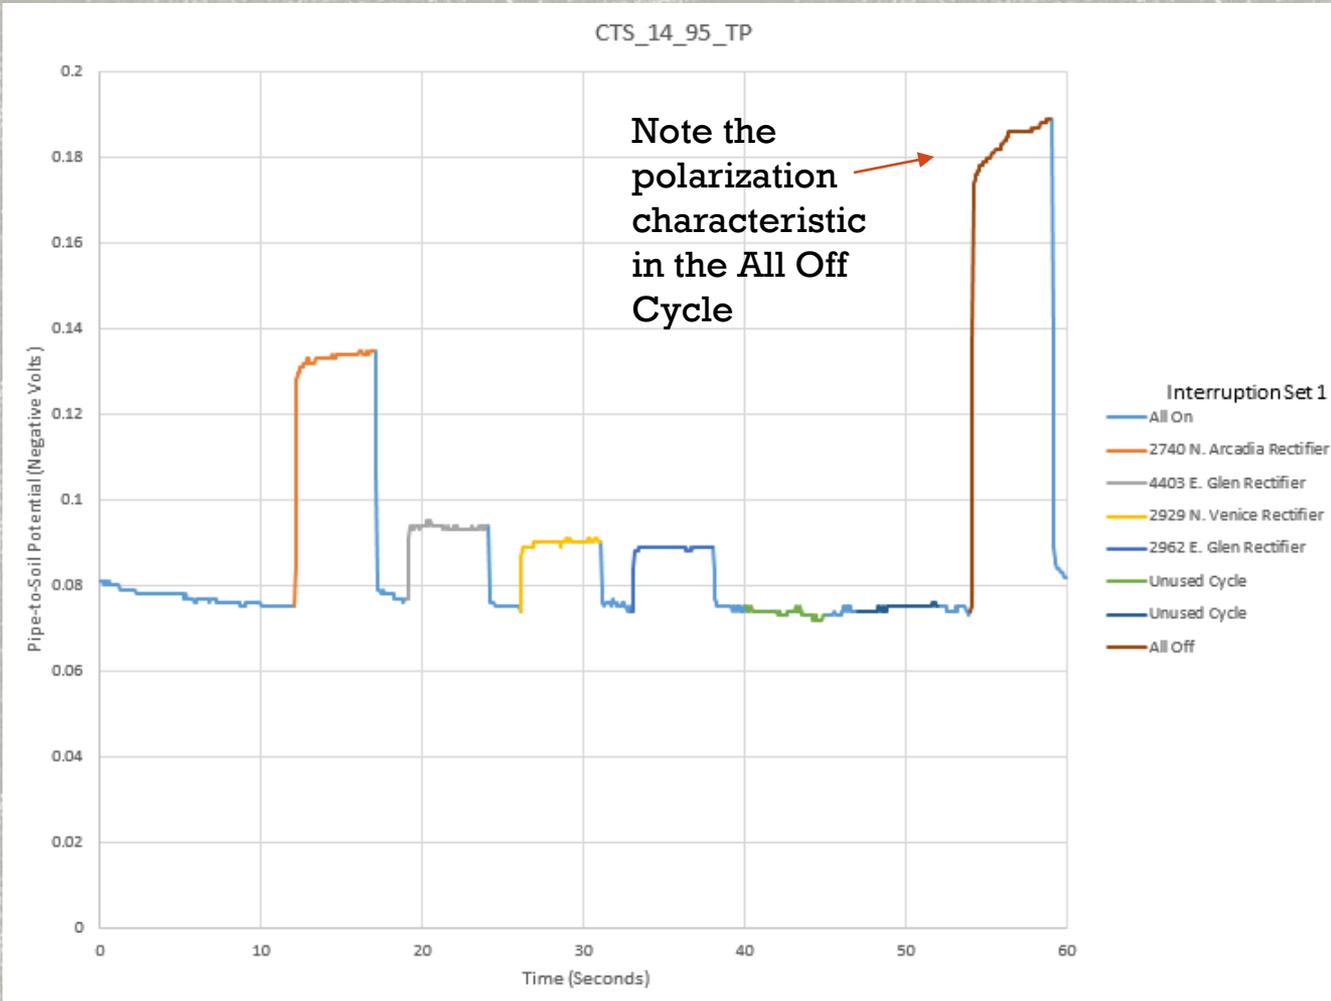
PERFORMING R.I.S. AT LEAK SITE

P/S POTENTIAL WAVEFORM

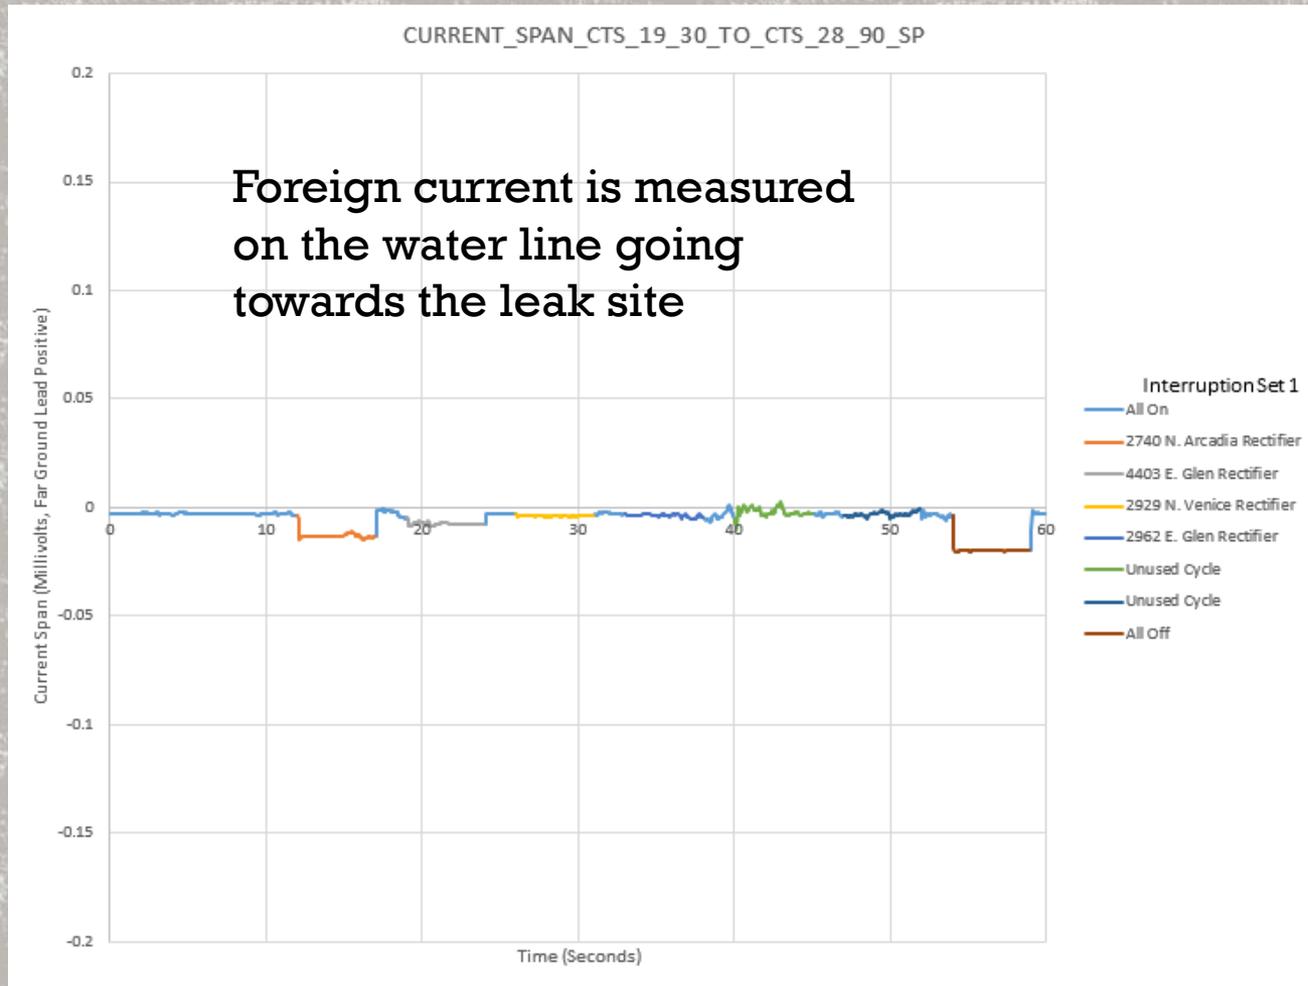
WAVEFORM ON CURRENT SPAN NEAR PREVIOUS LEAK SITE

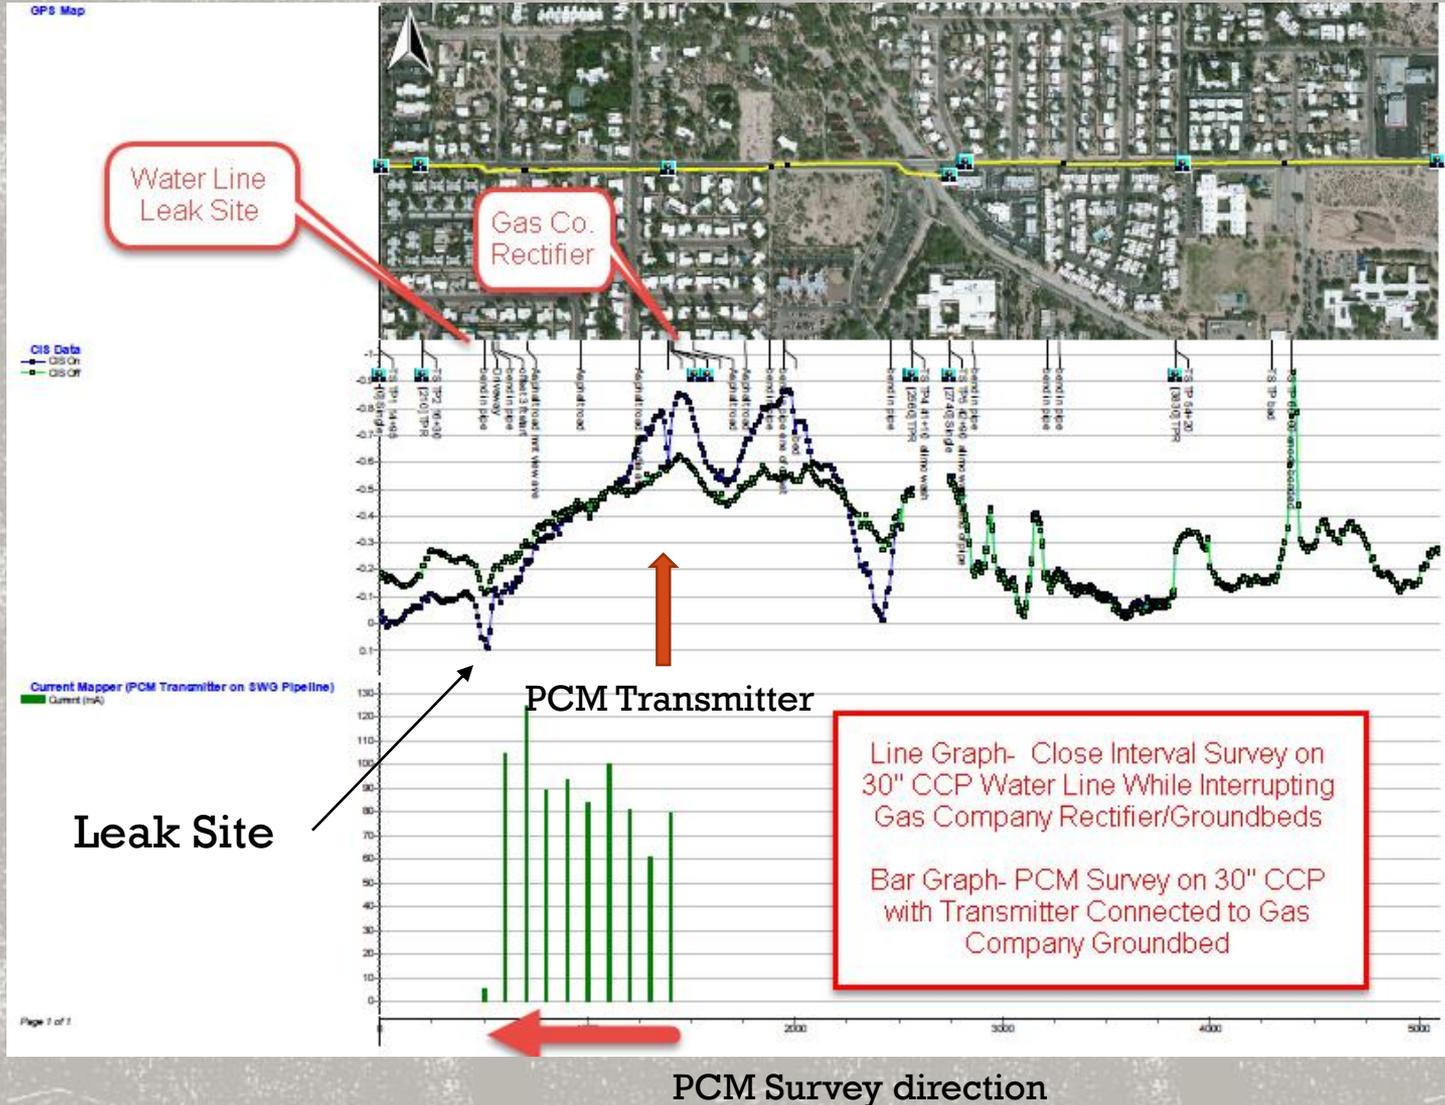
USING THE PIPELINE CURRENT MAPPER TO VALIDATE THE STRAY CURRENT

- The PCM validated the results of the Rectifier Influence Study. With the PCM transmitter installed on the Gas Company ground bed with return to the Gas Company pipeline, we were able to pick up current on the water line with the PCM receiver. As we took current measurements on the water line, the magnitude of current increased as we approached the leak site. One step past the leak site and the current could not be measured on the water line. We conclude that the PCM current was being discharged from the water line at this location.
