**Re: PPL Electric Utilities Corporation  
Quarterly Reliability Report for the  
Period Ended September 30, 2010  
Docket No. L-00030161**

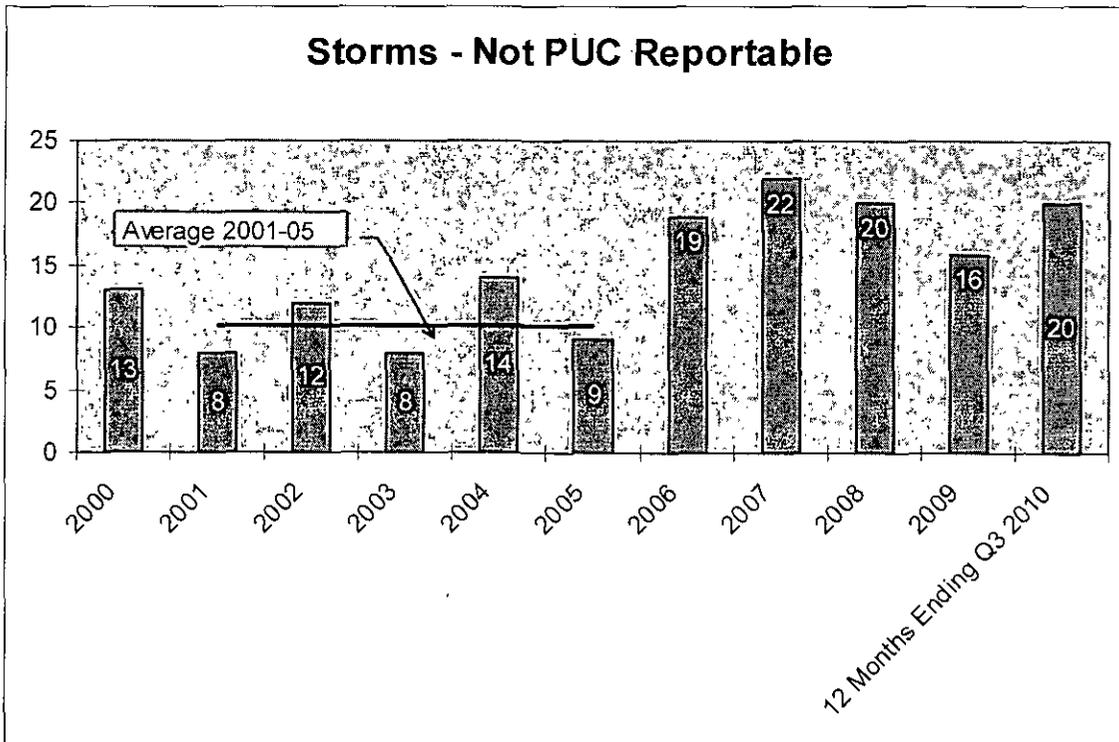
### Storms - Not PUC Reportable

In addition, there were twenty (20) storms that were not reportable, but which did require the opening of one or more area emergency centers to manage restoration efforts. This is 96% higher than the average of 10.2 storms per year for the five years from 2001 through 2005.
