**Re: PPL Electric Utilities Corporation  
2011 Annual Reliability Report**

**PPL Electric Utilities Corporation  
Annual Reliability Report  
to the  
Pennsylvania Public Utility Commission**

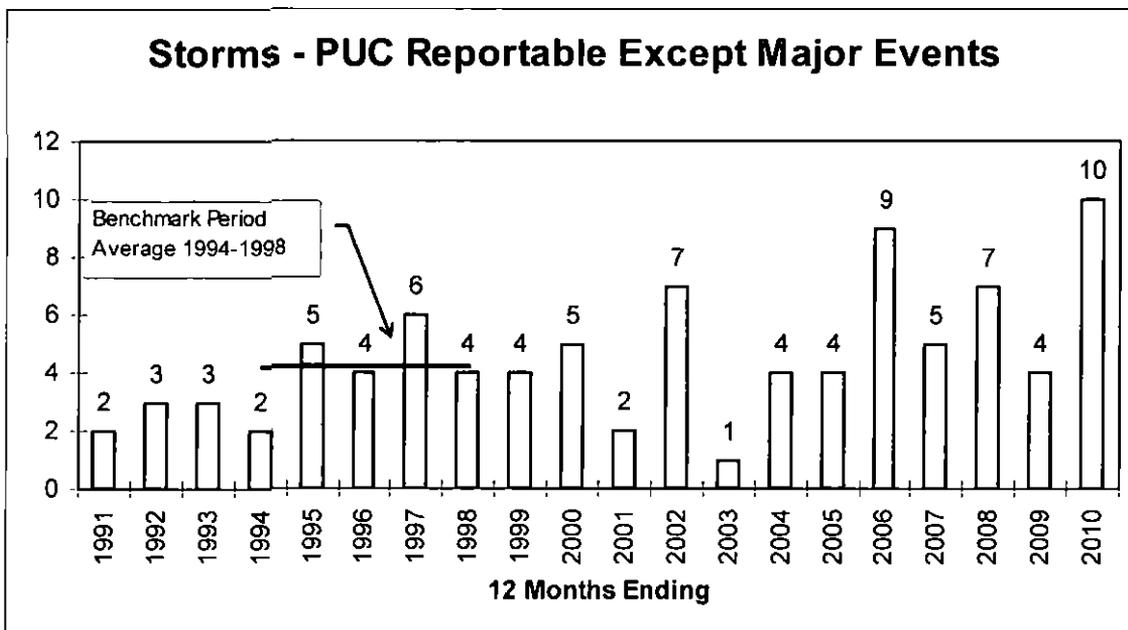
The general degradation in all metrics was partially due to a substantial increase in storm activity as compared to the three previous years. Specifically, PPL Electric experienced an average of 5.3 PUC-reportable storms ( $\geq 2,500$  customers interrupted for  $\geq 6$  hr.) per year during the three years from 2007 through 2009. The number of storms jumped to 10 in 2010, which is more than double the average of 4.2 storms per year experienced during the benchmark years, 1994 through 1998.

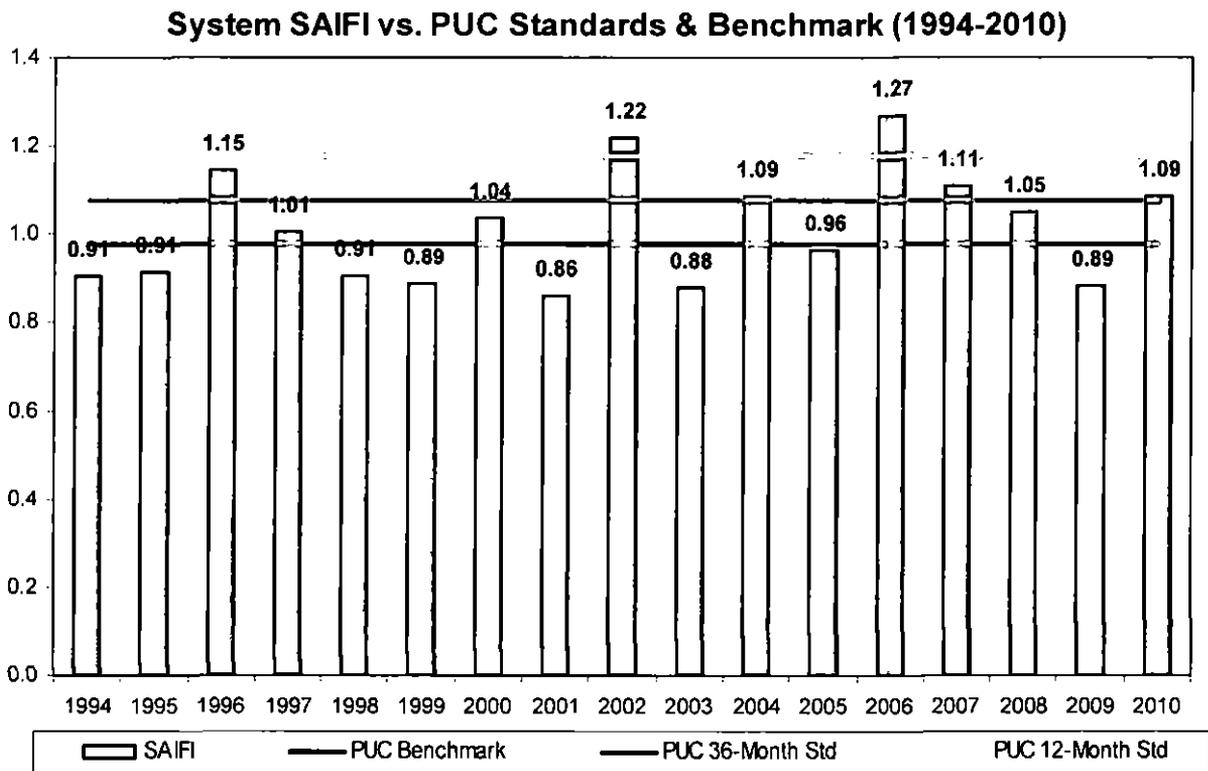
With the exception of the extraordinarily active storm years, SAIFI, CAIDI and SAIDI generally have been maintained at benchmark levels since the benchmark years of 1994 through 1998, as evidenced by the following three charts:
