**Re: PPL Electric Utilities Corporation
Quarterly Reliability Report for the
Period Ended September 30, 2011
Docket No. L-00030161**

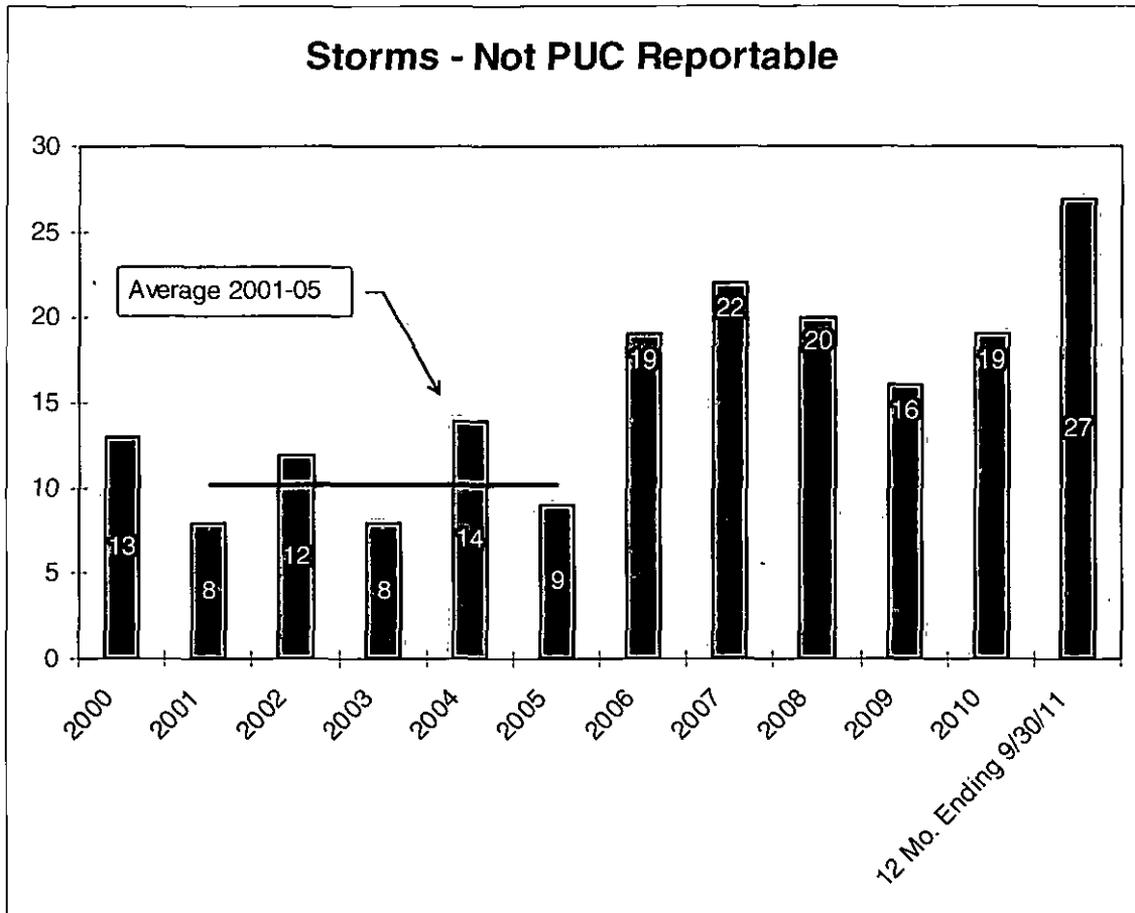
In addition, there were twenty-seven (27) storms that were not reportable, but which did require the opening of one or more area emergency centers to manage restoration efforts. This is 165% higher than the average of 10.2 non-reportable storms per year for the five years from 2001 through 2005.
