**Re: PPL Electric Utilities Corporation
2011 Annual Reliability Report**

L-00030161

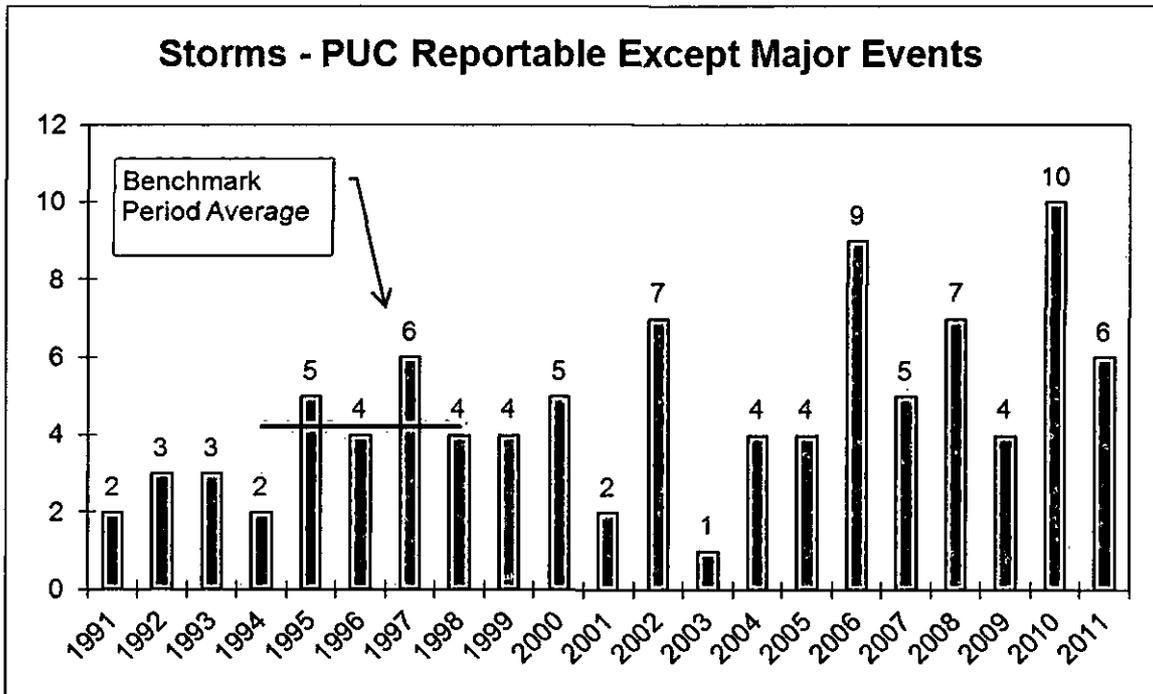
All metrics were negatively impacted due to a substantial increase in total storm activity as compared to the three previous years. Specifically, PPL Electric experienced an average of 25.3 PUC-reportable and non-reportable storms per year during the three years from 2008 through 2010. The number of storms jumped to 30 in 2011, a 19% increase.

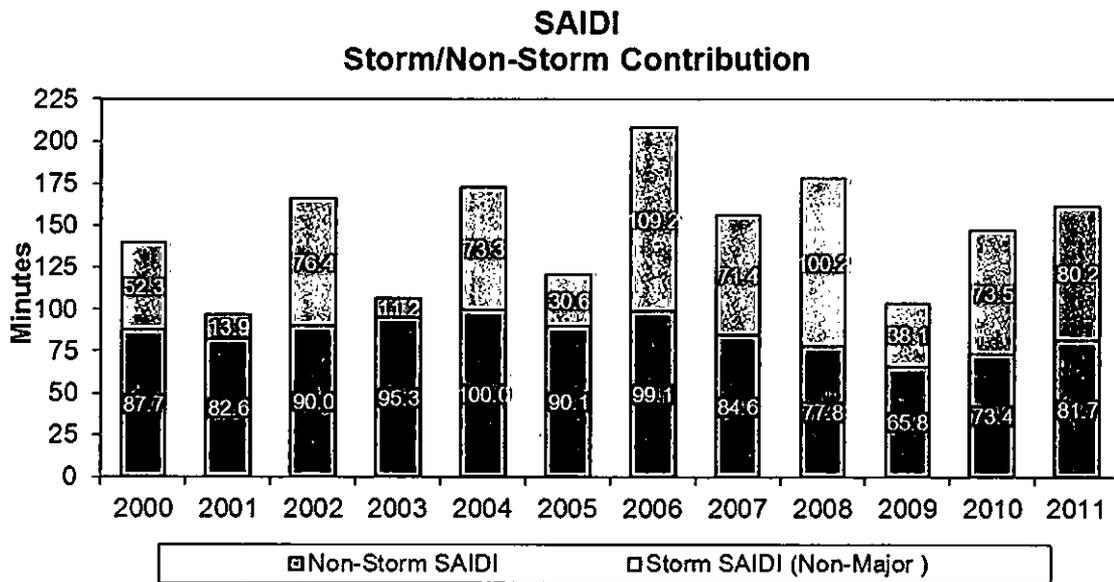
In a year with an average number of storms, customer service interruptions during storms typically contribute about one-third to the total SAIDI value. In 2011, storm interruptions contributed 49% of the SAIDI value.

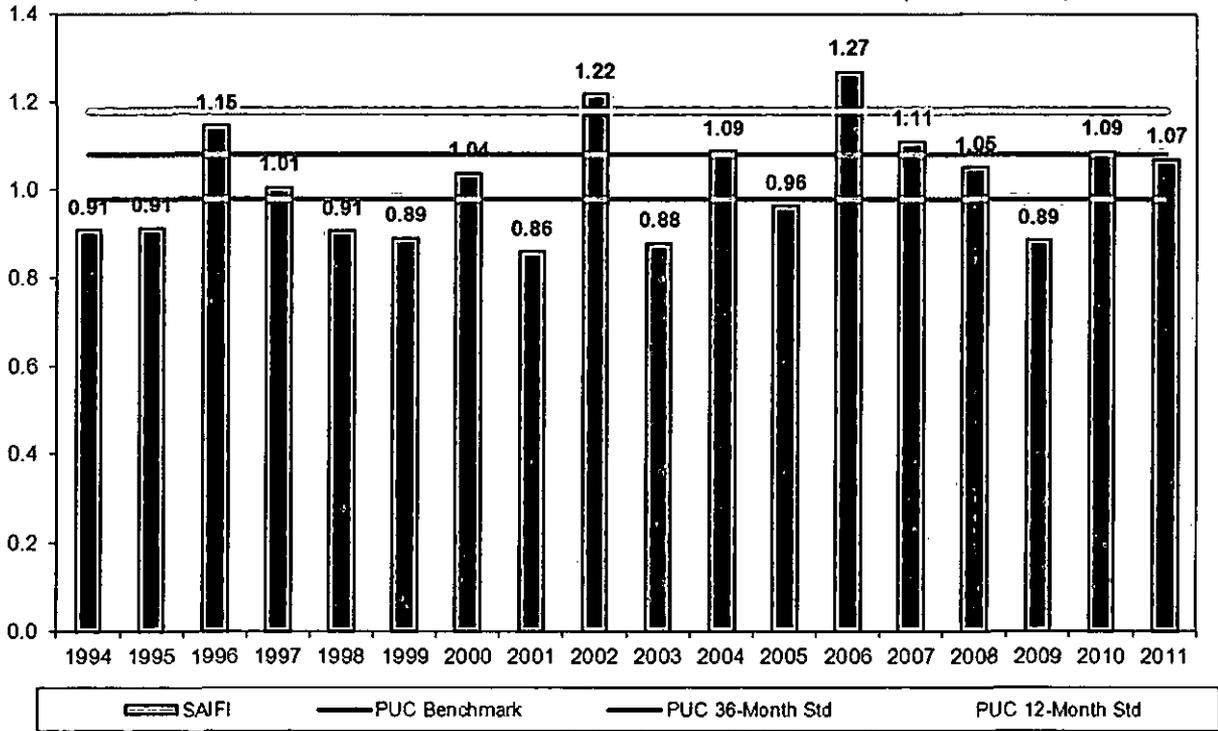
System SAIFI vs. PUC Standards & Benchmark (1994-2011)

With the exception of the extraordinarily active storm years, SAIFI, CAIDI and SAIDI generally have been maintained at benchmark levels since the benchmark years of 1994 through 1998, as evidenced by the following three charts:

The three-year rolling average for SAIFI, CAIDI and SAIDI remained below the three-year standard, as well as the rolling 12-month standard. Additionally, the three-year rolling average for SAIDI and CAIDI remained below the benchmark standard, while the three-year SAIFI was 9% over the benchmark standard.
