**Re: PPL Electric Utilities Corporation  
Quarterly Reliability Report for the  
Period Ended March 31, 2013  
Docket No. L-00030161**

**PPL Electric Utilities Corporation  
Quarterly Reliability Report  
to the  
Pennsylvania Public Utility Commission**

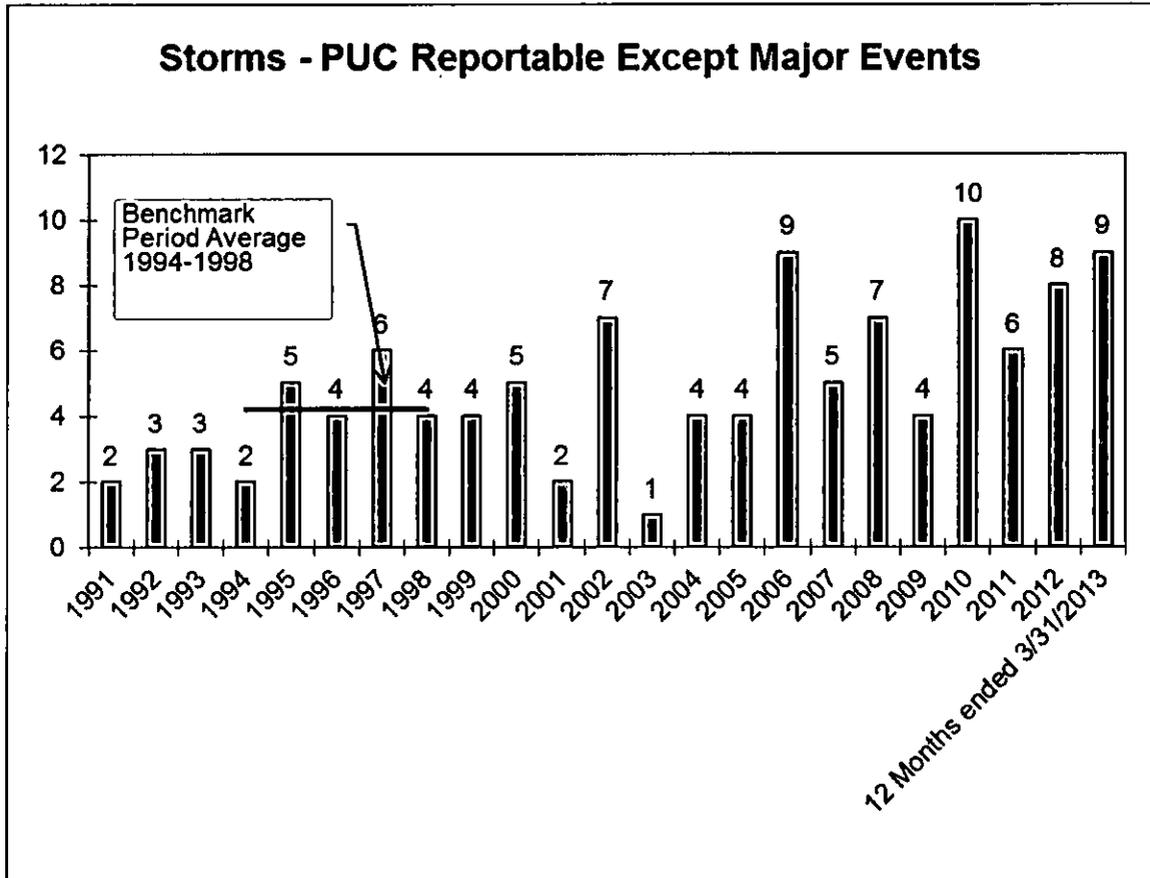
Specifically, during the 12-month reporting period, there was one (1) PUC major event and nine (9) PUC-reportable storms ( $\geq 2,500$  customers interrupted for  $\geq 6$  hours) other than major events.

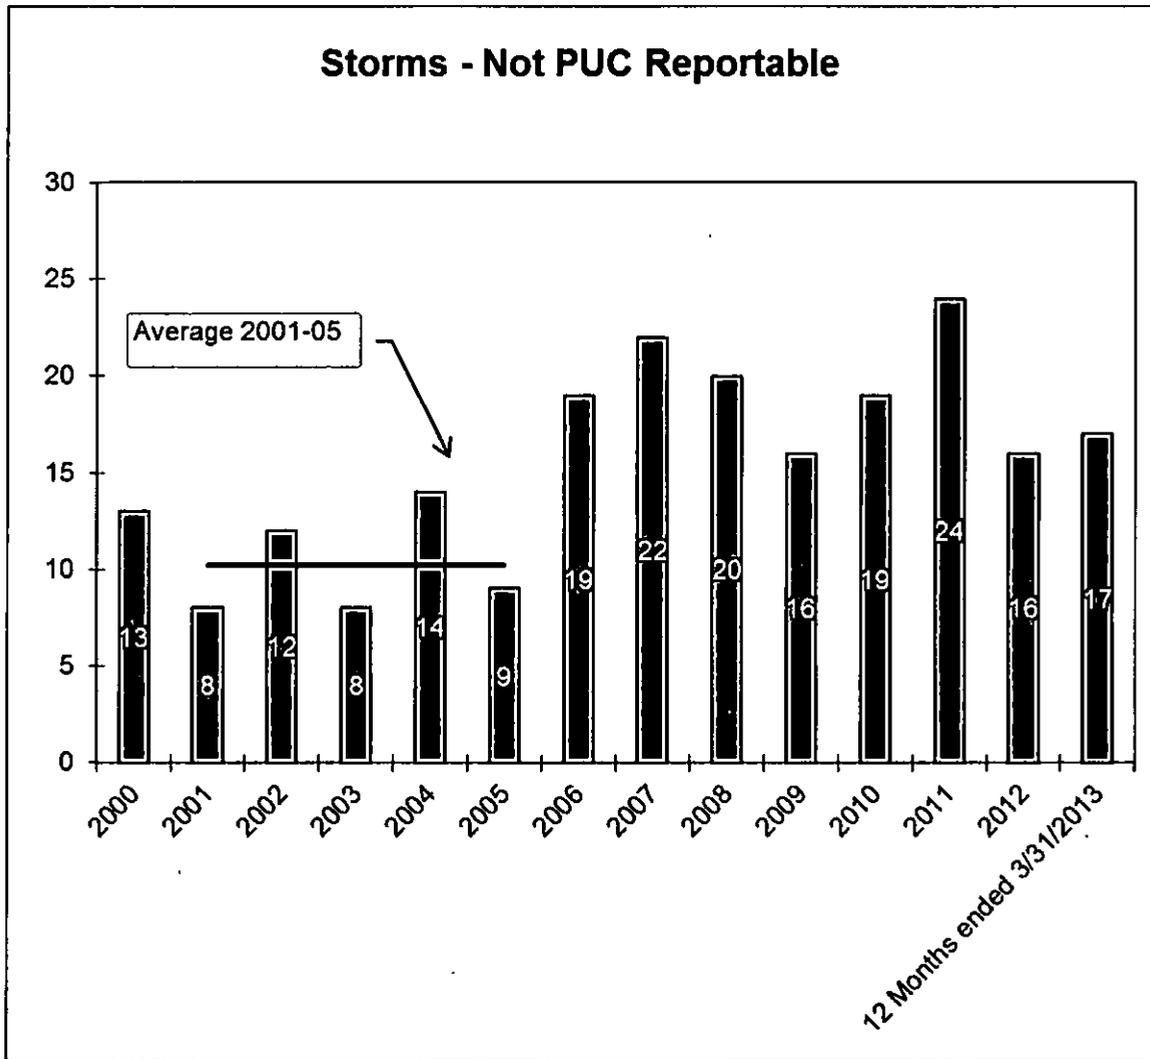
In addition, there were seventeen (17) storms that were not reportable, but which did require the opening of one or more area emergency centers to manage restoration efforts.
