**Re: PPL Electric Utilities Corporation
2013 Annual Reliability Report
Docket No. L-00030161**

**PPL Electric Utilities Corporation
2013 Annual Reliability Report
to the
Pennsylvania Public Utility Commission**

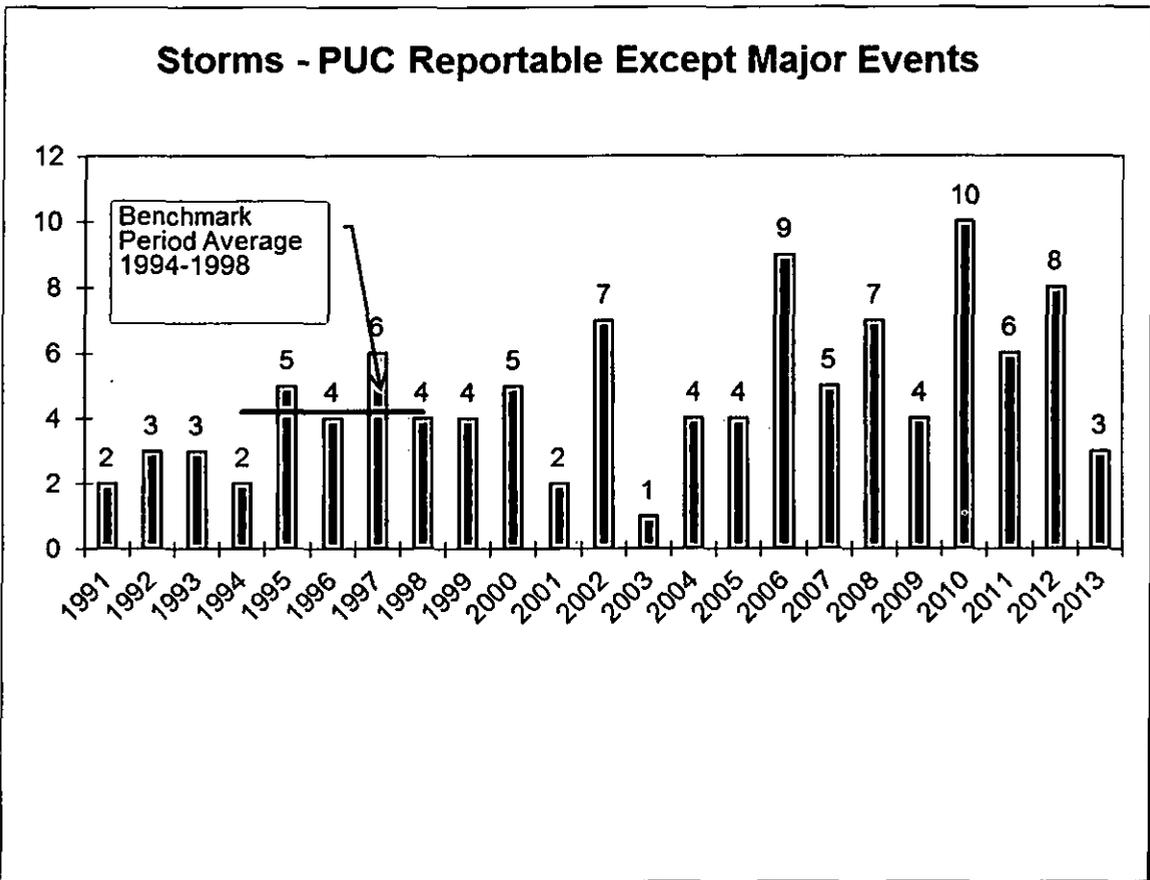
2013 was a mild year for PUC Reportable storms, and somewhat mild for Non-Reportable storms. Twenty-one percent of SAIDI was storm related.

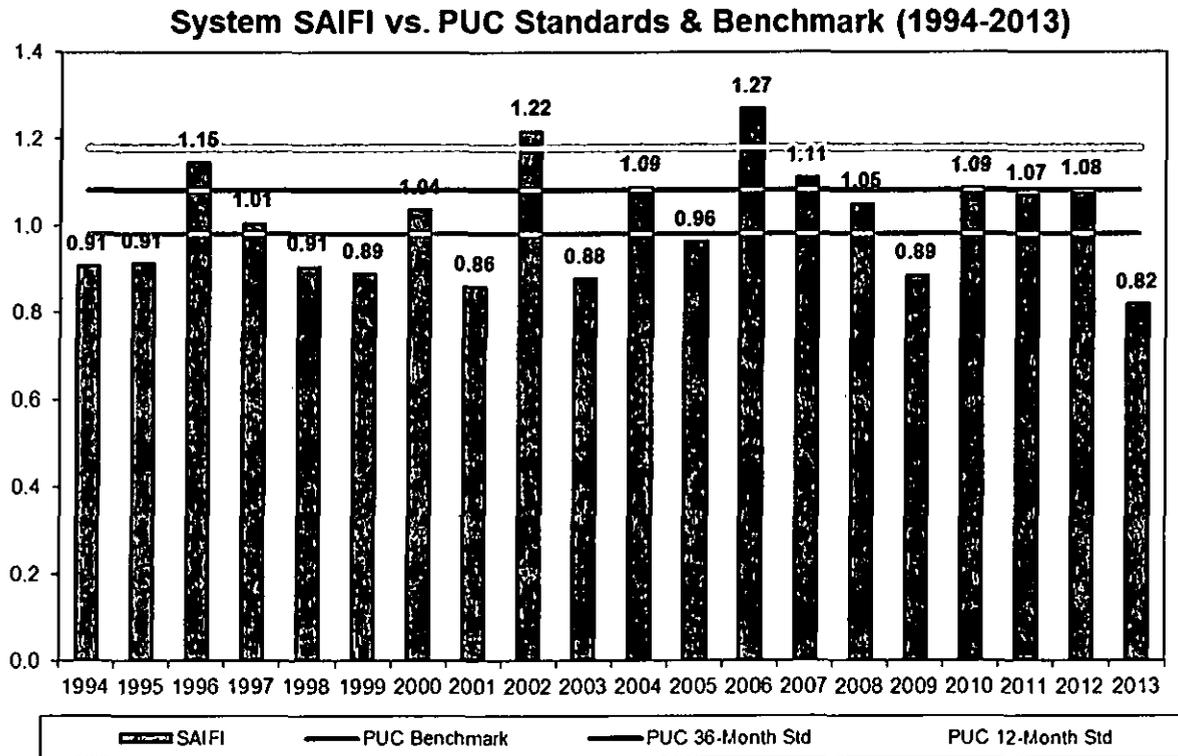
SAIFI, CAIDI and SAIDI generally have been maintained near benchmark levels and below the 36-month standard levels since the benchmark years of 1994 through 1998, as evidenced by the following three charts. For 2013 all values were significantly below the benchmark.
