**Re: PPL Electric Utilities Corporation
Quarterly Reliability Report for the
Period Ended September 30, 2014
Docket No. L-00030161**

**PPL Electric Utilities Corporation
Quarterly Reliability Report
to the
Pennsylvania Public Utility Commission**

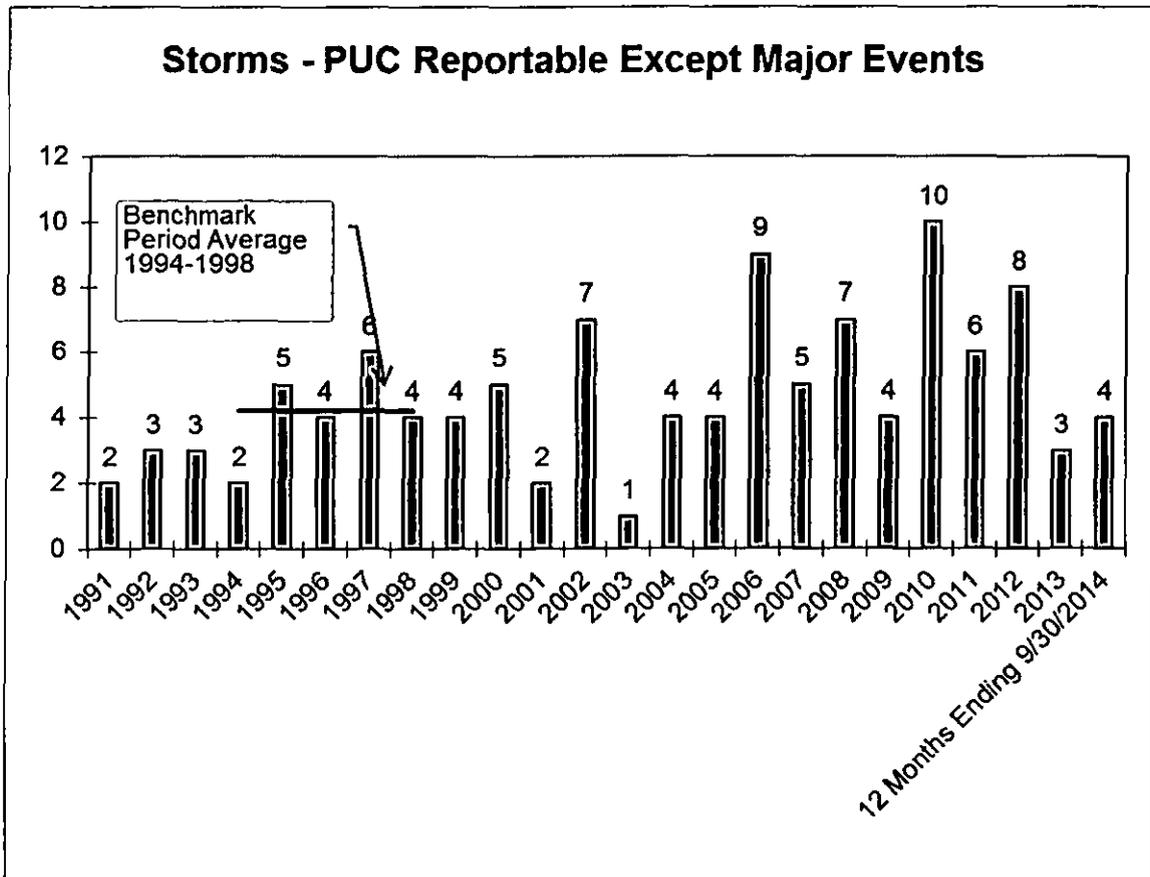
Specifically, during the 12-month reporting period, there were no (0) PUC major events and four (4) PUC-reportable storms ($\geq 2,500$ customers interrupted for ≥ 6 hours) other than major events.

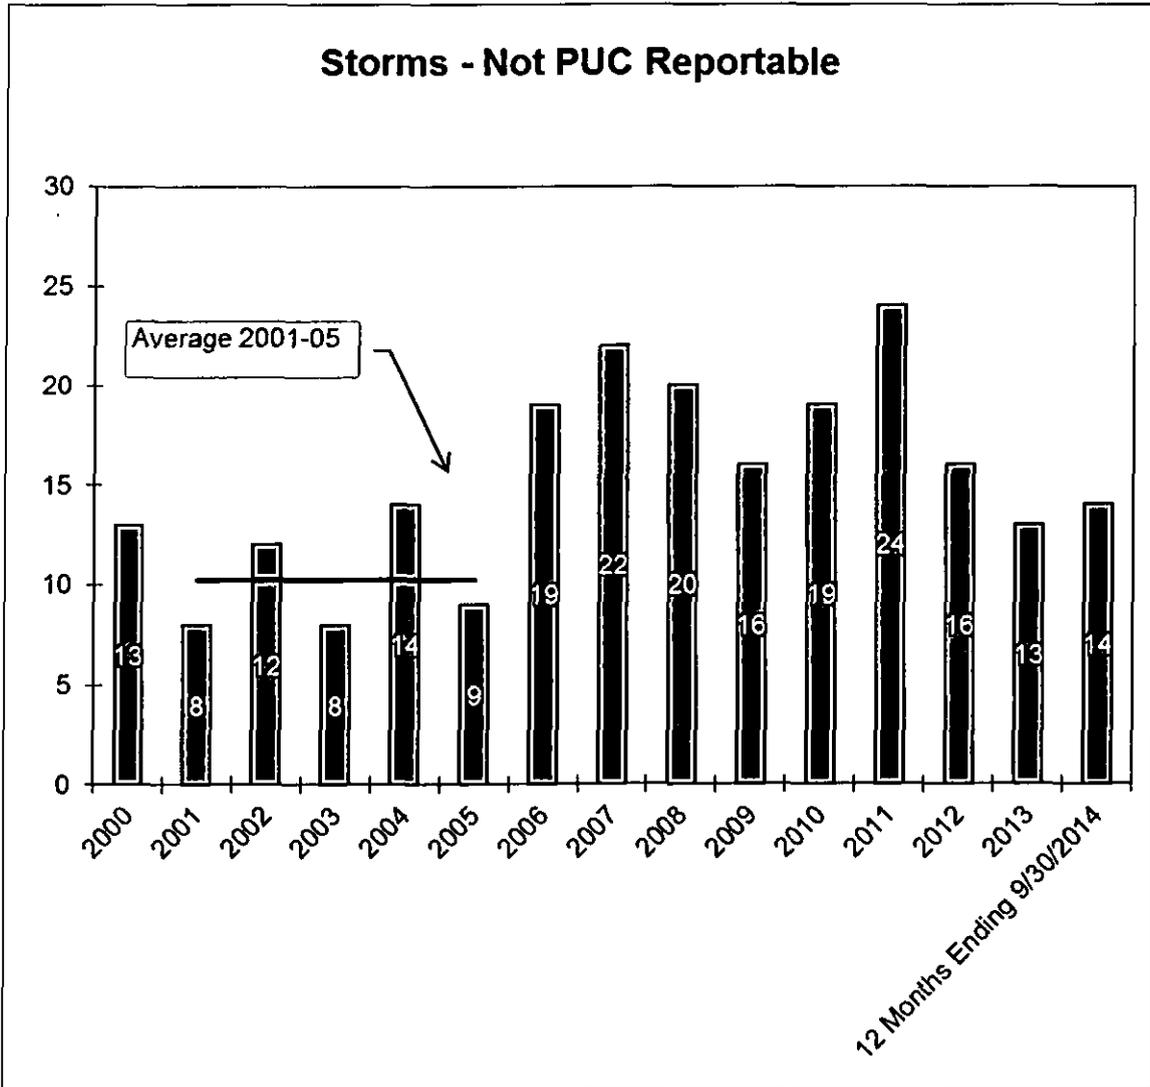
In addition, there were fourteen (14) storms that were not reportable, but which did require the opening of one or more area emergency centers to manage restoration efforts.
