**Re: PPL Electric Utilities Corporation
Quarterly Reliability Report for the
Period Ended June 30, 2006
Docket No. L-00030161**

**PPL Electric Utilities Corporation
Quarterly Reliability Report
to the
Pennsylvania Public Utility Commission**

**PECO Energy Company
Quarterly Reliability Report
For Period Ending June 30, 2006**

**Joint 2nd Quarter 2006 Service Reliability Report –
 Pennsylvania Power Company,
 Pennsylvania Electric Company and
 Metropolitan Edison Company**

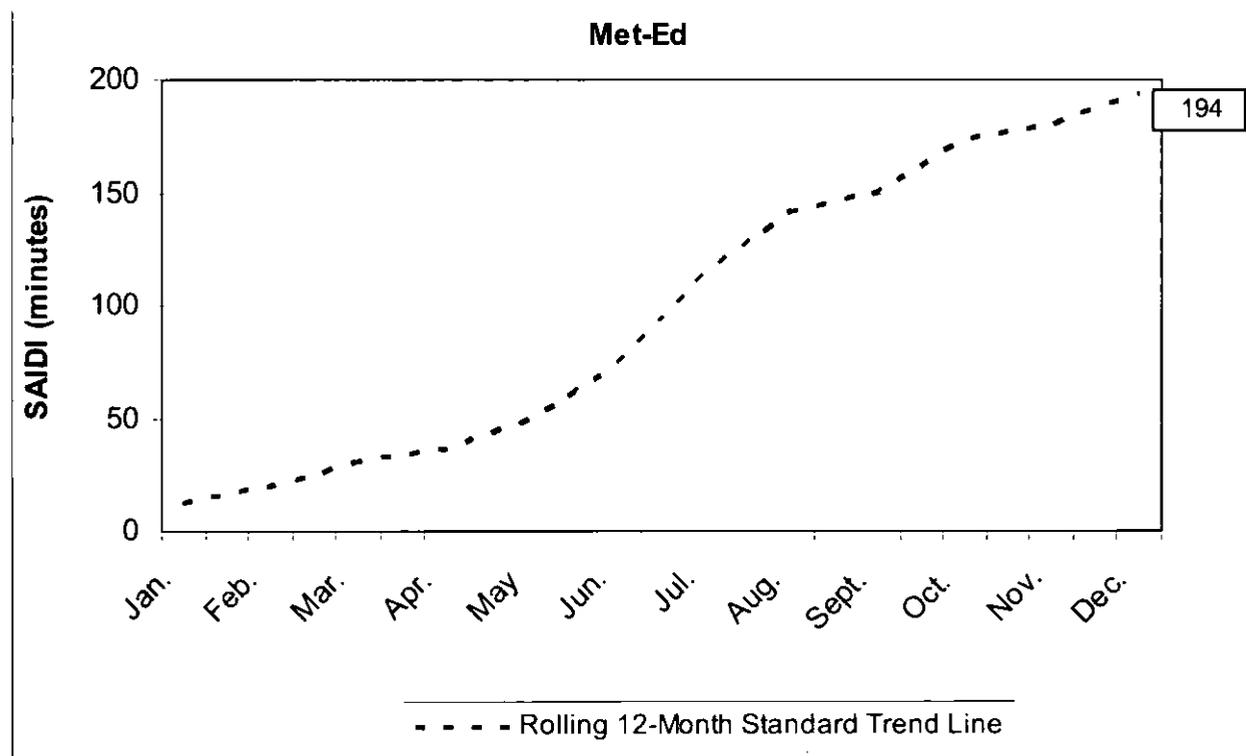
The normalized trend line is a slight modification to a straight-line trend, taking into consideration the three-year historical performance of each Company, with higher SAIDI accumulation (customer minutes of interruption) during the summer storm months, and lower SAIDI accumulation in the winter months. For example, Met-Ed's 3-year historical performance indicates the Company would expect to accumulate more SAIDI in June through August (approximately 30 minutes per month) than in November through December (approximately 10 minutes per month). As shown in the Met-Ed chart below, the Commission's 12-Month Rolling Standard of 194 is plotted using this normalized trending approach.

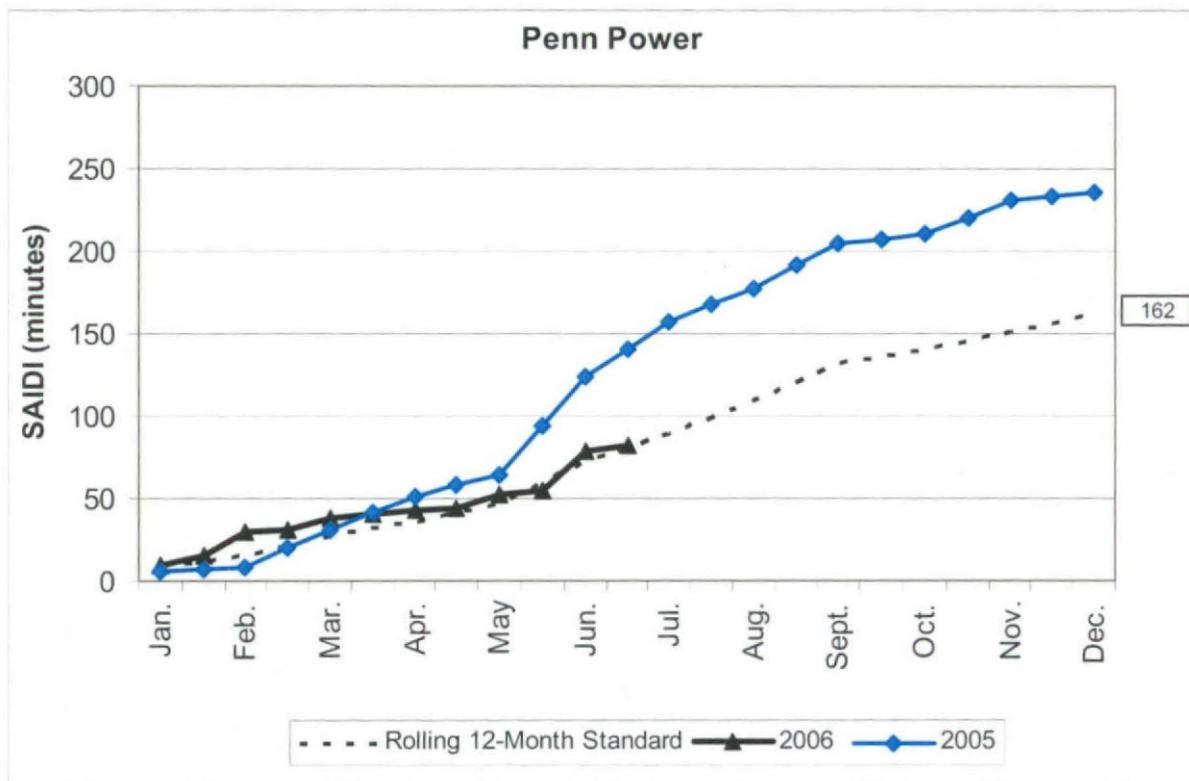
Penn Power’s year-to-date SAIDI performance is on target with the 3-year normalized standard trend line, based on the Commission’s Rolling 12-Month Standard for SAIDI of 162 at year-end 2006. Penn Power is 59.2 minutes better than the 2005 actual trend line. The increases in the 2006 actual line in February and June reflect the impact of non-excludable weather events in the service territory.

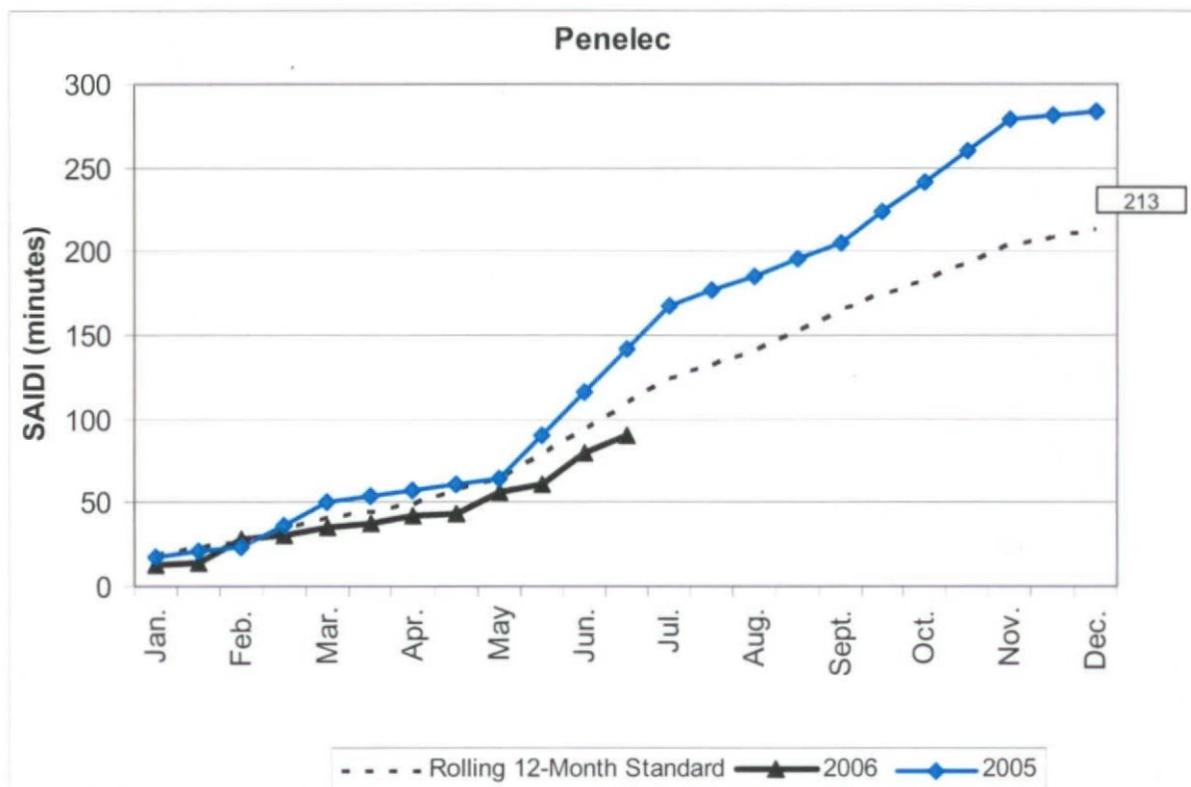
Penelec's year-to-date SAIDI performance is better than the targeted 3-year normalized standard trend line by 18.8 minutes and better than 2005 actual by 51.3 minutes. This year-to-date performance positions Penelec to come in better than the Commission's Rolling 12-Month Standard for SAIDI of 213 at year-end 2006.

A Request for Exclusion of Major Outage for Reliability Reporting Purposes (see § 57.195(e)(1) for details) was submitted to the Commission on July 28. If approved, this request would result in a 7.4 minute improvement in Penelec's year-to-date position. The graph above does not reflect the impact of the Major Event, which is pending Commission approval.

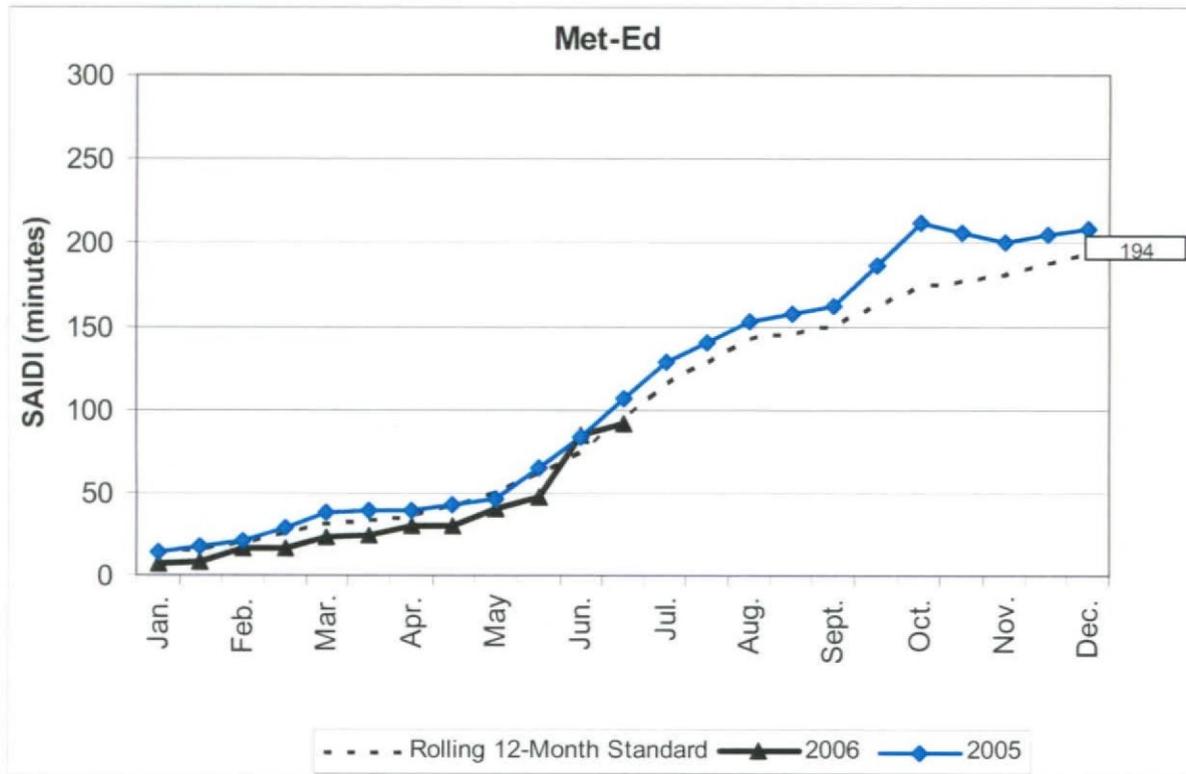
Met-Ed’s year-to-date SAIDI performance is slightly better than the targeted 3-year normalized standard trend line by 2.3 minutes and 14.3 minutes better than the 2005 actual trend line. Based on prior years’ experience, Met-Ed is on target to achieve the Commission’s Rolling 12-Month Standard for SAIDI of 194 at year-end 2006.

The sudden increase in the 2006 trend line in June reflects the impact of weather events late in that month for which a Request for Exclusion of Major Outage for Reliability Reporting Purposes (see § 57.195(e)(1) for details) was submitted to the Commission on July 28. If approved, this request would result in a 14.0 minute improvement in Met-Ed’s year-to-date position. The graph above does not reflect the impact of the Major Event, which is pending Commission approval.
