Re: Second Quarter 2006 Reliability Report of Allegheny Power

**Allegheny Power
Quarterly Report for Second Quarter 2006**

**PPL Electric Utilities Corporation
Quarterly Reliability Report
to the
Pennsylvania Public Utility Commission**

Joint 3rd Quarter 2006 Service Reliability Report –
Pennsylvania Power Company,
Pennsylvania Electric Company, and
Metropolitan Edison Company
Pursuant to 52 PA Code §57.195(e)

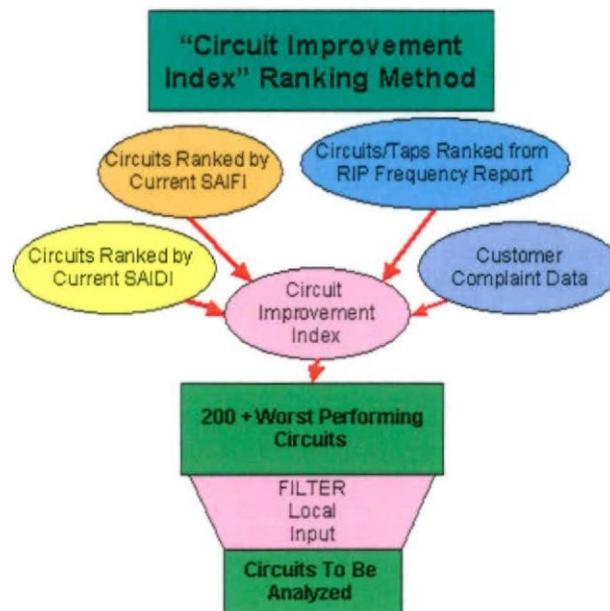
A schematic diagram of the process follows:

Circuit Improvement Index replaces Distribution Circuit Improvement Index (DCII) as the primary means of selecting poor performing circuits for annual evaluation. DCII is a satisfactory ranking if statistics alone (SAIFI, CAIDI, SAIDI, and ASAI) are used to evaluate circuit performance based on a five-year system average performance. But circuit improvement involves much more than just a high-level statistical ranking. Circuits need to be evaluated for a number of factors including frequency of lockouts, frequency of major tap interruptions representing individual customer outage frequency, customer complaint data (if applicable), plus traditional reliability indexes such as SAIFI and SAIDI. A 'master' circuit improvement list will be generated annually and reviewed at the local levels for field input. Field offices, being closer to the customer, have information needed to complete the selection process based on known circuit problems. The master list will then be narrowed to the 100 or so circuits to be studied for the next year. No less than the required applicable state commission requirement will be addressed. Under the new circuit selection method, about the same number of circuits will be evaluated since 5% of AP's 1850 circuits equals 93 circuits. Once circuits are selected for the next year, individual analysis will take place as part of AP's ongoing structured Reliability Improvement Program (RIP). Outage causes will be evaluated, circuit outage maps will be created to assist in the evaluation if needed, and budgets and work plans will be established to improve reliability for viable projects.

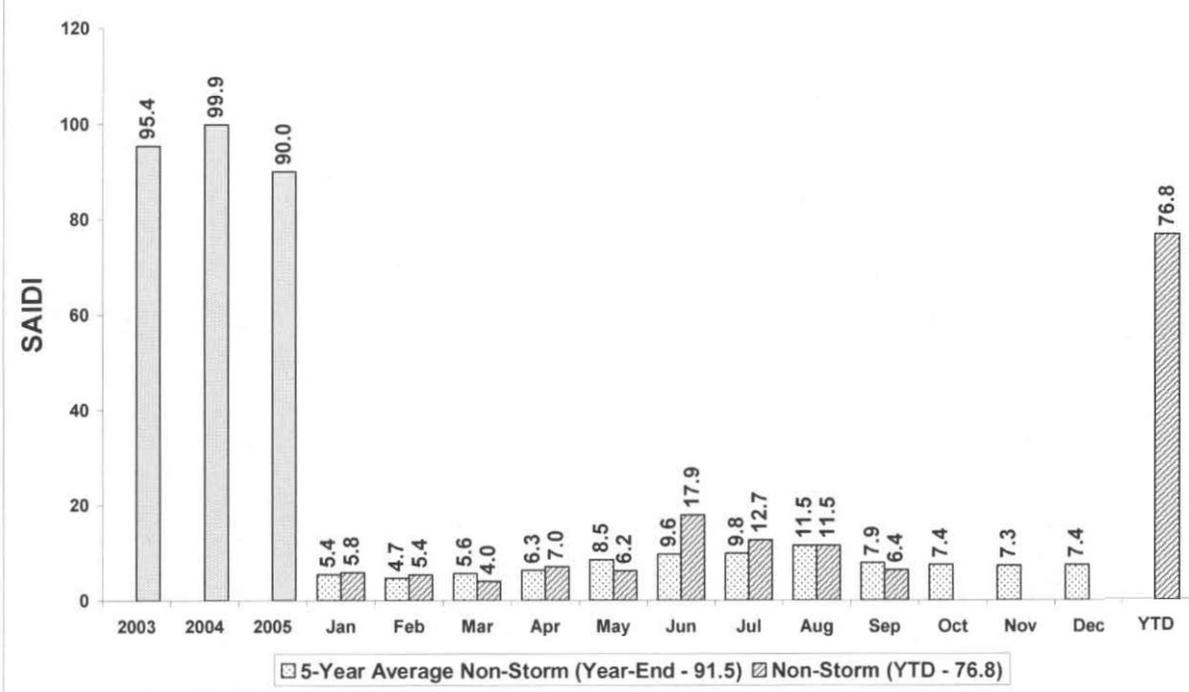
Non-Storm Customer Minutes Lost

As shown in the chart below, the year-to-date non-storm SAIDI is 76.8 minutes. Assuming that the 2006 fourth quarter non-storm SAIDI will be at the five-year average of 22.1 minutes (sum of the bars for October, November, and December), PPL Electric projects a year-end non-storm SAIDI of 98.9 minutes.

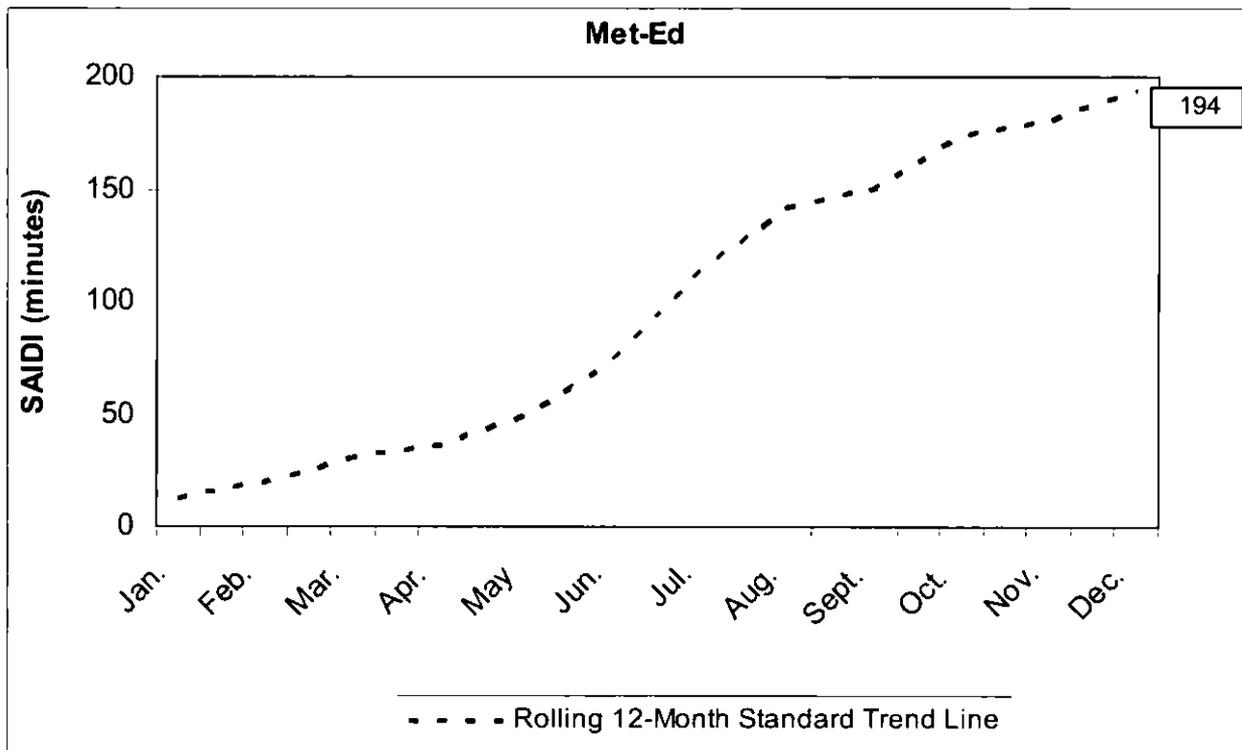
Normalized Trend

The normalized trend line is a slight modification to a straight-line trend, taking into consideration the three-year historical performance of each Company, with higher SAIDI accumulation (customer minutes of interruption) during the summer storm months, and lower SAIDI accumulation in the winter months. For example, Met-Ed's 3-year historical performance indicates the Company would expect to accumulate more SAIDI in June through August (approximately 30 minutes per month) than in November through December (approximately 10 minutes per month). As shown in the Met-Ed chart below, the Commission's 12-Month Rolling Standard of 194 is plotted using this normalized trending approach.

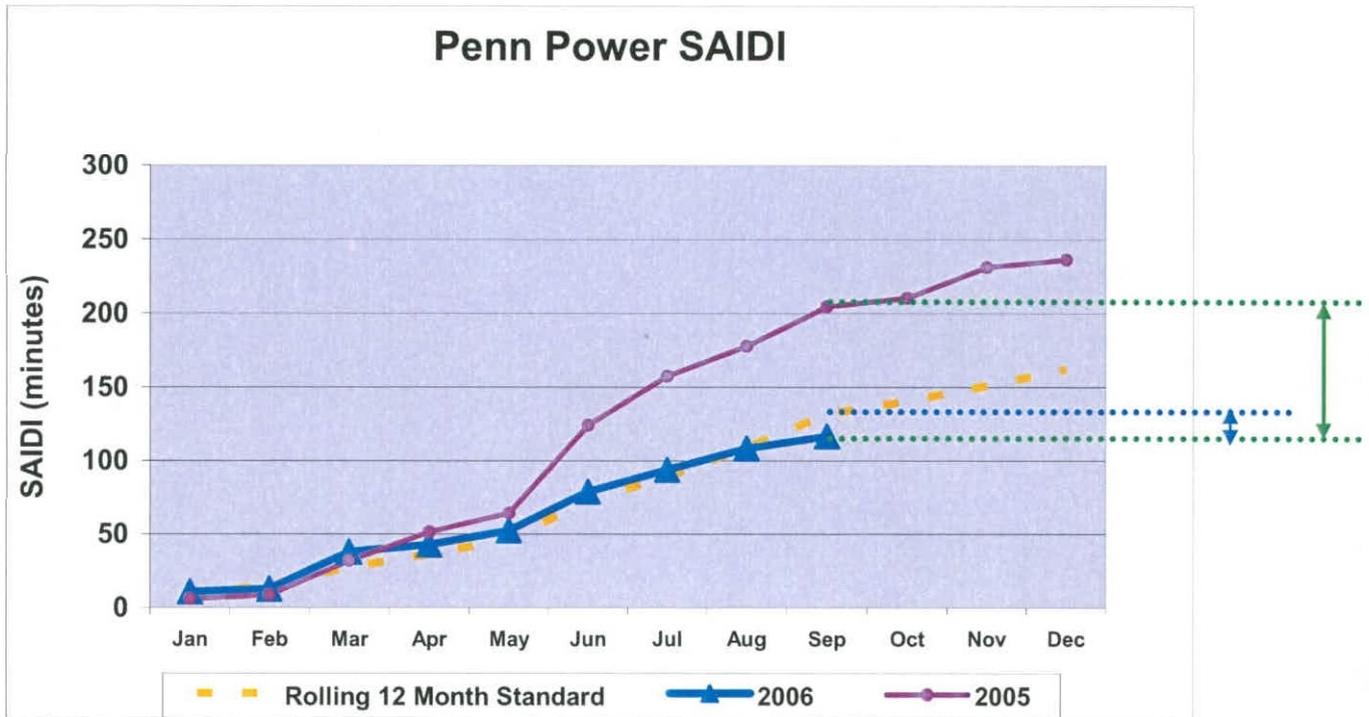
↑ Penn Power's 2006 YTD SAIDI for 3rd quarter ending:
↑ Represents a 44% improvement over actual results for the same YTD period in 2005
↕ Trending 11% below the Commission's 12-Month Standard

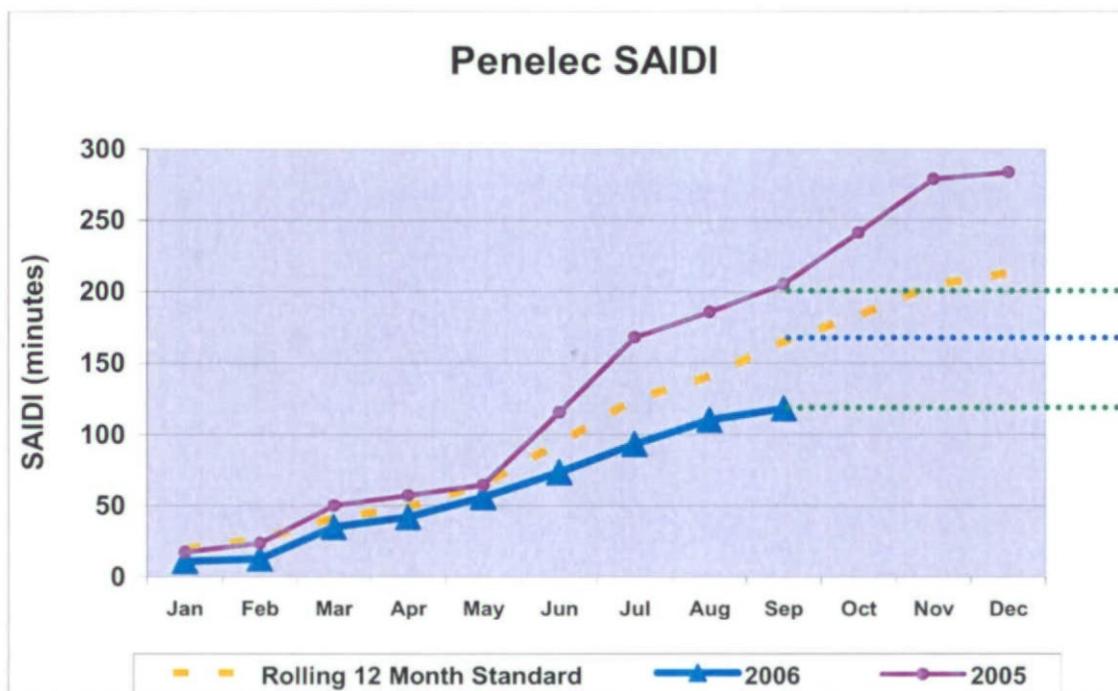
Penelec's 2006 YTD SAIDI for 3rd quarter ending:

Represents a 42% improvement over actual results for the same YTD period in 2005

Trending 28% below the 12-Month Commission Standard

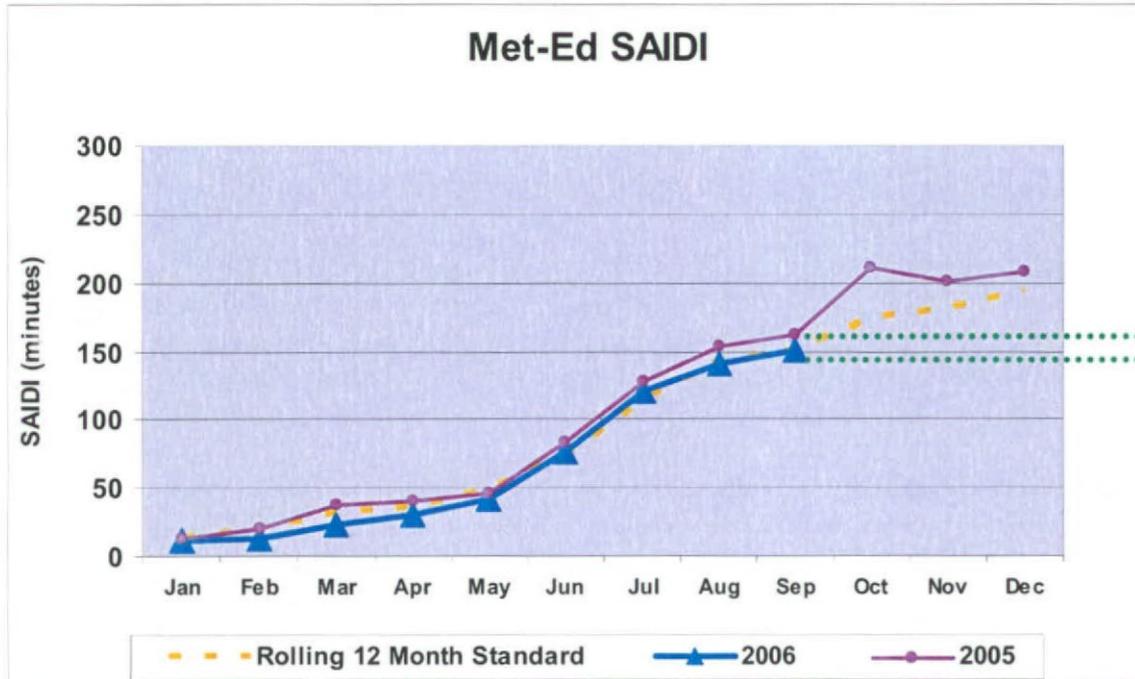
Met-Ed's 2006 YTD SAIDI for 3rd quarter ending:

- ★ Represents a 7% improvement over actual results for the same YTD period in 2005.

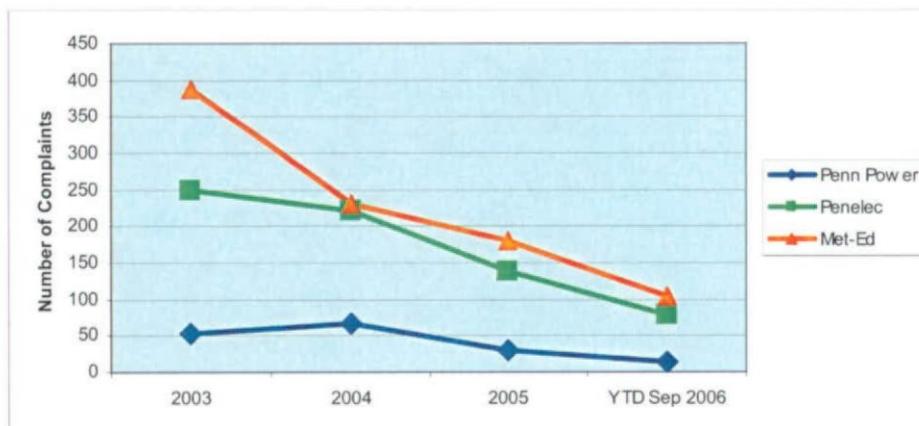
- The reliability performance improvement demonstrated to date and as described in Section e(2) of this report.
- The Companies' increased and improved communication with customers through the utilization of reverse interactive voice response ("IVR").
- Reduction in service reliability-related customer complaints (see graph below).
