Re: Joint 2<sup>nd</sup> Quarter 2007 Reliability Report - Pennsylvania Power Company, Pennsylvania Electric Company, and Metropolitan Edison Company pursuant to 52 PA Code §57.195(e)

Joint 2<sup>nd</sup> Quarter 2007 Reliability Report –  
Pennsylvania Power Company,  
Pennsylvania Electric Company, and  
Metropolitan Edison Company  
Pursuant to 52 PA Code §57.195(e)

**PPL Electric Utilities Corporation  
Quarterly Reliability Report  
to the  
Pennsylvania Public Utility Commission**

UGI Utilities, Inc. – Electric Division  
System Reliability Report:  
Quarterly Update

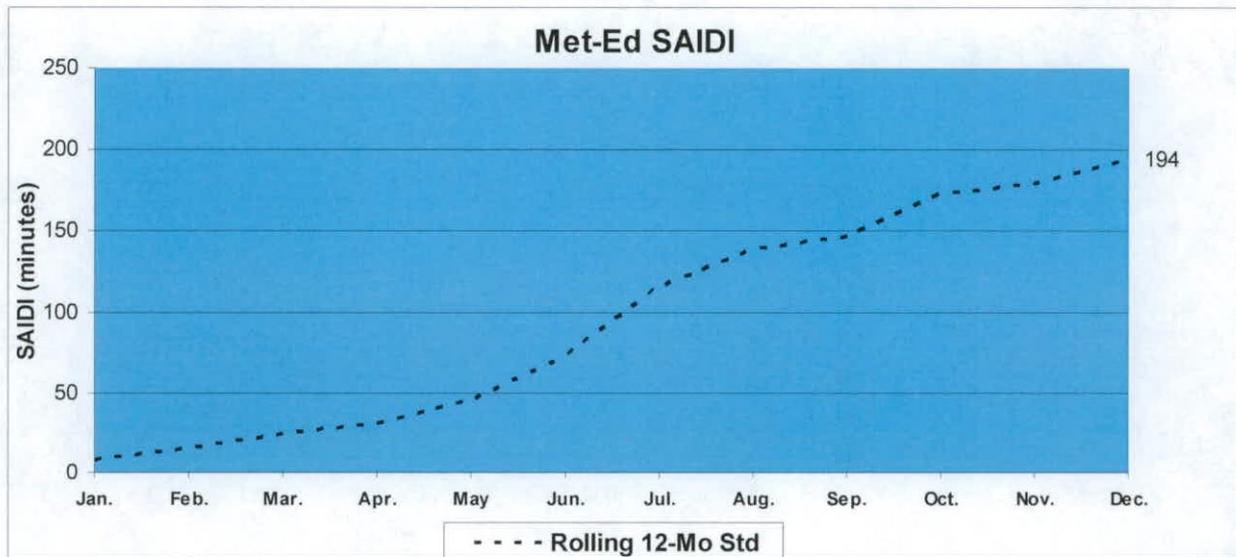
The normalized trend line is a slight modification to a straight-line trend, taking into consideration the three-year historical performance of each Company, with higher SAIDI accumulation (customer minutes of interruption) during the summer storm months, and lower SAIDI accumulation in the winter months. For example, Met-Ed's 3-year historical performance indicates the Company would expect to accumulate more SAIDI in June through August (approximately 31 minutes per month) than in November through December (approximately 11 minutes per month). As shown in the Met-Ed chart below, the Commission's 12-Month Rolling Standard of 194 is plotted using this normalized trending approach.

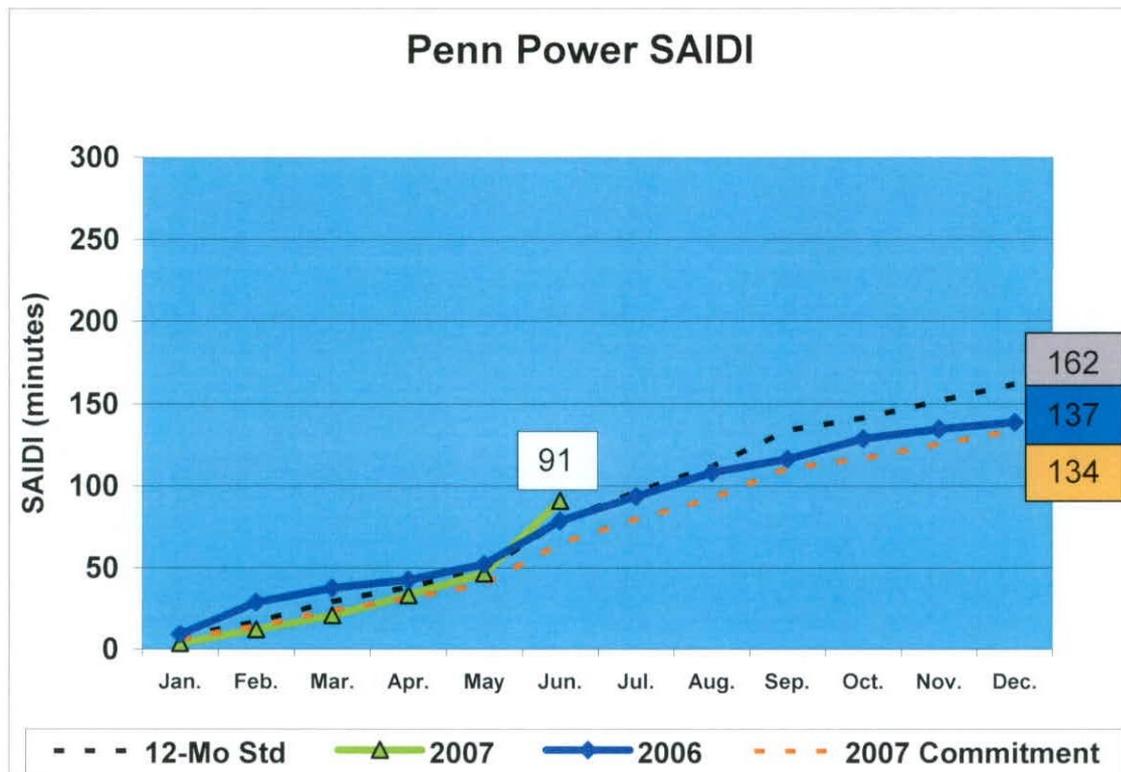
2<sup>nd</sup> Quarter 2007 Non-Excludable Events with a  $\geq 1$  minute impact on SAIDI

<i>Penn Power</i>				
Start Date	Customers Affected	Customer Minutes Interrupted	Cause	SAIDI Impact
May 1	1,163	487,791	Tornado	3.1
May 20	4,618	244,754	Lightning	1.5
June 8	11,547	4,732,144	Lightning	30.0
June 13	9,003	914,164	Lightning	5.8
June 21	3,372	466,705	Lightning	3.0
June 27	4,724	986,380	Lightning	6.2
<b>Total</b>	<b>34,427</b>	<b>7,831,938</b>		<b>50</b>

The sudden increase in the 2007 trend line(s) for each of the Operating Companies reflects the impact of weather events that affected their respective service territories. These weather events did not meet the threshold for a Request for Exclusion of Major Outage for Reliability Reporting Purposes (see § 57.195(e)(1)). The tables, following each Company's trend line graph, further illustrate the SAIDI impact of these non-excludable events.

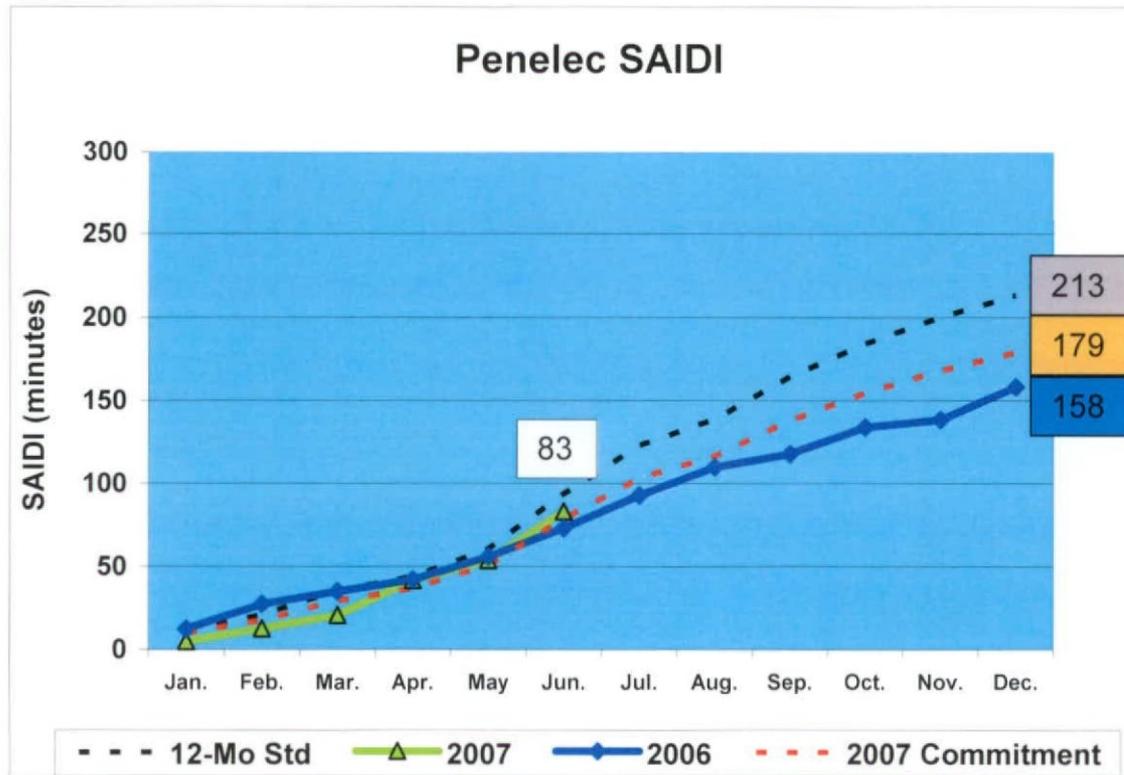
2<sup>nd</sup> Quarter 2007 Non-Excludable Events with a ≥ 1 minute impact on SAIDI

<i>Penelec</i>				
Start Date	Customers Affected	Customer Minutes Interrupted	Cause	SAIDI Impact
April 11	11,552	2,530,818	Wind	4.3
April 16	24,937	5,246,637	Snow / Wind	9.0
May 1	3,669	1,218,761	Lightning / Wind	2.1
June 8	34,214	6,565,507	Wind / Lightning	11.3
June 12	16,296	1,381,020	Wind / Lightning	2.4
June 19	10,299	1,150,929	Wind / Lightning	2.0
June 27	15,190	2,128,387	Wind / Lightning	3.7
<b>Total</b>	<b>116,157</b>	<b>20,222,059</b>		<b>35</b>

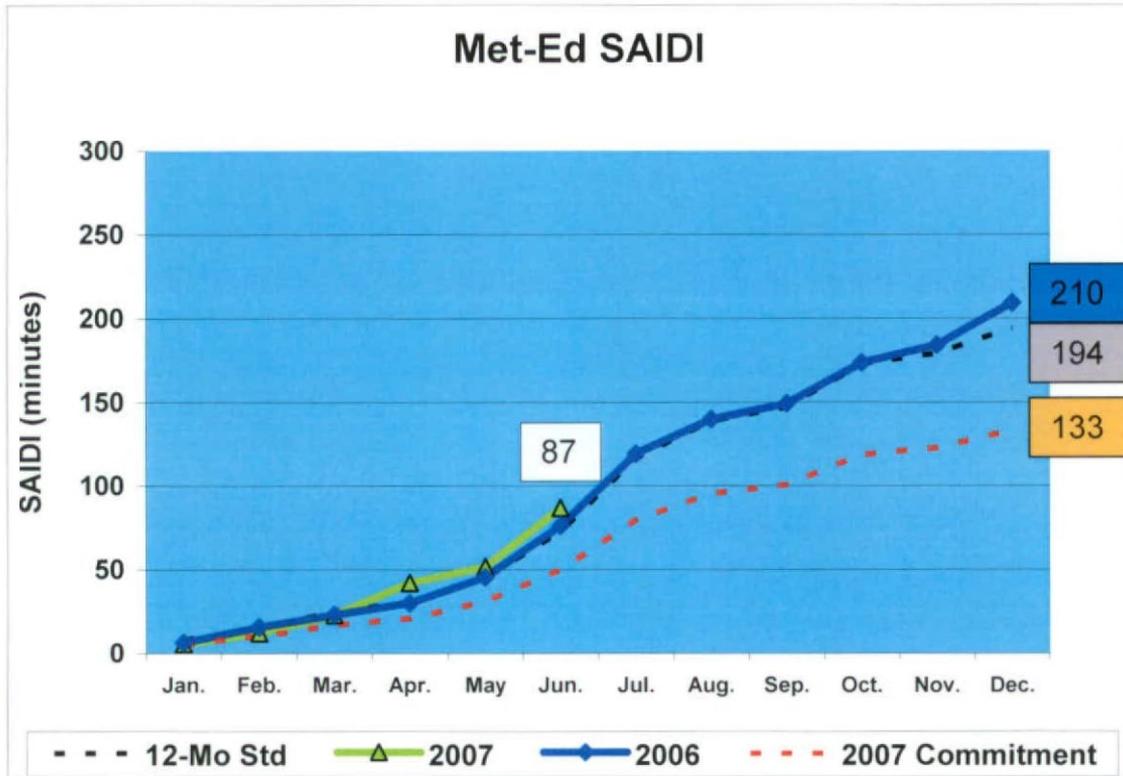
2<sup>nd</sup> Quarter 2007 Non-Excludable Events with a  $\geq 1$  minute impact on SAIDI

<i>Met-Ed</i>				
Start Date	Customers Affected	Customer Minutes Interrupted	Cause	SAIDI Impact
April 15	36,247	7,166,826	Wind, Rain, Snow	13.3
June 1	21,459	2,761,472	Lightning	5.1
June 3	5,994	667,507	Wind, Rain	1.2
June 12	5,112	874,131	Lightning, Rain	1.6
June 13	23,078	1,808,279	Lightning, Rain	3.4
June 19	31,654	6,256,960	Lightning, Rain	11.6
June 27	11,081	719,925	Lightning, Rain	1.3
<b>Total</b>	<b>134,625</b>	<b>20,255,100</b>		<b>38</b>

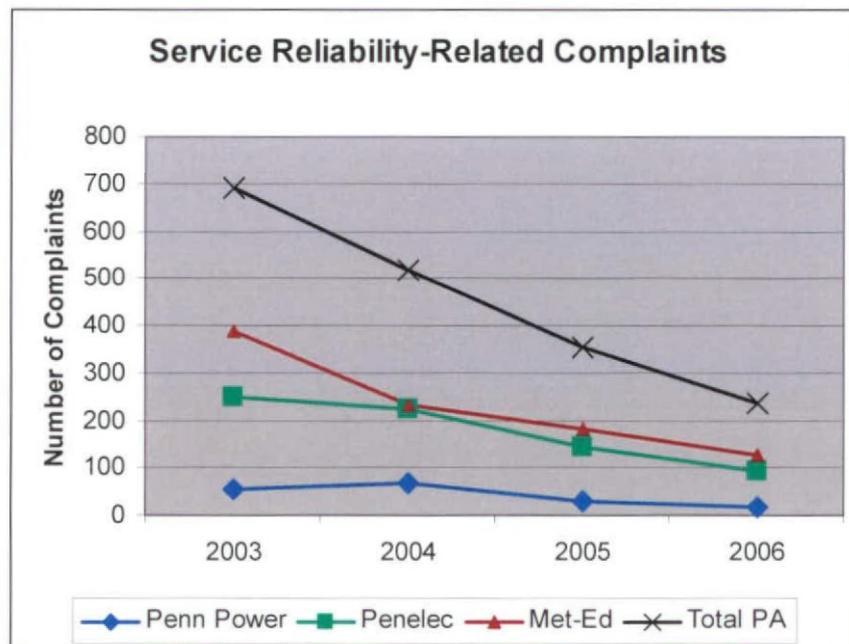
- The reliability performance improvement demonstrated to date and as described in Section e(2) of this report.
- The Companies' increased and improved communication with customers through the utilization of reverse interactive voice response ("IVR").
- Reduction in service reliability-related customer complaints (see graph below).

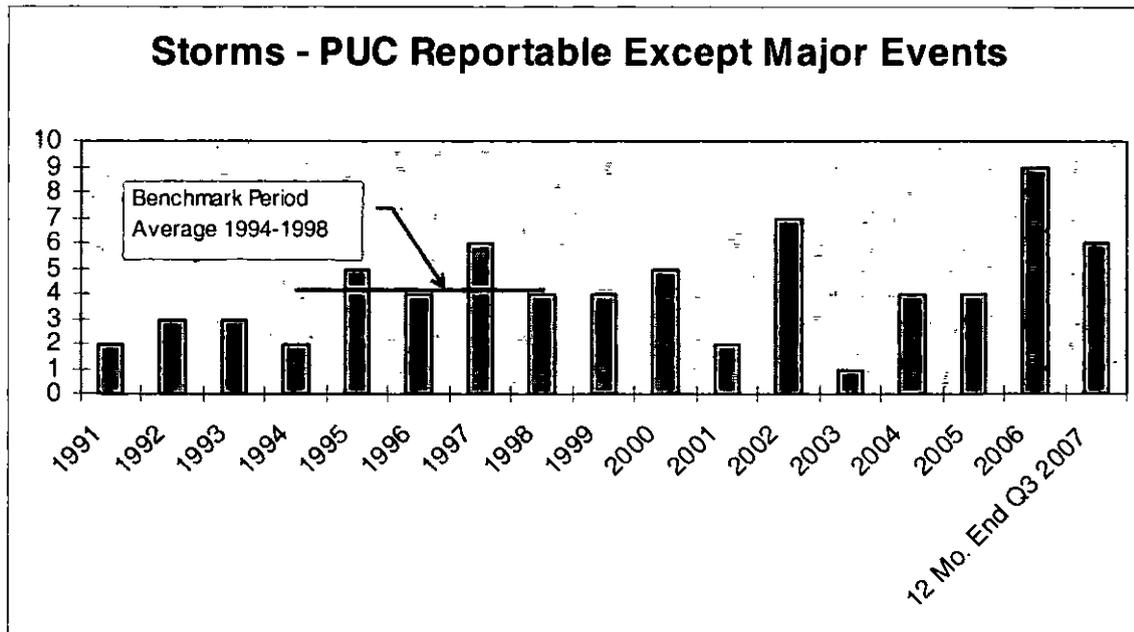
Specifically, during the twelve-month reporting period, there were six (6) PUC-reportable storms ( $\geq 2,500$  customers interrupted for  $\geq 6$  hr.). This is well above the average of 4.2 storms per year during the benchmark years, 1994-1998.

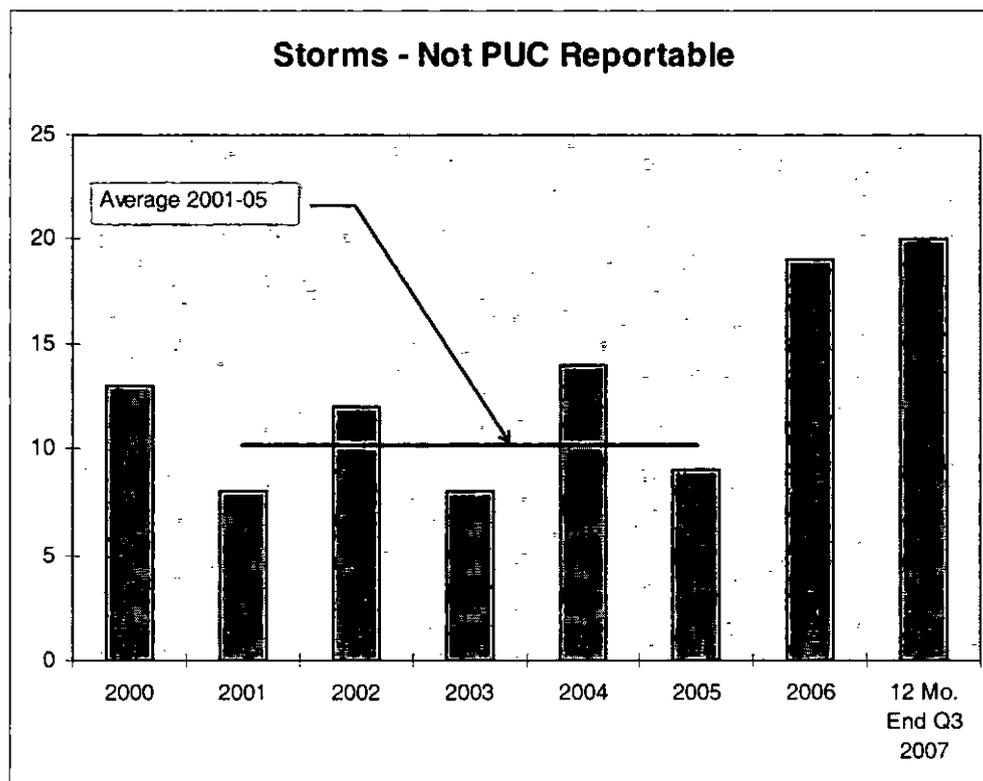
In addition, there were twenty (20) storms that were not reportable, but which did require opening one or more area emergency centers to manage restoration efforts. This is 96% higher than the average of 10.2 storms per year for the five years from 2001 through 2005.

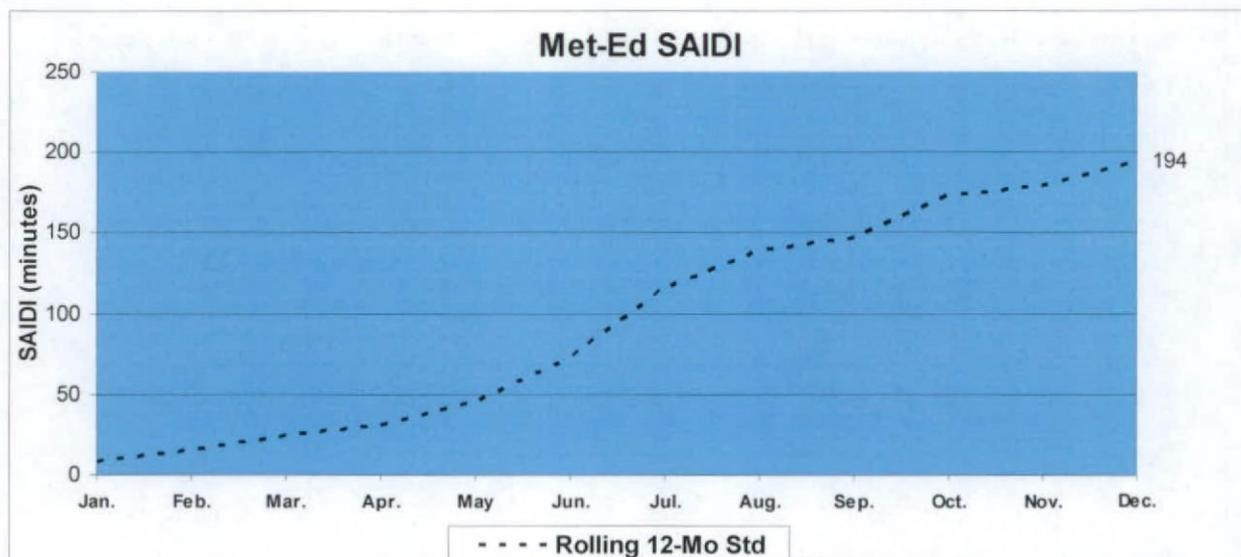
The normalized trend line is a slight modification to a straight-line trend, taking into consideration the three-year historical performance of each Company, with higher SAIDI accumulation (customer minutes of interruption) during the summer storm months, and lower SAIDI accumulation in the winter months. For example, Met-Ed's 3-year historical performance indicates the Company would expect to accumulate more SAIDI in June through August (approximately 31 minutes per month) than in November through December (approximately 11 minutes per month). As shown in the Met-Ed chart below, the Commission's 12-Month Rolling Standard of 194 is plotted using this normalized trending approach.

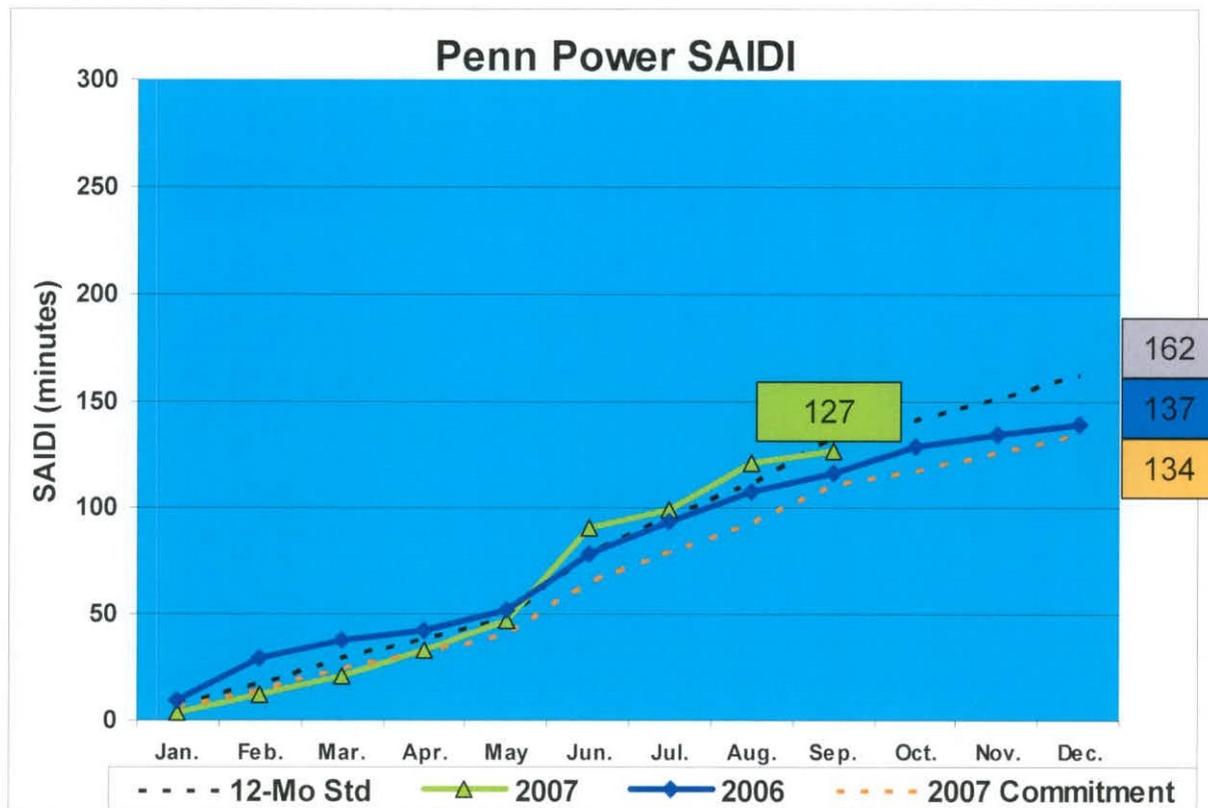
3rd Quarter 2007 Non-Excludable Events with a  $\geq 1$  minute impact on SAIDI

<i>Penn Power</i>				
Start Date	Customers Affected	Customer Minutes Interrupted	Cause	SAIDI Impact
Aug 7	10,960	1,728,630	Thunderstorm	11
<b>Total</b>	<b>10,960</b>	<b>1,728,630</b>		<b>11</b>

The increase in the 2007 trend line(s) for each of the Operating Companies reflects the impact of weather events that affected their respective service territories. These weather events did not meet the threshold for a Request for Exclusion of Major Outage for Reliability Reporting Purposes (see § 57.195(e)(1)). The tables, following each Company's trend line graph, further illustrate the SAIDI impact of these non-excludable events.

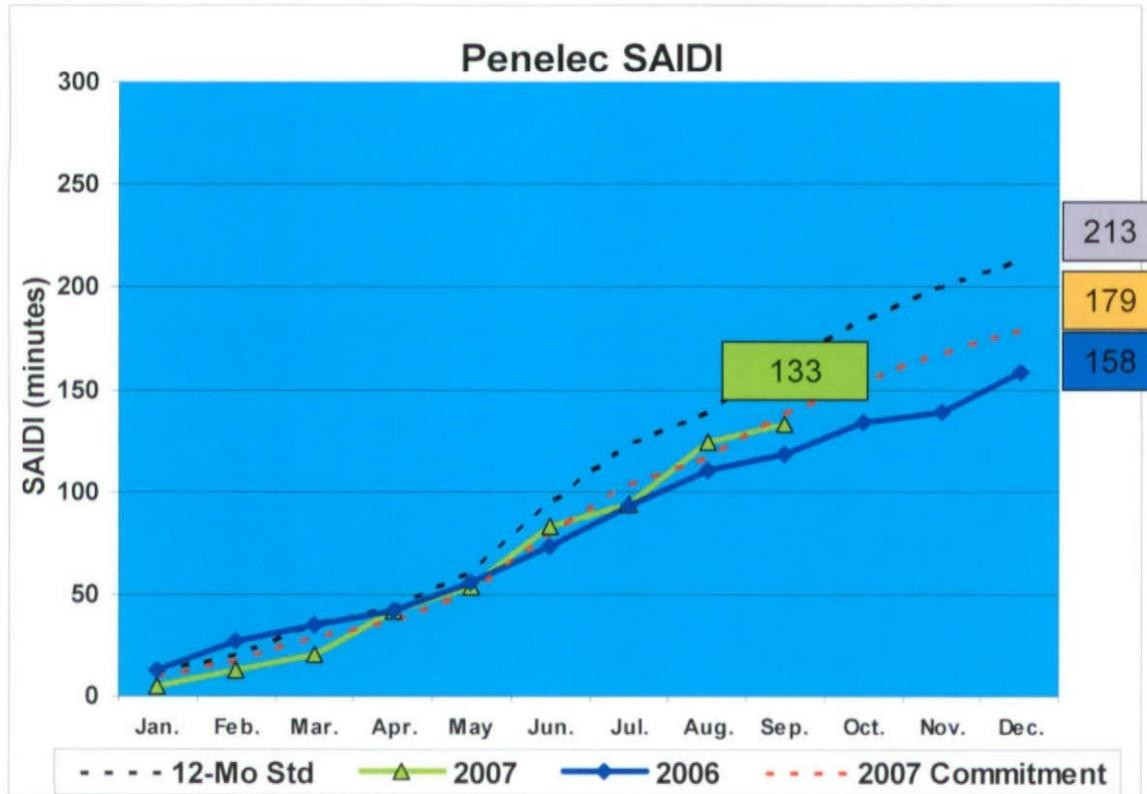
3<sup>rd</sup> Quarter 2007 Non-Excludable Events with a ≥ 1 minute impact on SAIDI

<i>Penelec</i>				
Start Date	Customers Affected	Customer Minutes Interrupted	Cause	SAIDI Impact <sup>(a)</sup>
July 28	4,351	666,198	Thunderstorm	1
Aug 2	8,573	831,187	Thunderstorm	1
Aug 7	35,002	3,468,589	Thunderstorm	6
Aug 17	2,350	765,486	Thunderstorm	1
Aug 23	40,025	6,375,127	Thunderstorm	11
Aug 30	3,490	265,427	Thunderstorm	1
Sept 8	6,293	831,664	Thunderstorm	1
Sept 26	3,525	1,459,053	Thunderstorm	3
Sept 27	4,164	539,052	Thunderstorm	1
<b>Total</b>	<b>107,773</b>	<b>15,201,783</b>		<b>26</b>

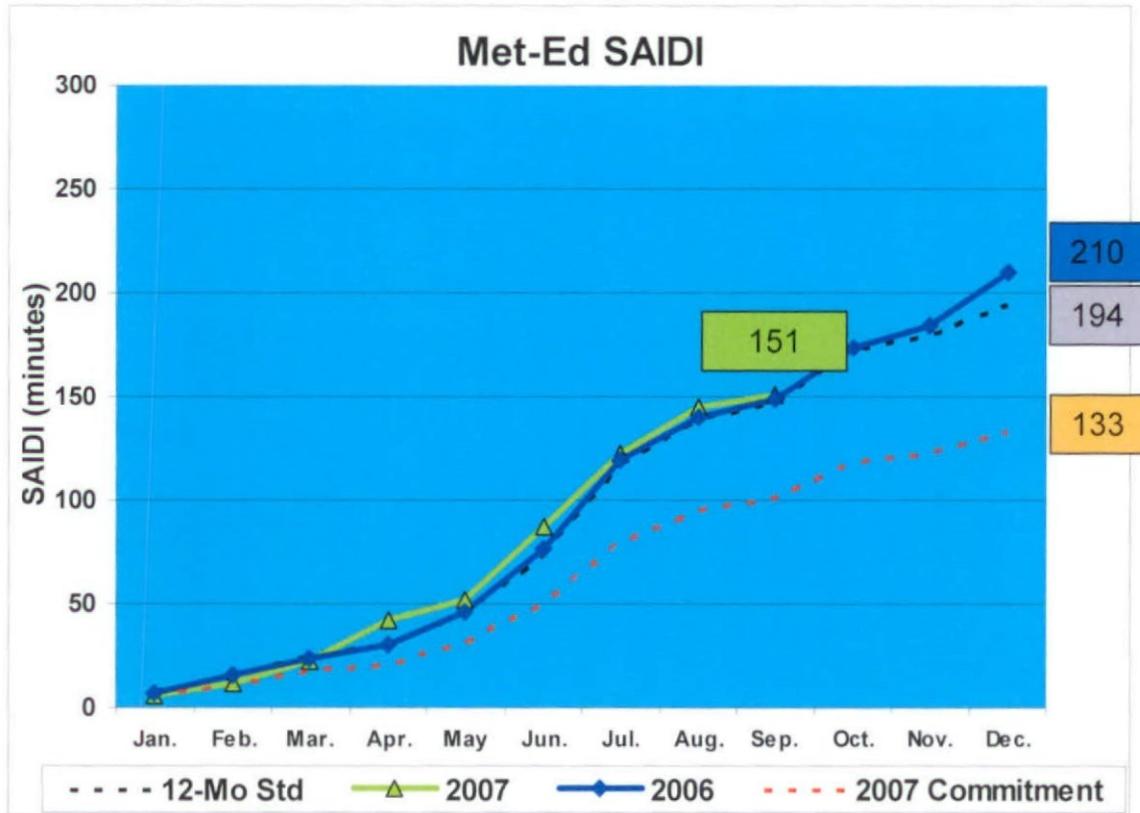
3<sup>rd</sup> Quarter 2007 Non-Excludable Events with a ≥ 1 minute impact on SAIDI

<i>Met-Ed</i>				
Start Date	Customers Affected	Customer Minutes Interrupted	Cause	SAIDI Impact <sup>(a)</sup>
July 10	22,488	11,369,559	Thunderstorm	21
July 27	37,392	3,473,074	Thunderstorm	7
Aug 3	14,767	1,883,709	Rain/Wind	4
Aug 8	5,923	956,256	Thunderstorm	2
Aug 9	8,717	709,327	Thunderstorm	1
Aug 25	24,908	2,643,596	Thunderstorm	5
Sept 27	2,447	289,699	Thunderstorm	1
<b>Total</b>	<b>116,642</b>	<b>21,325,220</b>		<b>39</b>

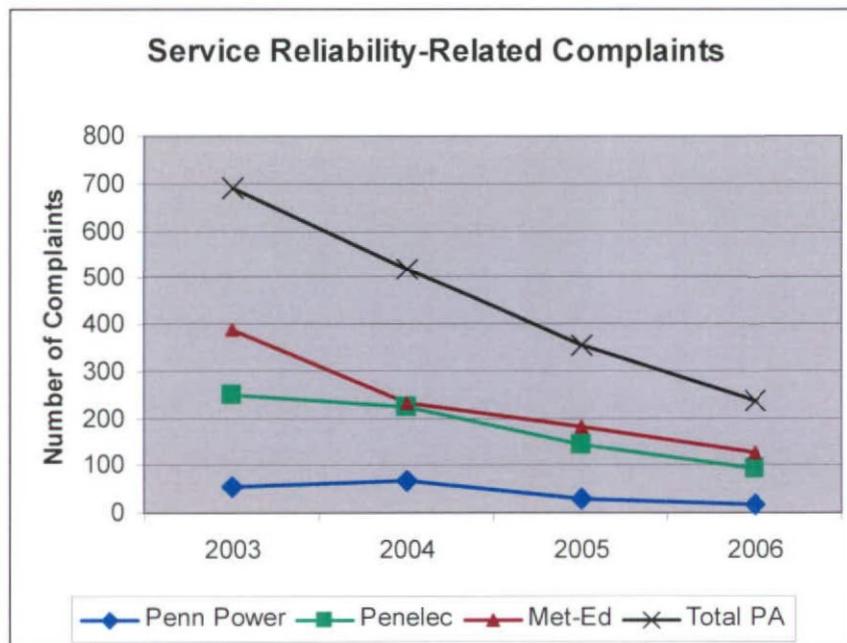
- The reliability performance improvement demonstrated to date and as described in Section e(2) of this report.
- The Companies' increased and improved communication with customers through the utilization of reverse interactive voice response ("IVR").
- Reduction in service reliability-related customer complaints (see graph below).

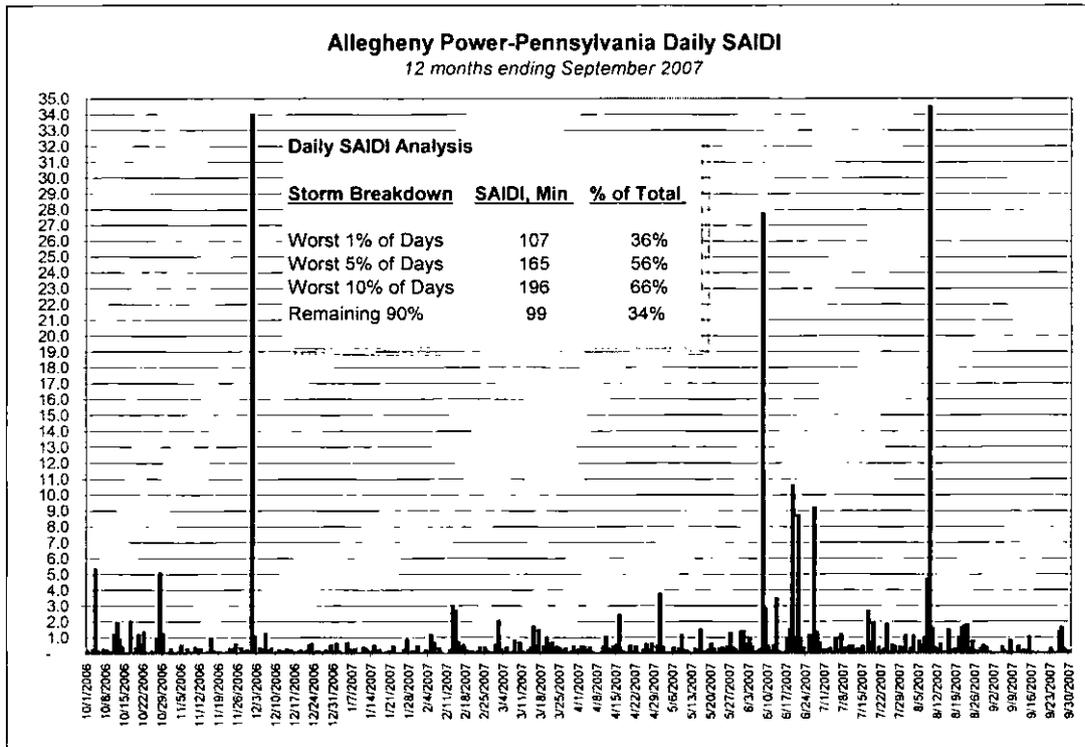
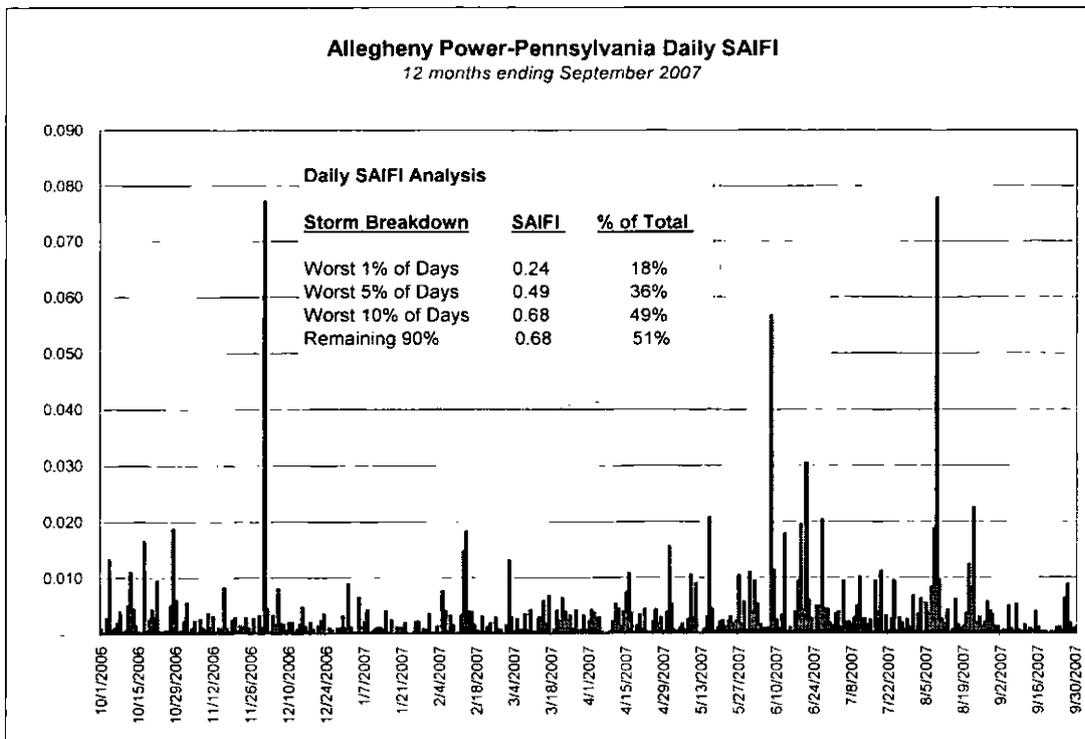
The daily SAIDI and SAIFI are shown in the charts below.

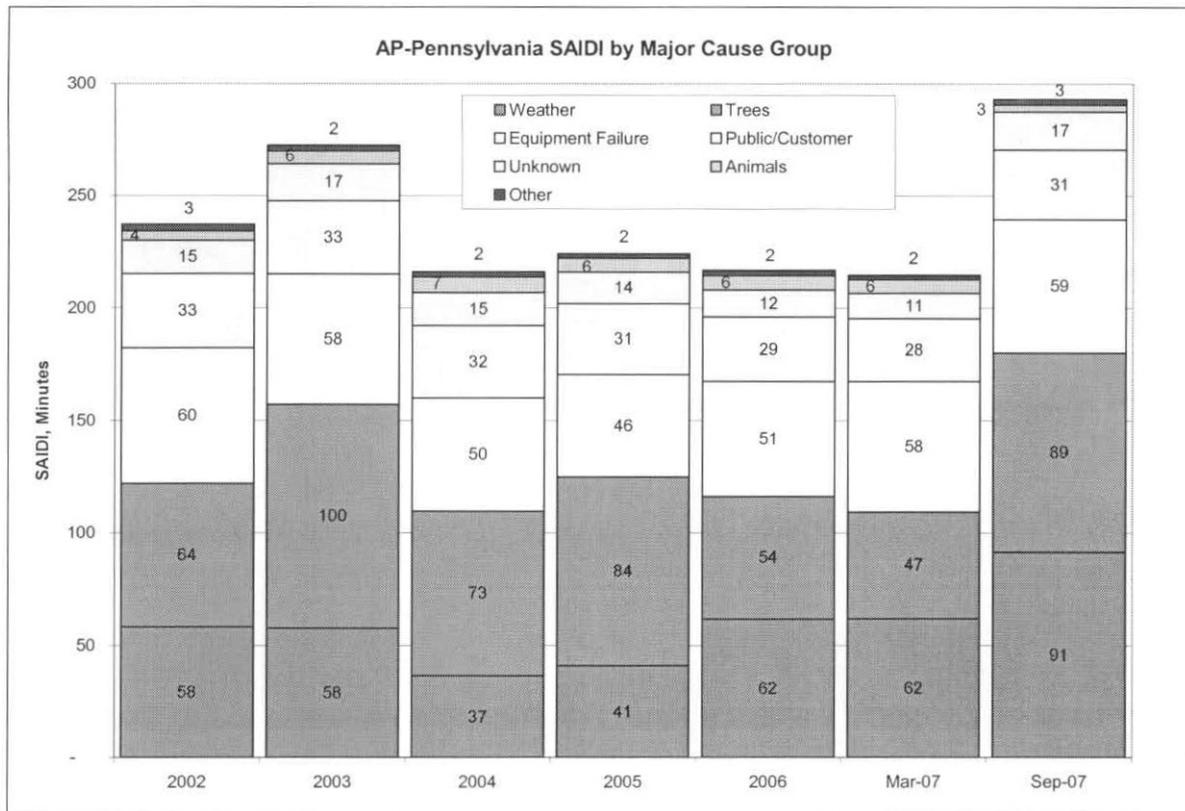
Initial data analysis by high level cause is shown below. While we have seen some increase in equipment-related outages in 2007, the largest increases have been in weather-related and tree-related outages, particularly since the 1<sup>st</sup> quarter of 2007, before which Allegheny's SAIDI was gradually declining. Allegheny Power will continue to do more detailed analysis on the summer increase in statistics.

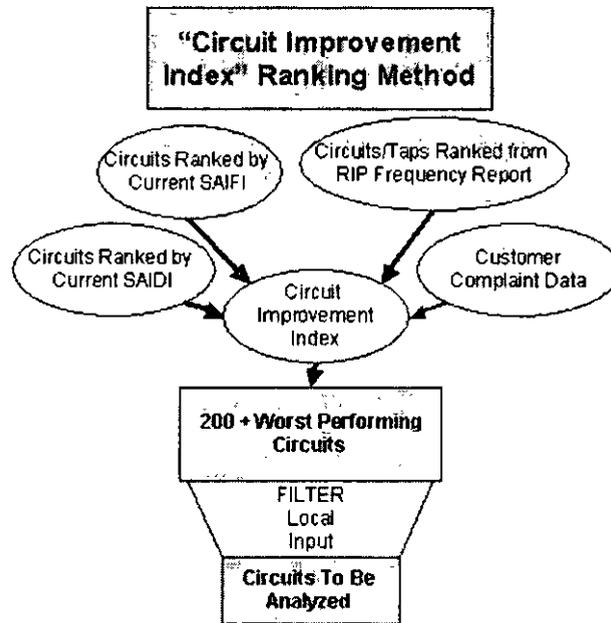
5% of AP's 1850 circuits equals 93 circuits. Once circuits are selected for the next year, individual analysis will take place as part of AP's ongoing structured Reliability Improvement Program (RIP). Outage causes will be evaluated, circuit outage maps will be created to assist in the evaluation if needed, and budgets and work plans will be established to improve reliability for viable projects.

A schematic diagram of the process follows:
